Road Condition Analysis Report

Road: Marine Drive in Mumbai

Date: 2025-04-22 20:52:25

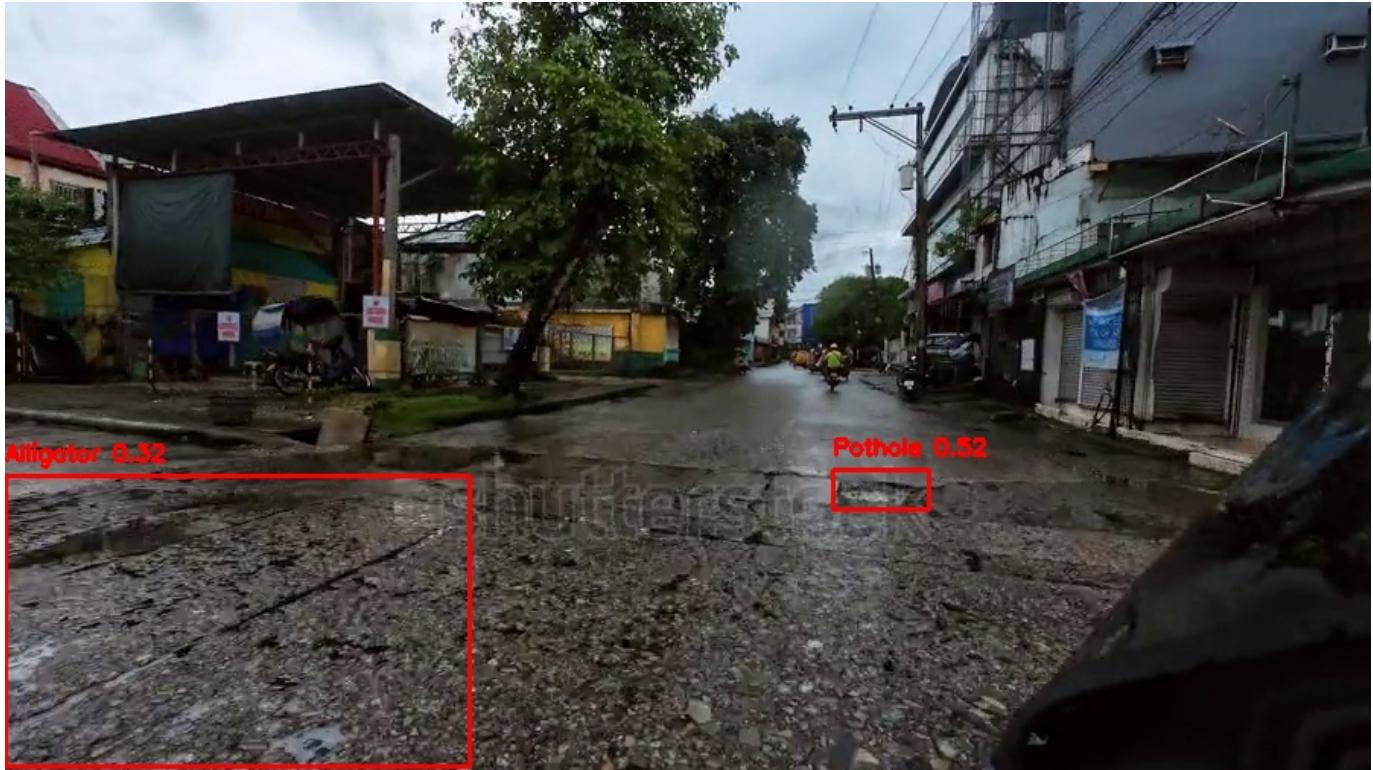
Frame 1: Detected defects - Pothole (0.52), Alligator (0.32)

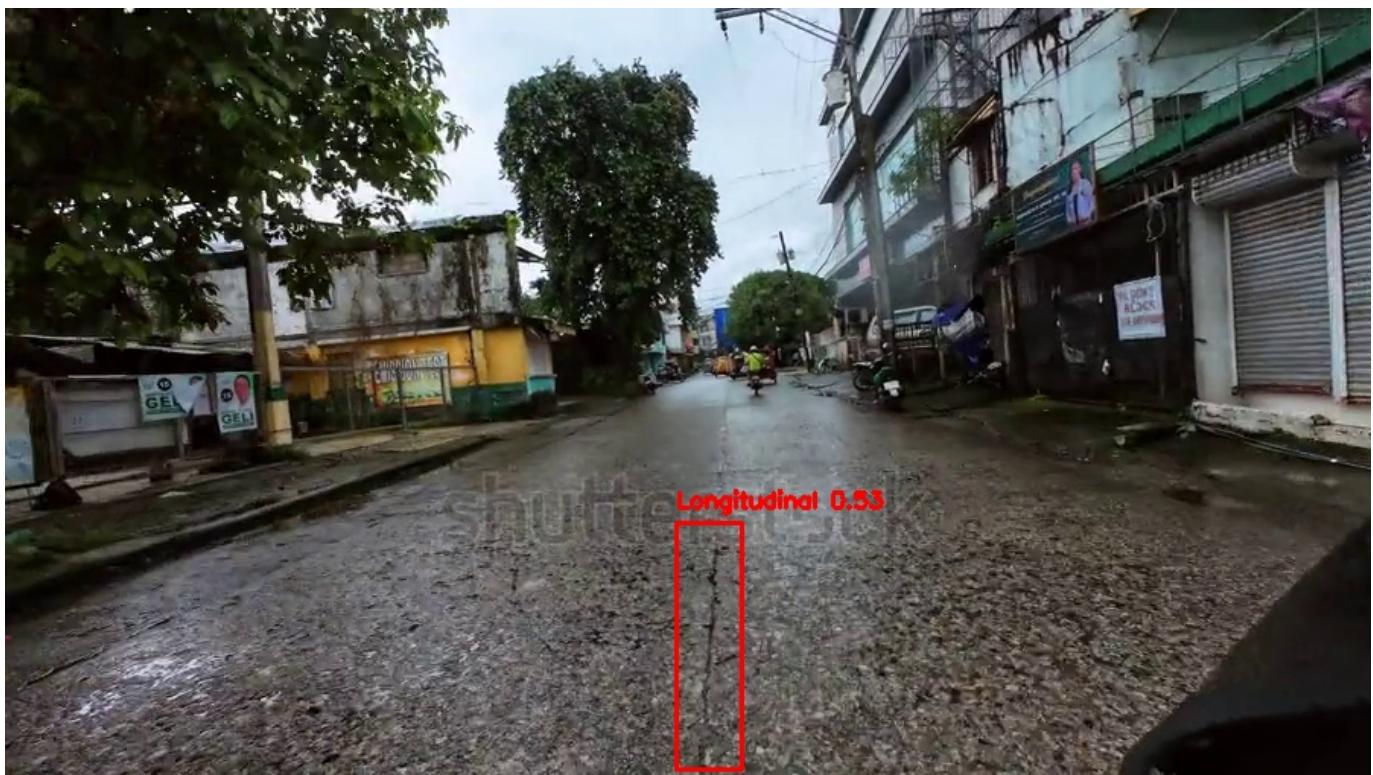
Frame 2: Detected defects - Longitudinal (0.53)

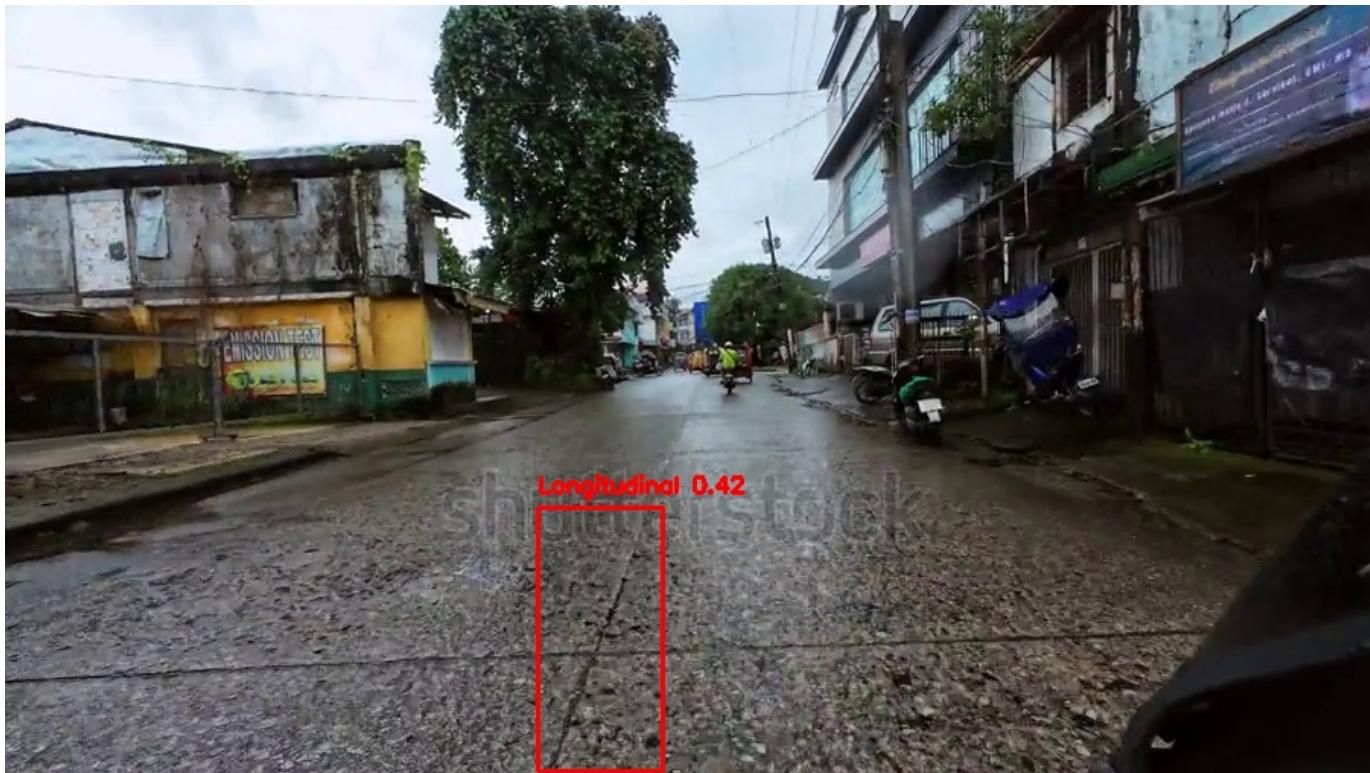
Frame 3: Detected defects - Longitudinal (0.42)

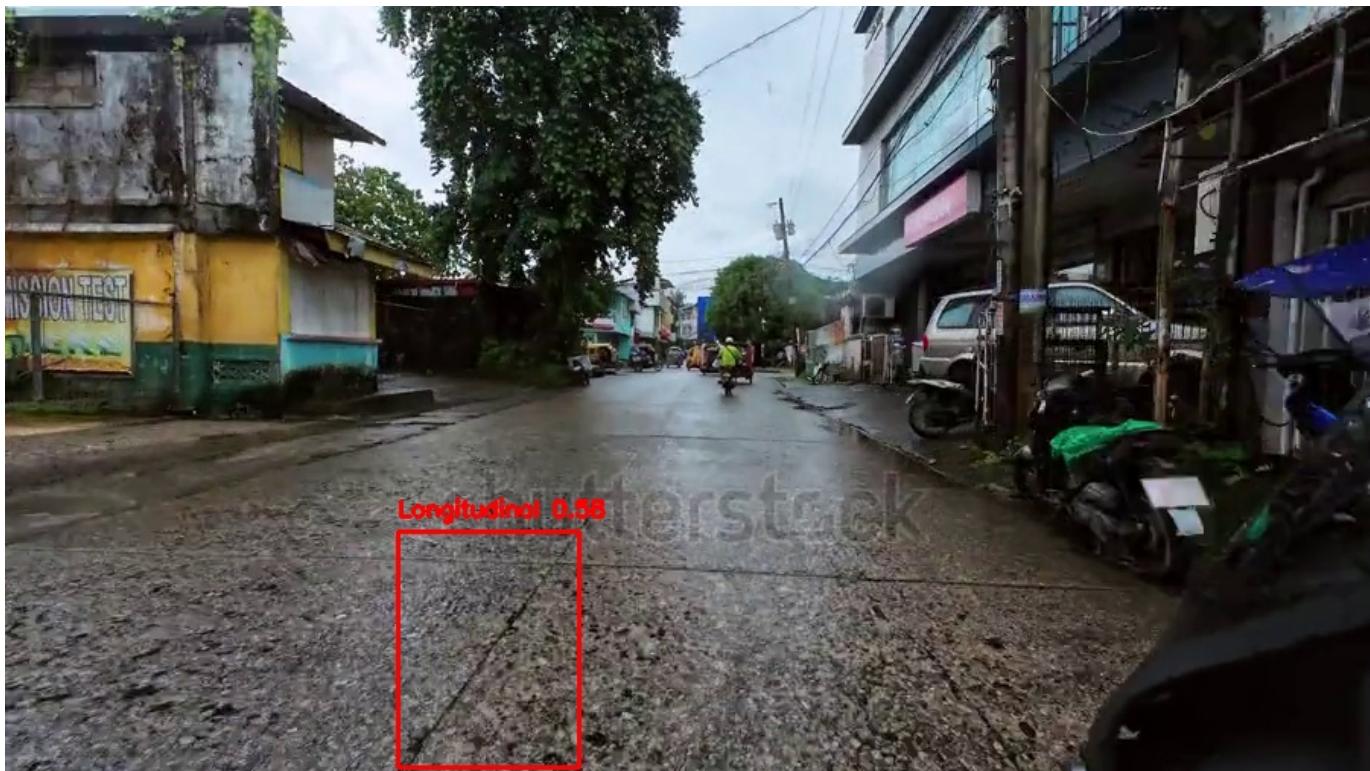
Frame 4: Detected defects - Longitudinal (0.58)

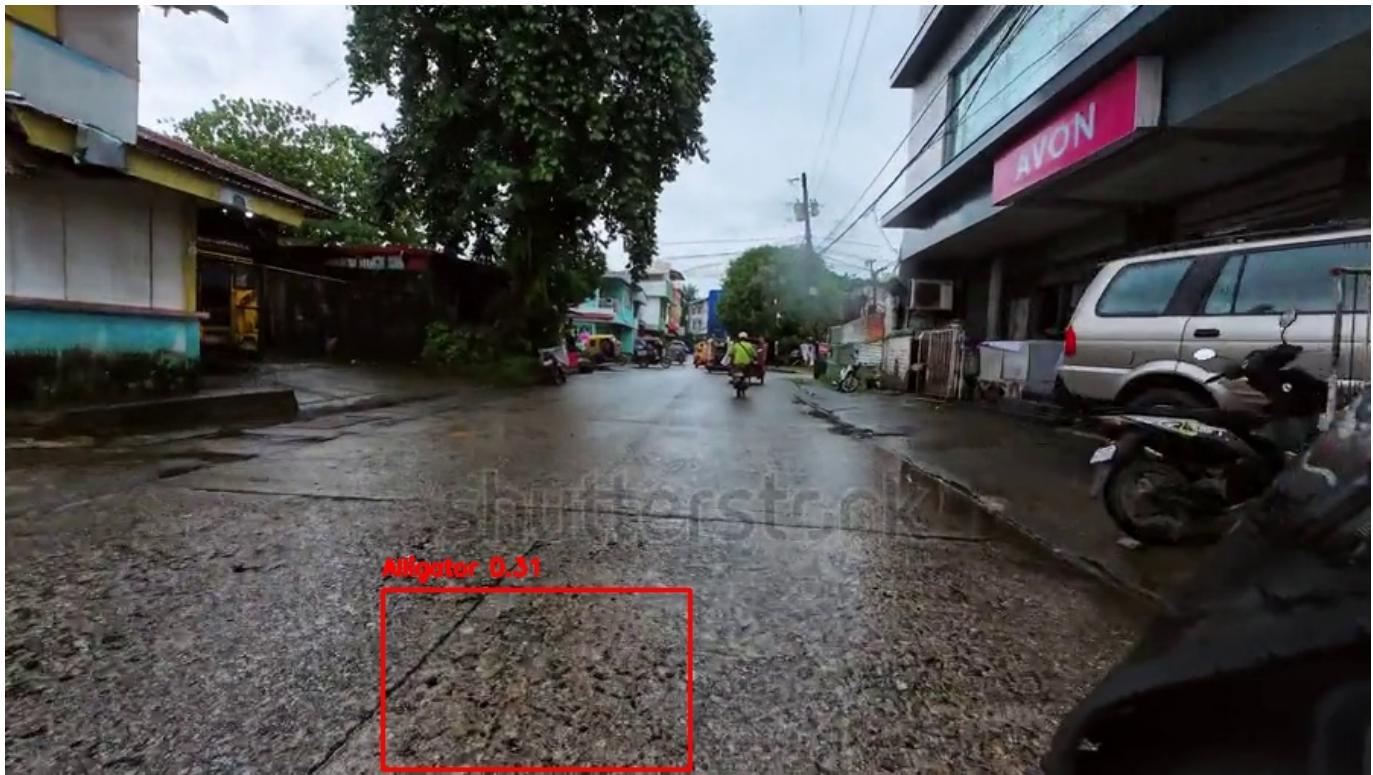
Frame 5: Detected defects - Alligator (0.31)

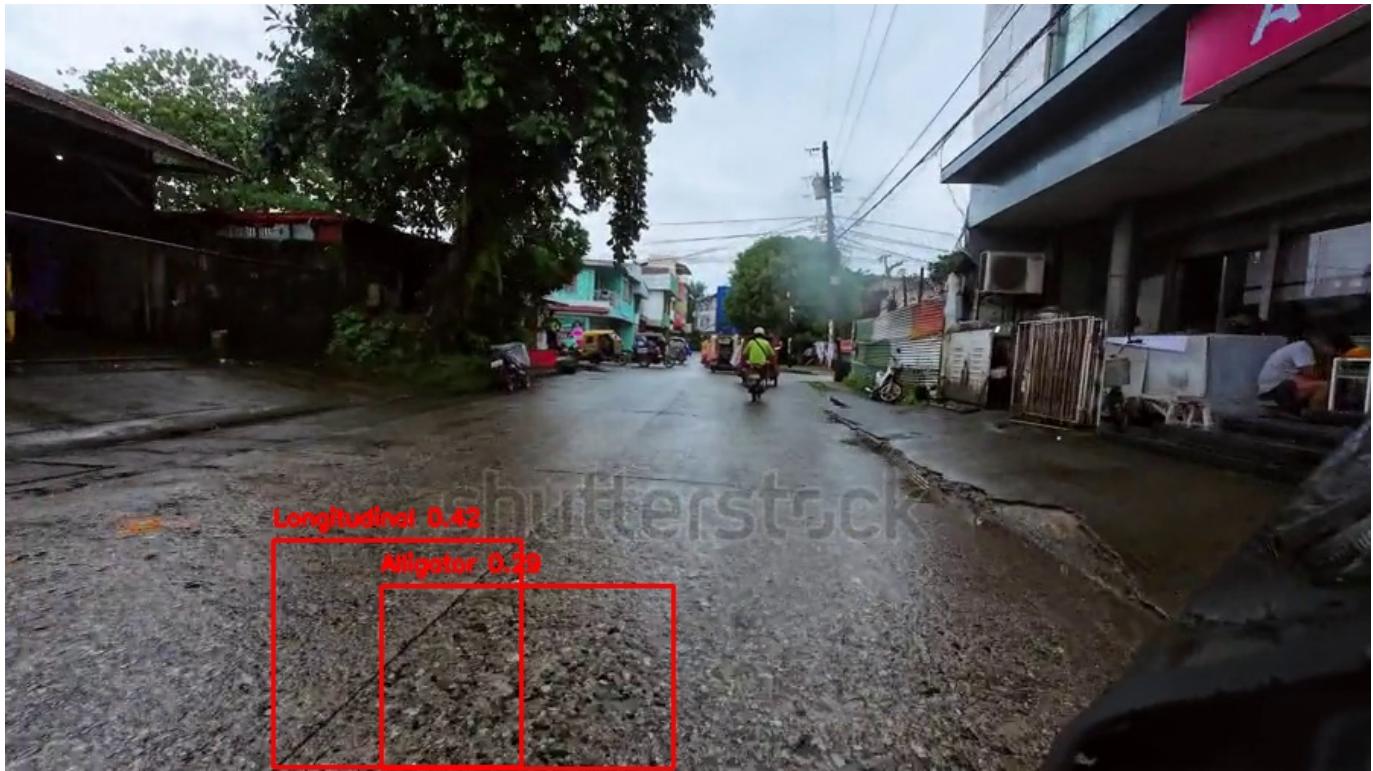
Frame 6: Detected defects - Longitudinal (0.42), Alligator (0.29)

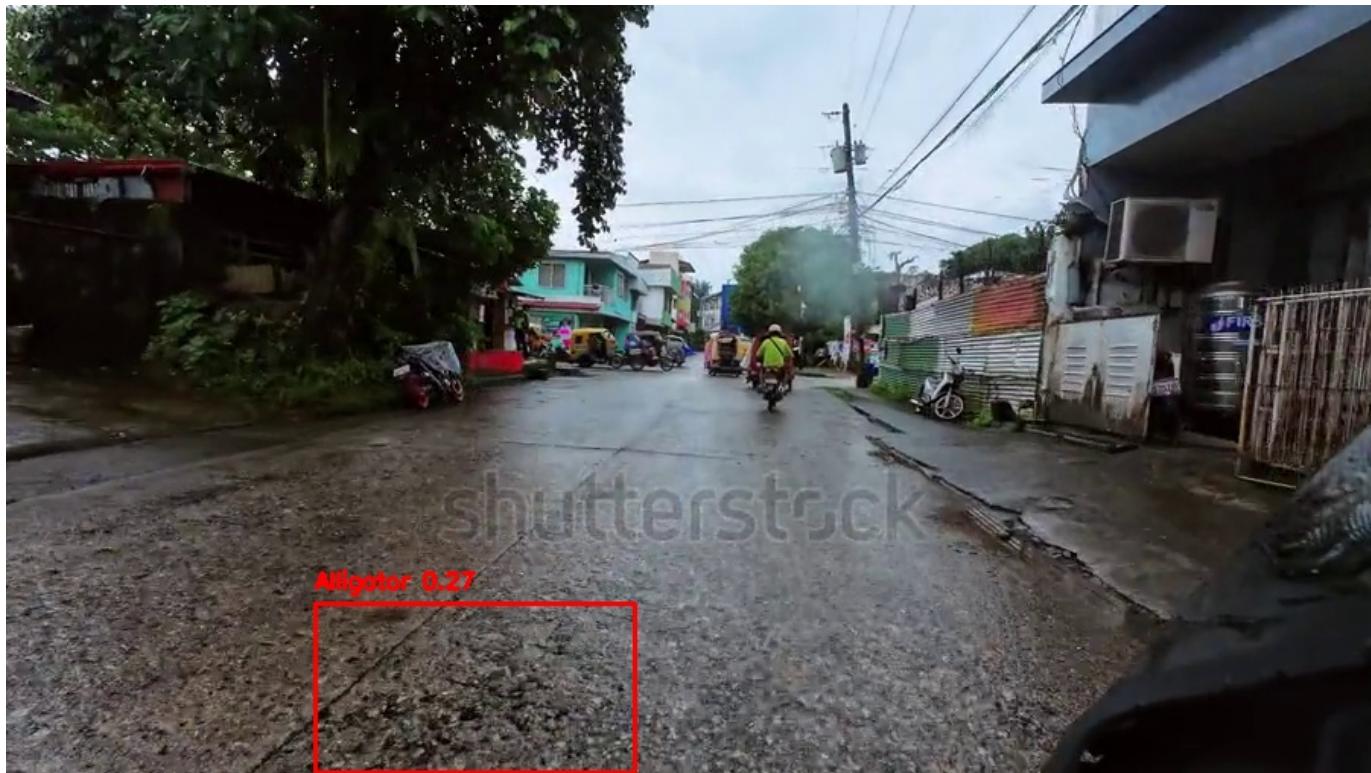
Frame 7: Detected defects - Alligator (0.27)

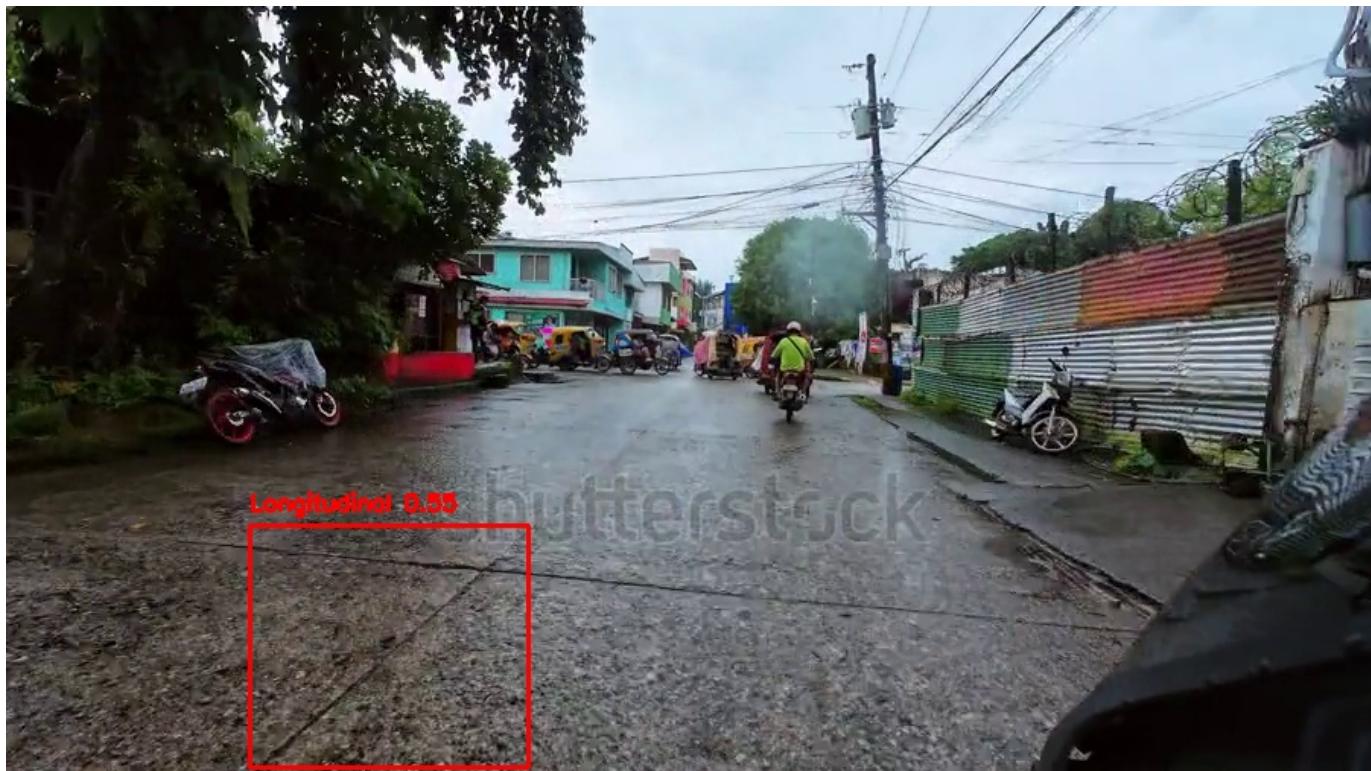
Frame 8: Detected defects - Longitudinal (0.55)

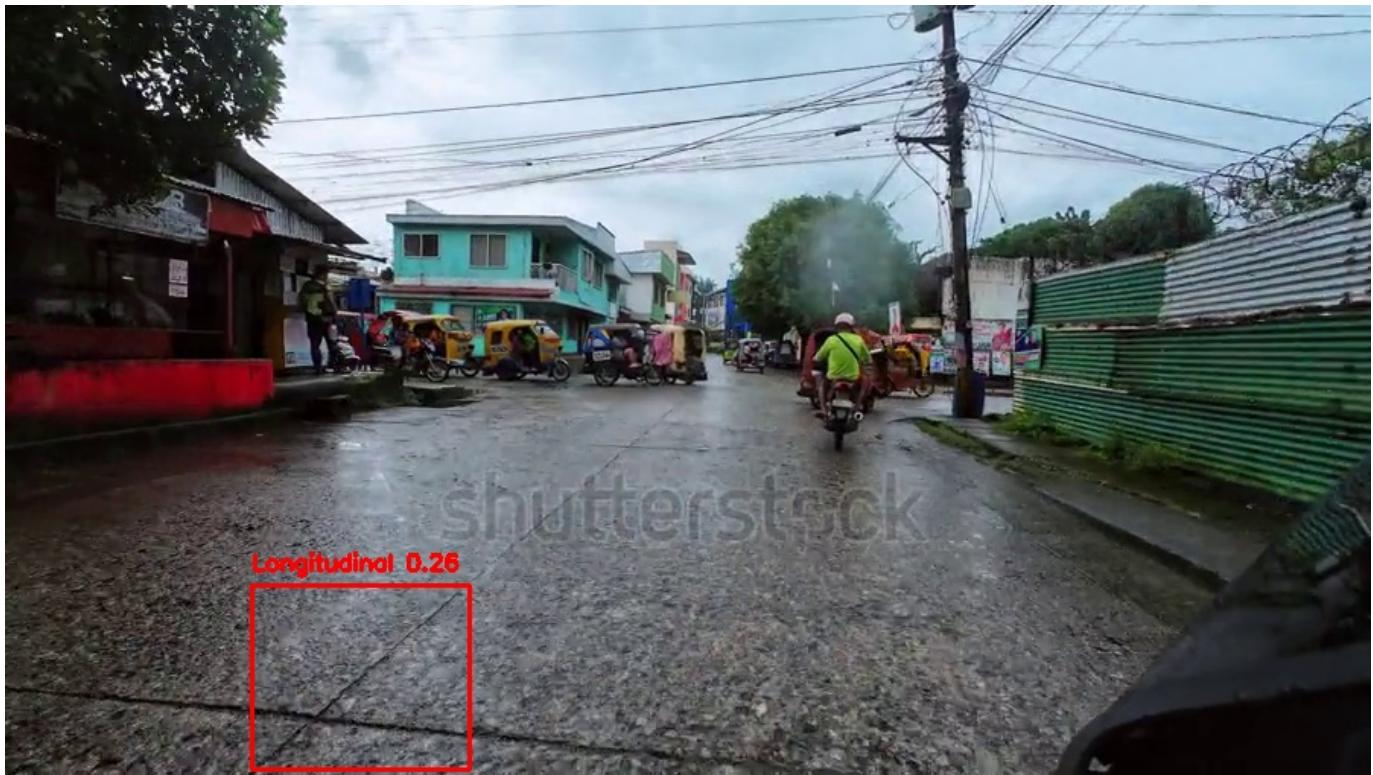
Frame 9: Detected defects - Longitudinal (0.26)

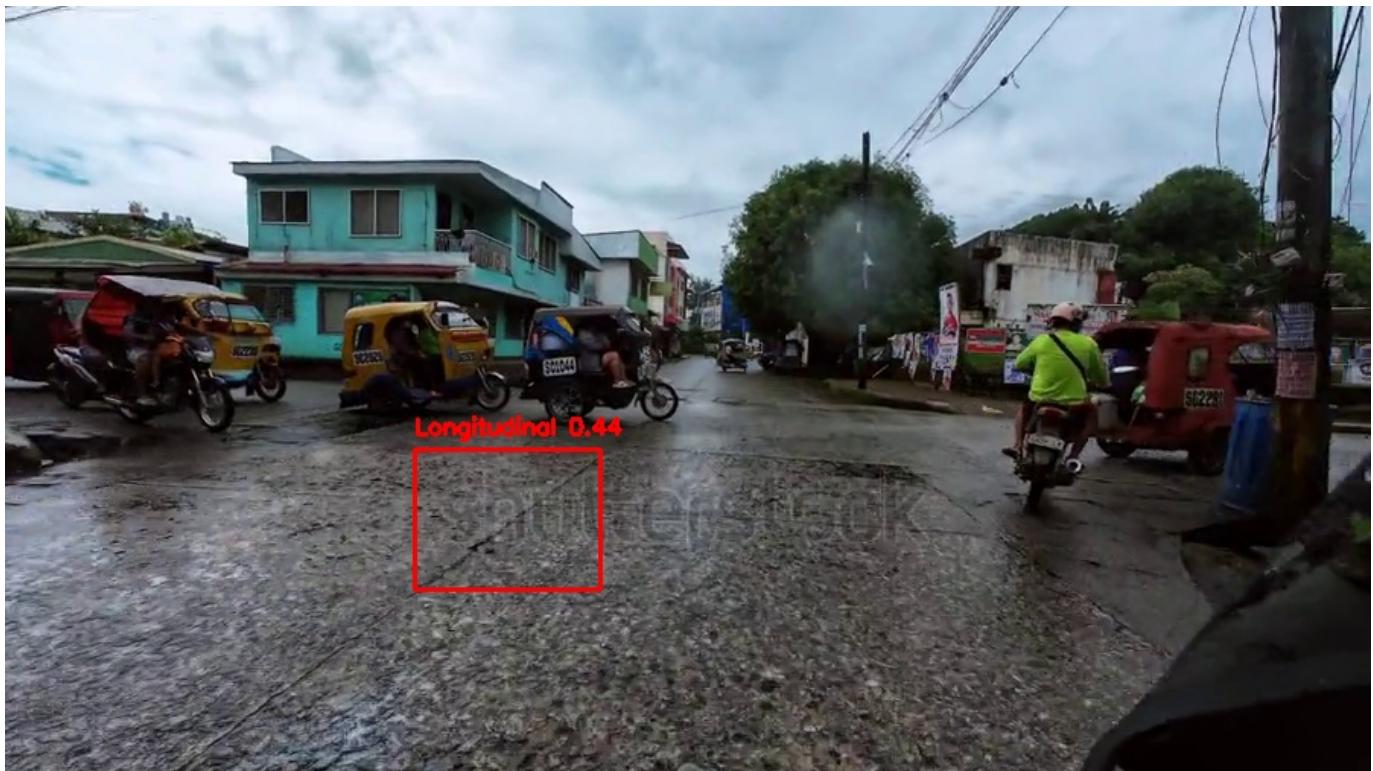
Frame 10: Detected defects - Longitudinal (0.44)

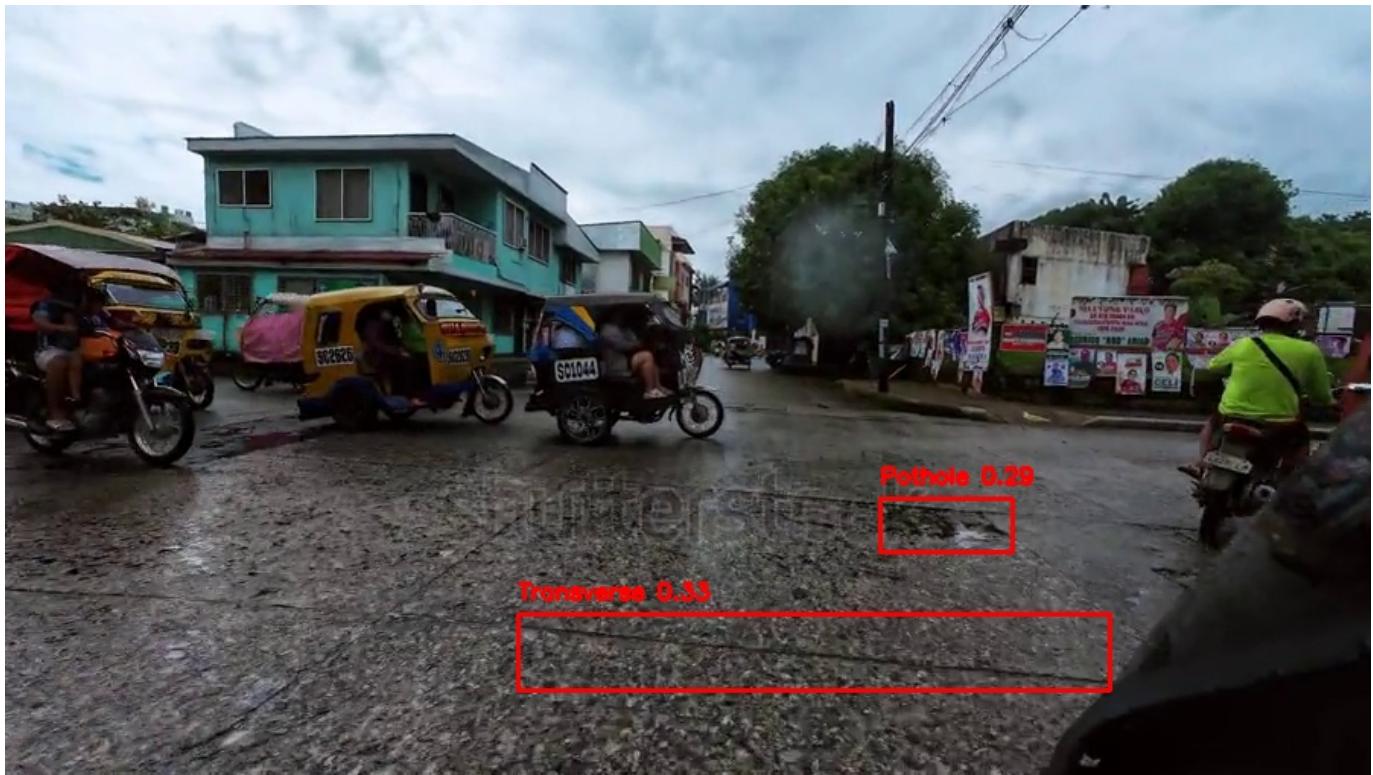
Frame 11: Detected defects - Transverse (0.33), Pothole (0.29)

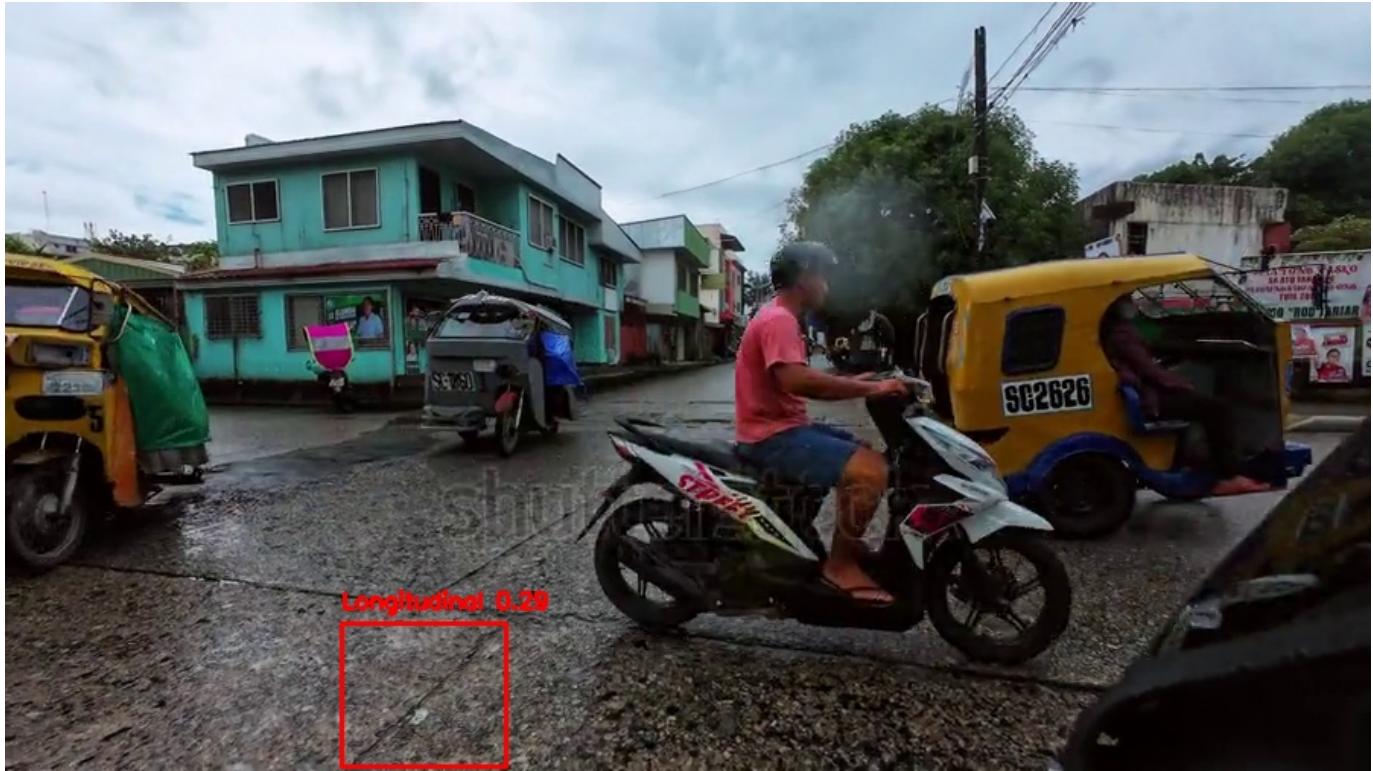
Frame 12: Detected defects - Longitudinal (0.29)

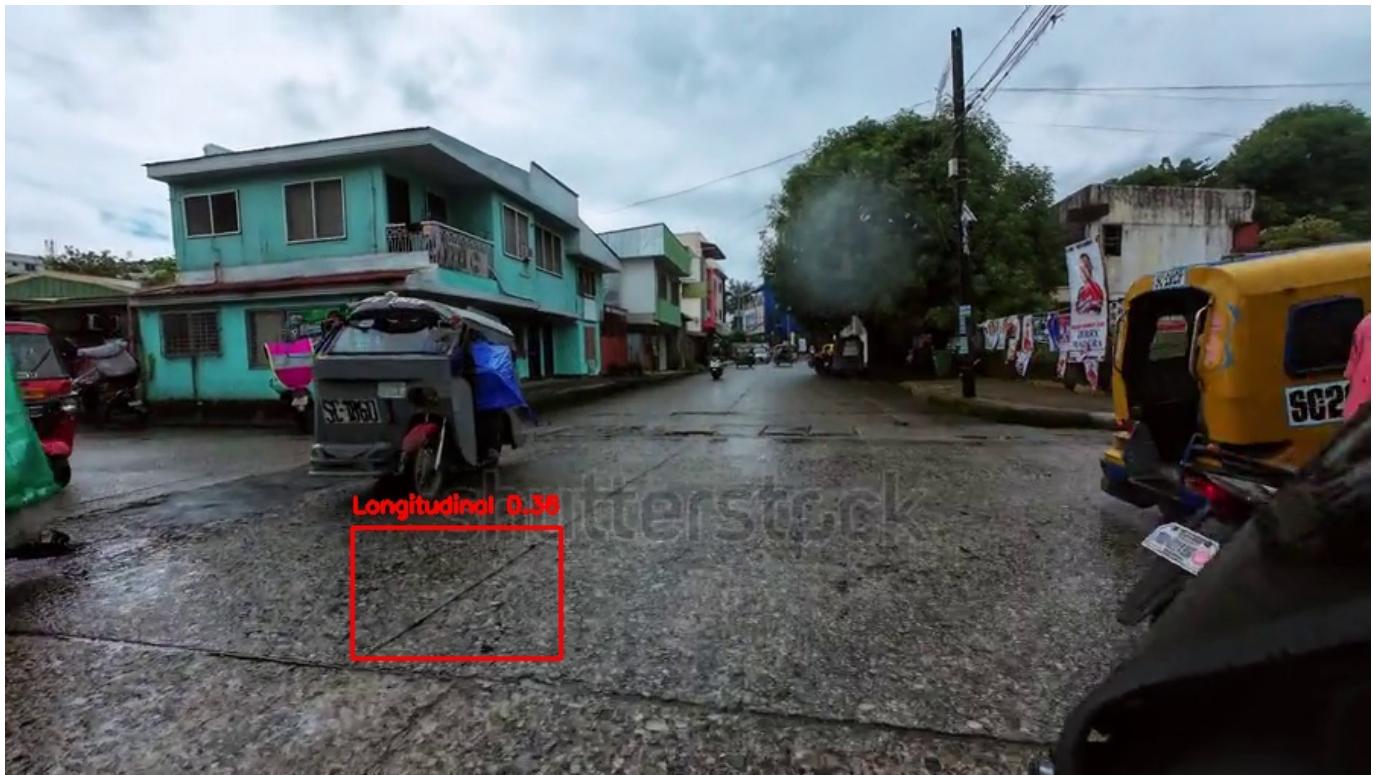
Frame 13: Detected defects - Longitudinal (0.36)

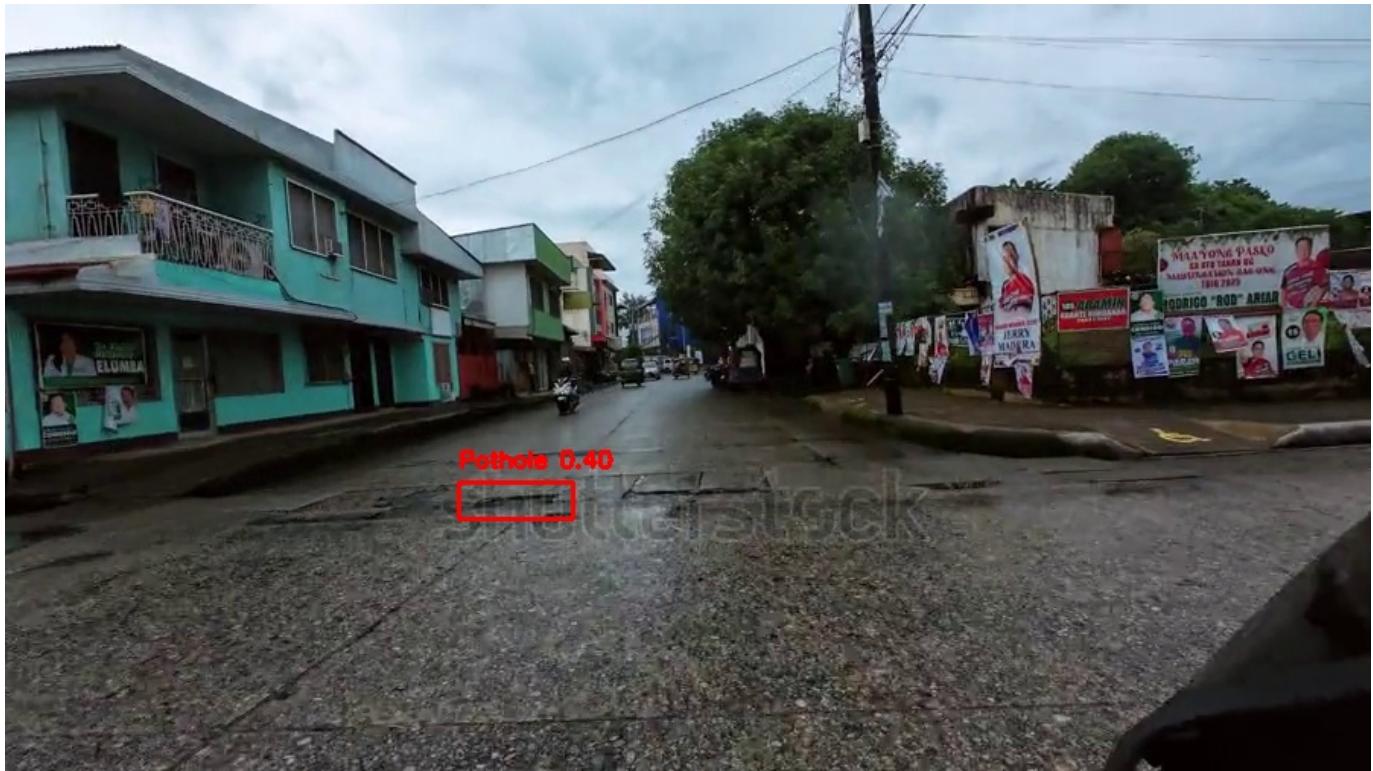
Frame 14: Detected defects - Pothole (0.40)

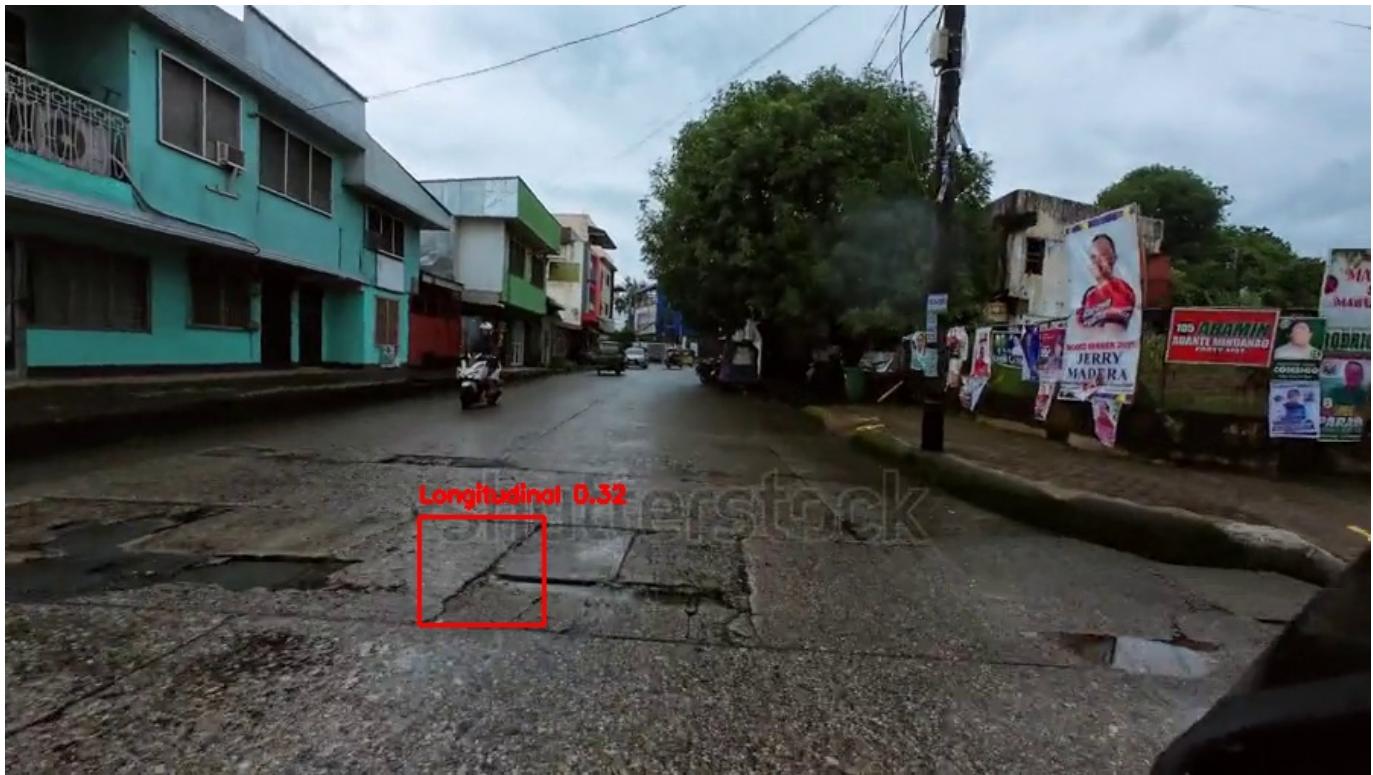
Frame 15: Detected defects - Longitudinal (0.32)

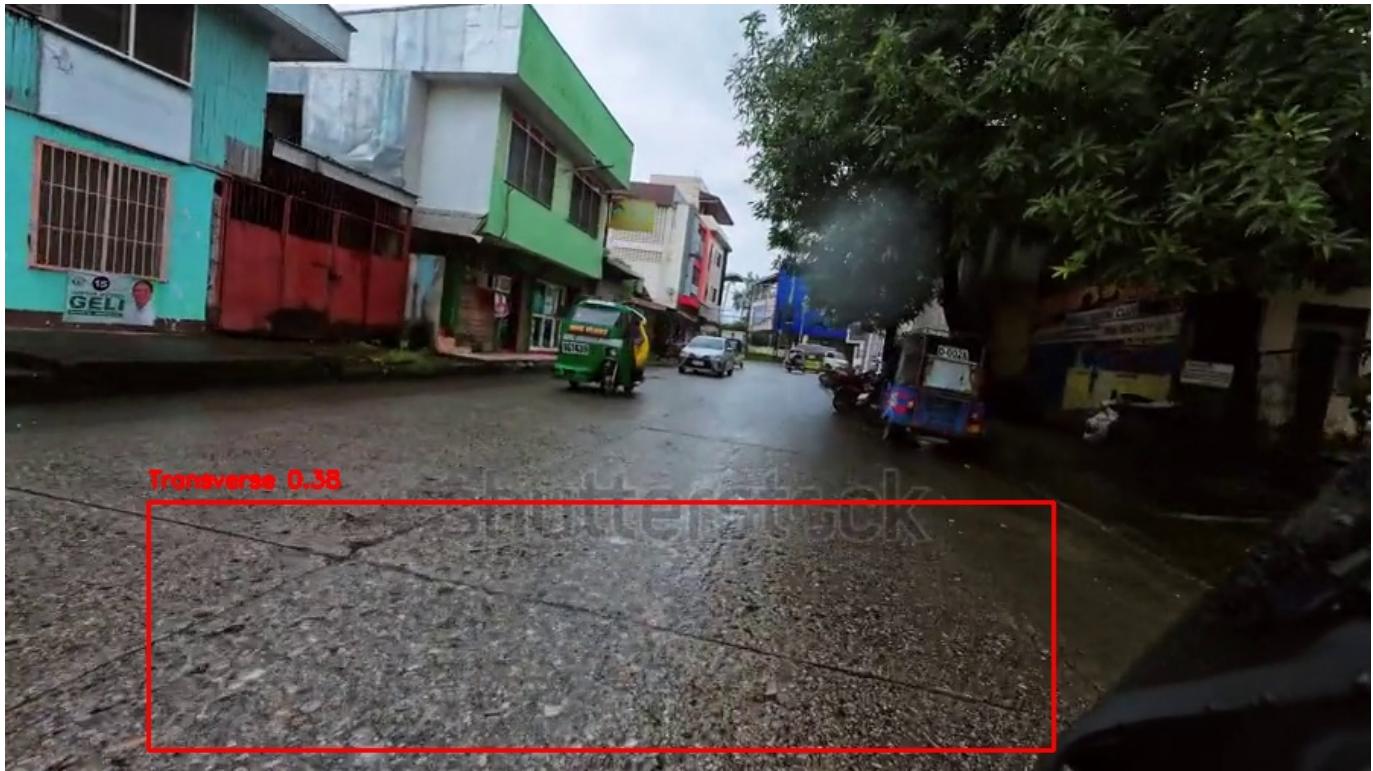
Frame 16: Detected defects - Transverse (0.38)

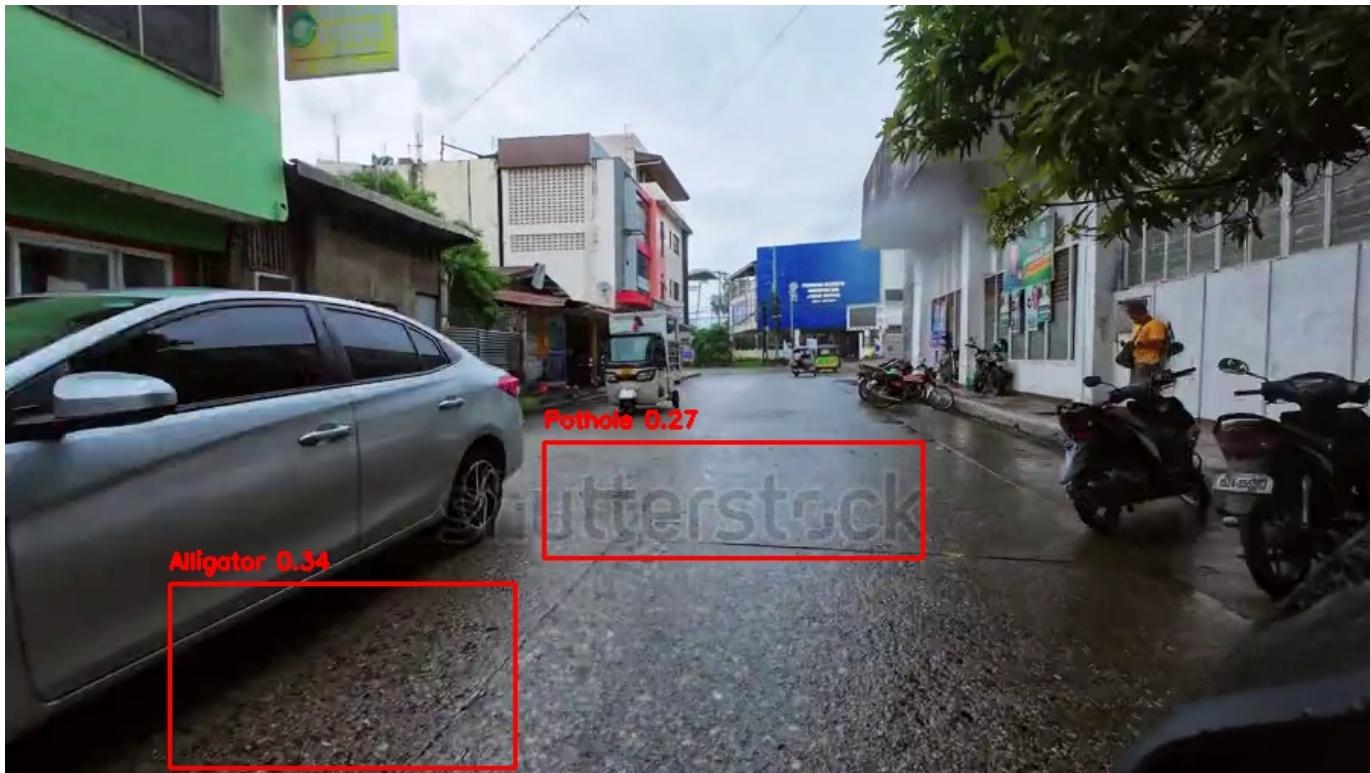
Frame 17: Detected defects - Alligator (0.34), Pothole (0.27)

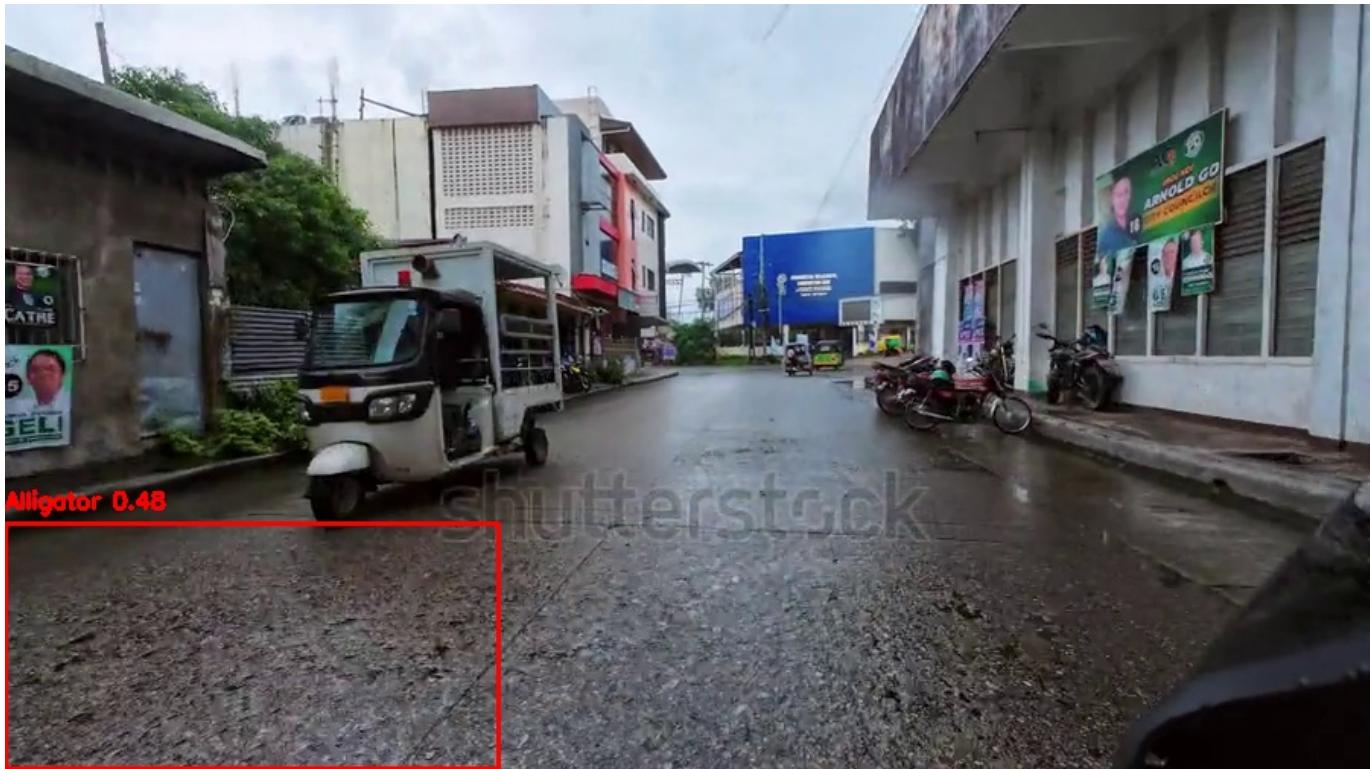
Frame 18: Detected defects - Alligator (0.48)

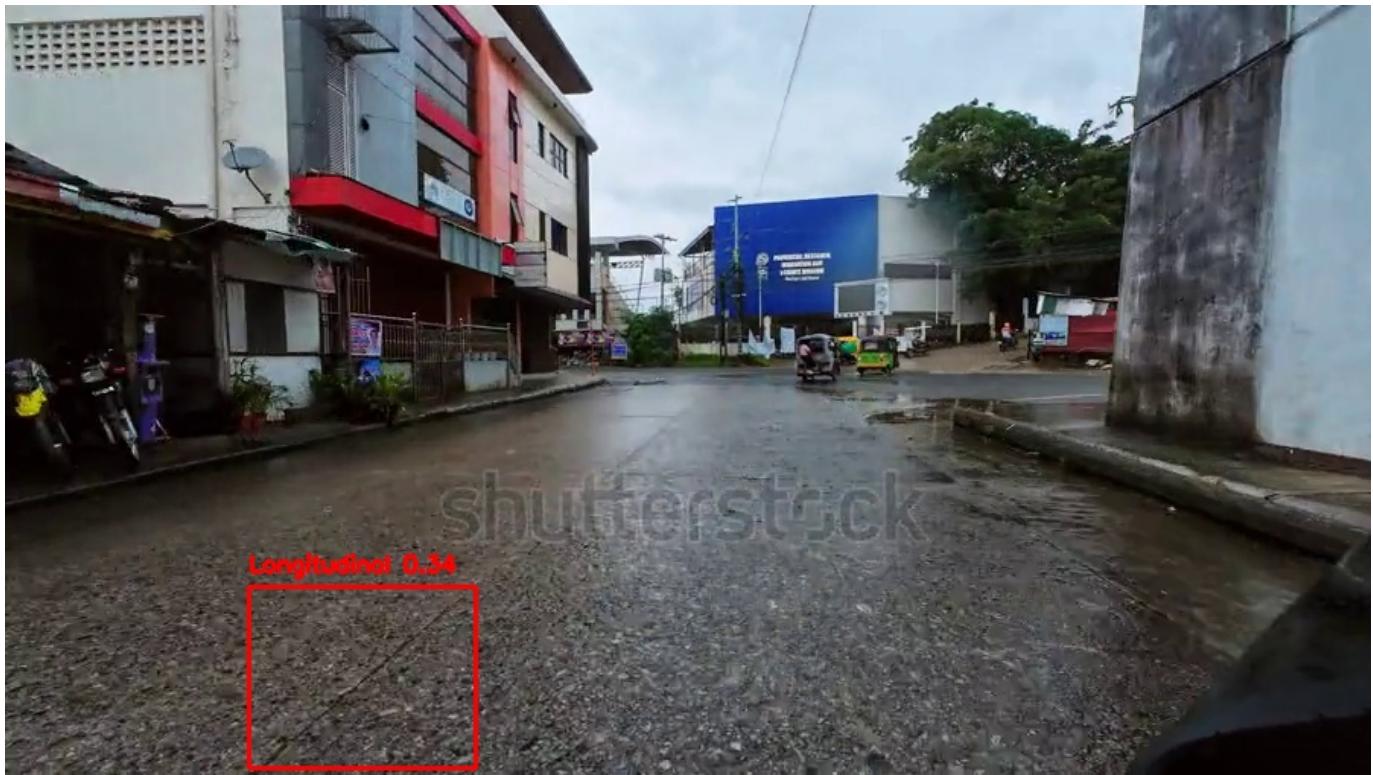
Frame 19: Detected defects - Longitudinal (0.34)

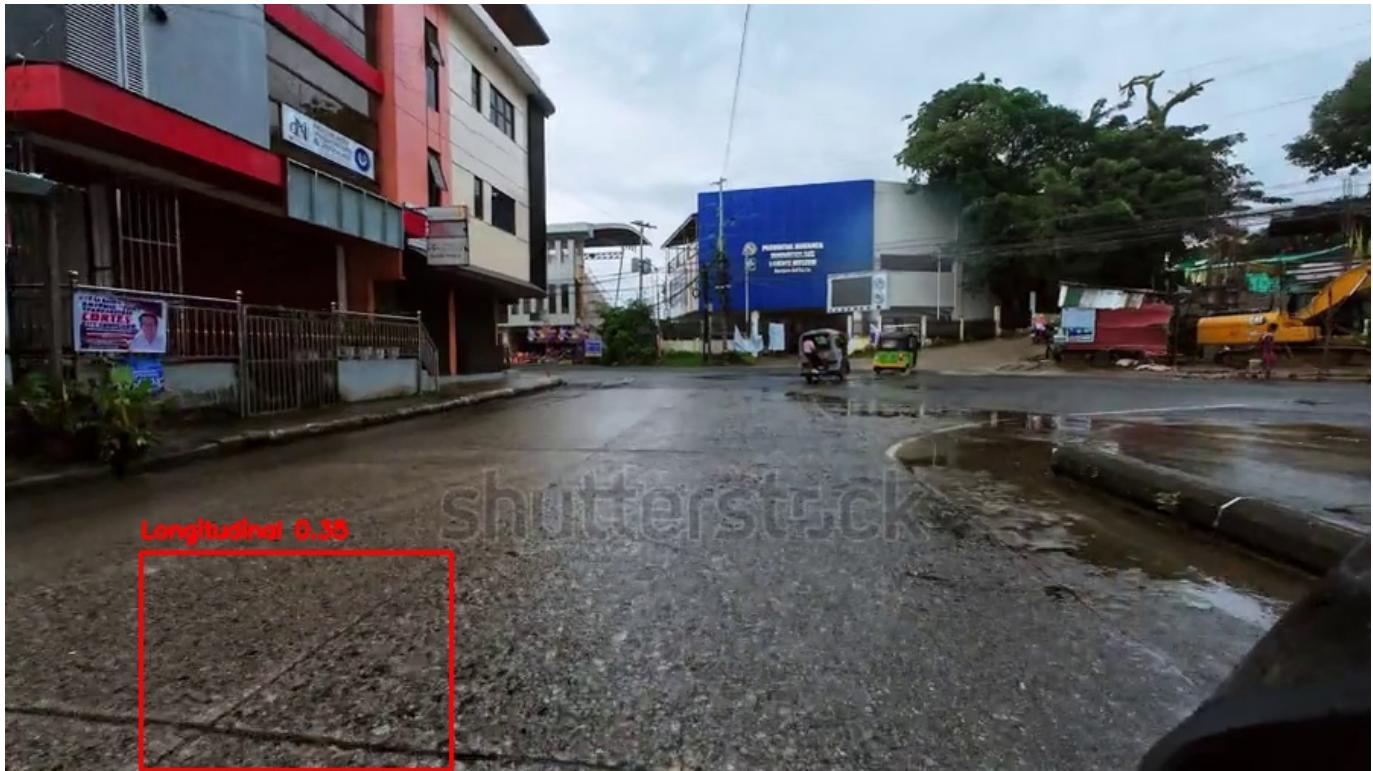
Frame 20: Detected defects - Longitudinal (0.35)

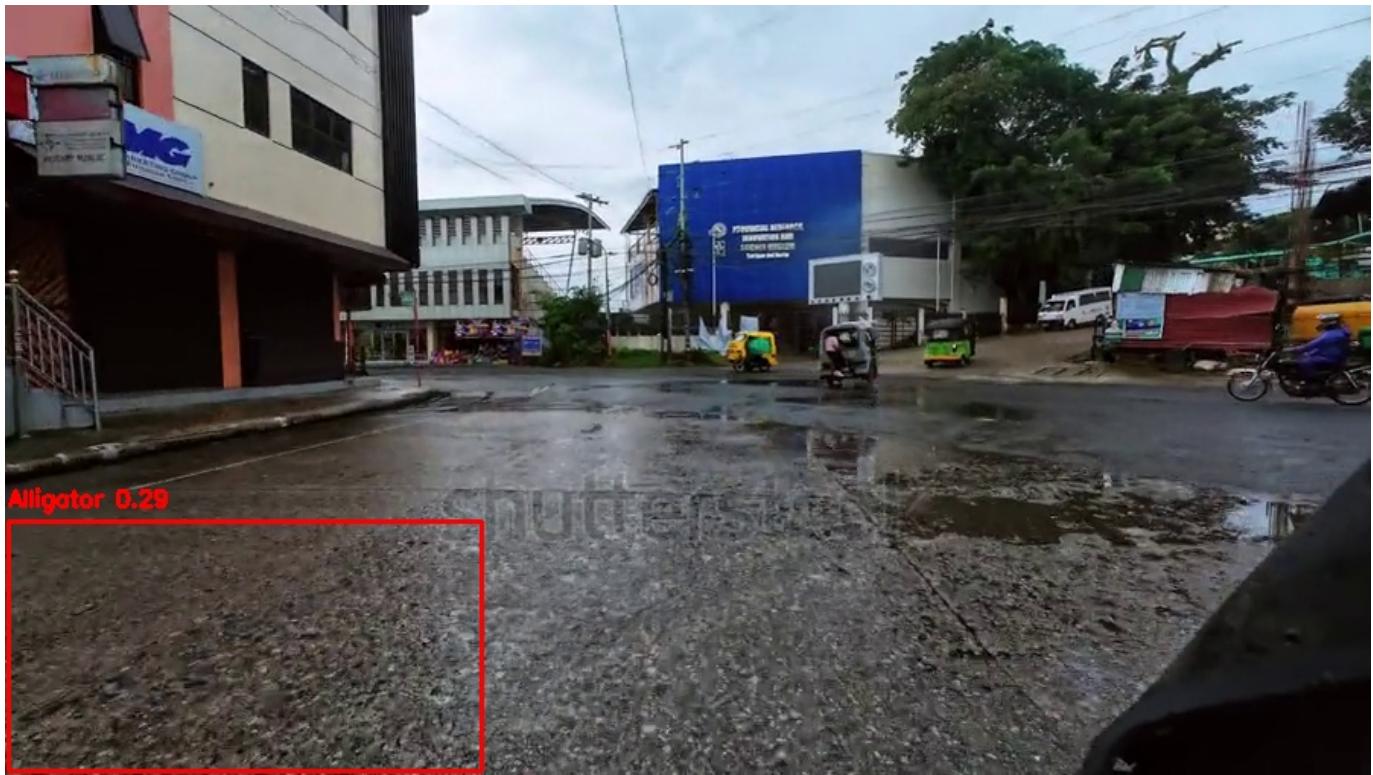
Alligator 0.29

Frame 21: Detected defects - Alligator (0.29)
