Road Condition Analysis Report

Road: Marine Drive in Mumbai

Date: 2025-04-22 20:52:25

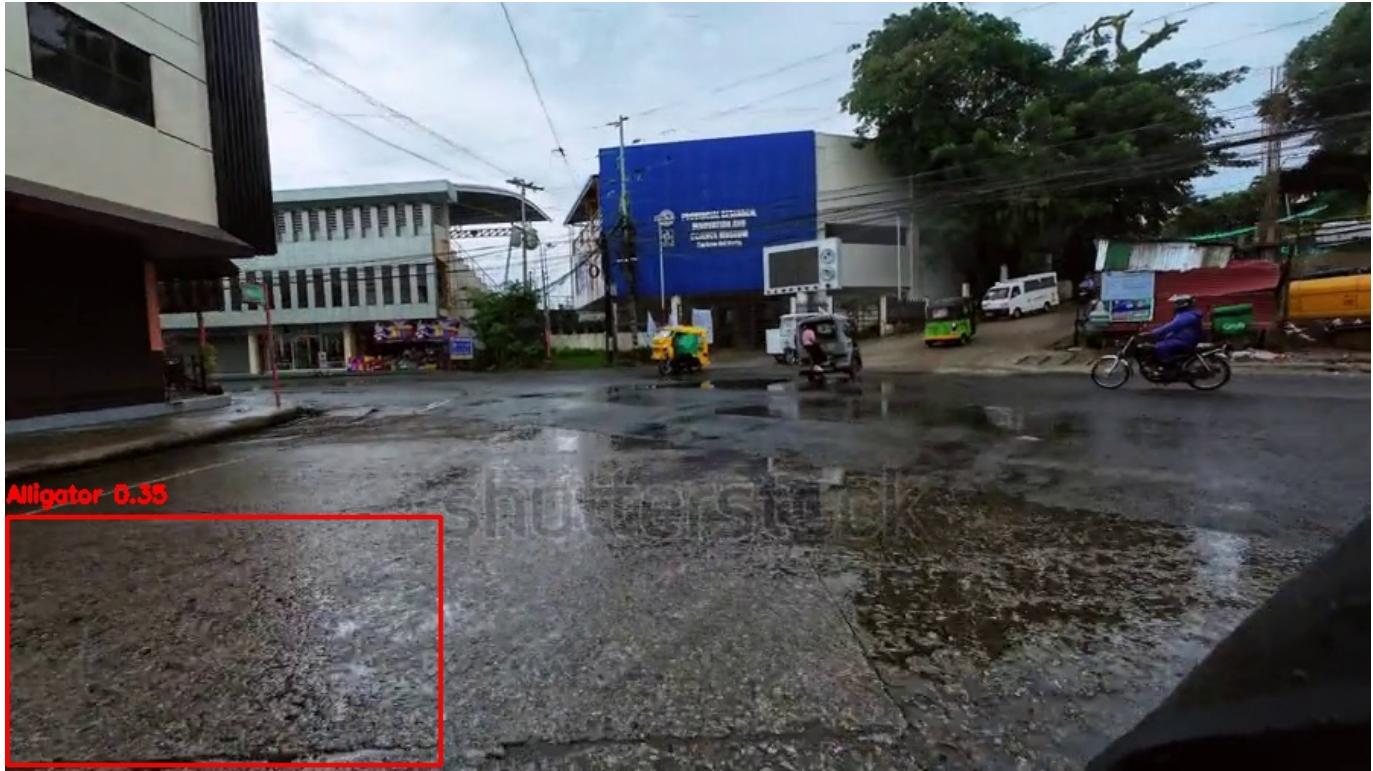
Alligator 0.35

Frame 22: Detected defects - Alligator (0.35)

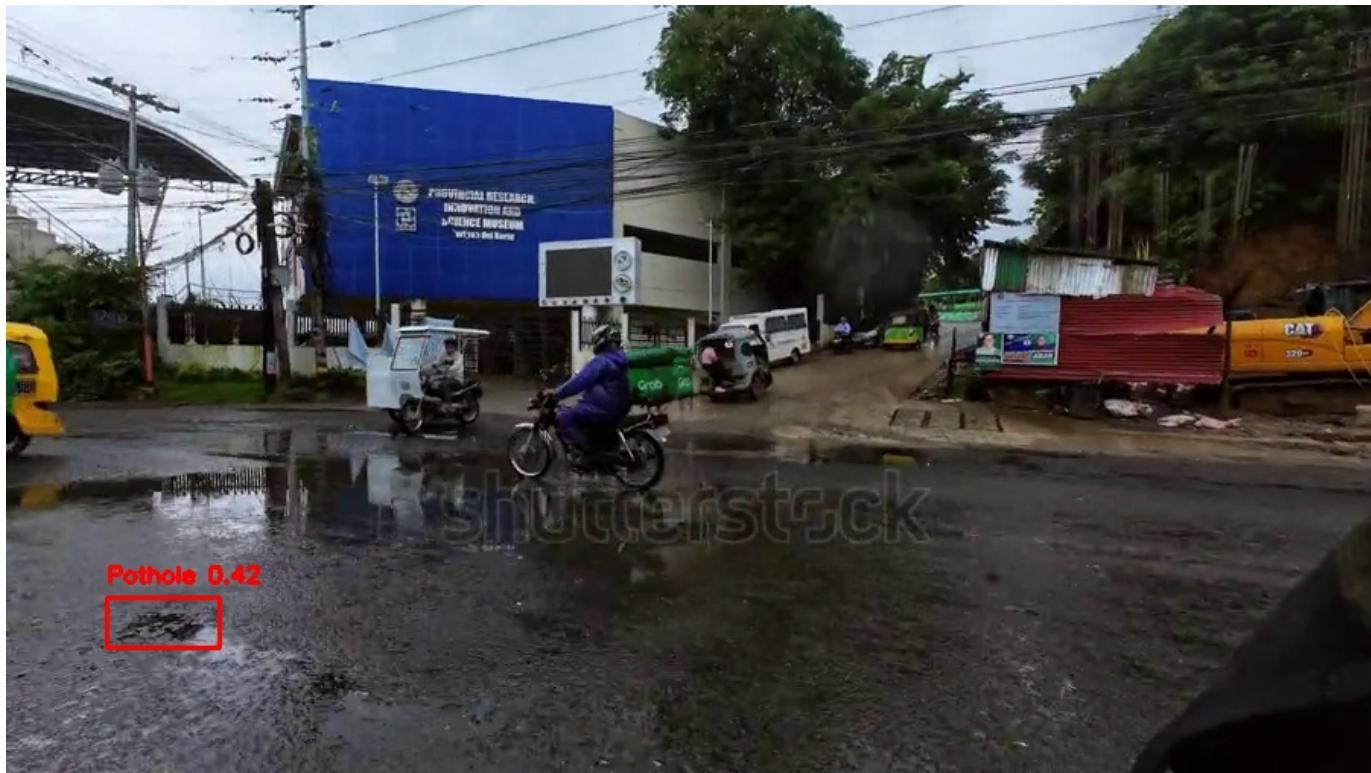
Frame 23: Detected defects - Pothole (0.42)
