Road Condition Analysis Report

Road: Marine Drive in Mumbai

Date: 2025-04-22 20:57:03

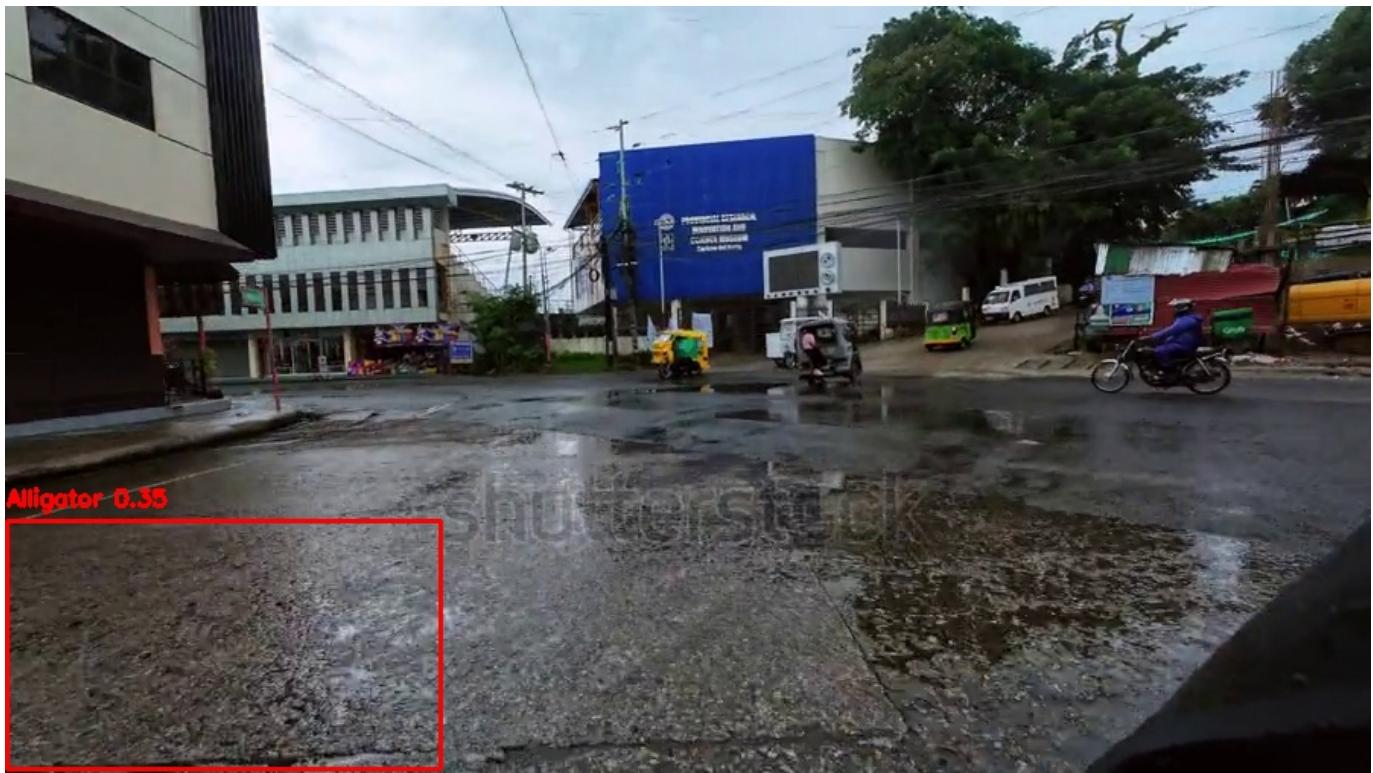
Alligator 0.35

Frame 22: Detected defects - Alligator (0.35)
