Road Condition Analysis Report

Road: Marine Drive in Mumbai

Date: 2025-04-22 21:02:49

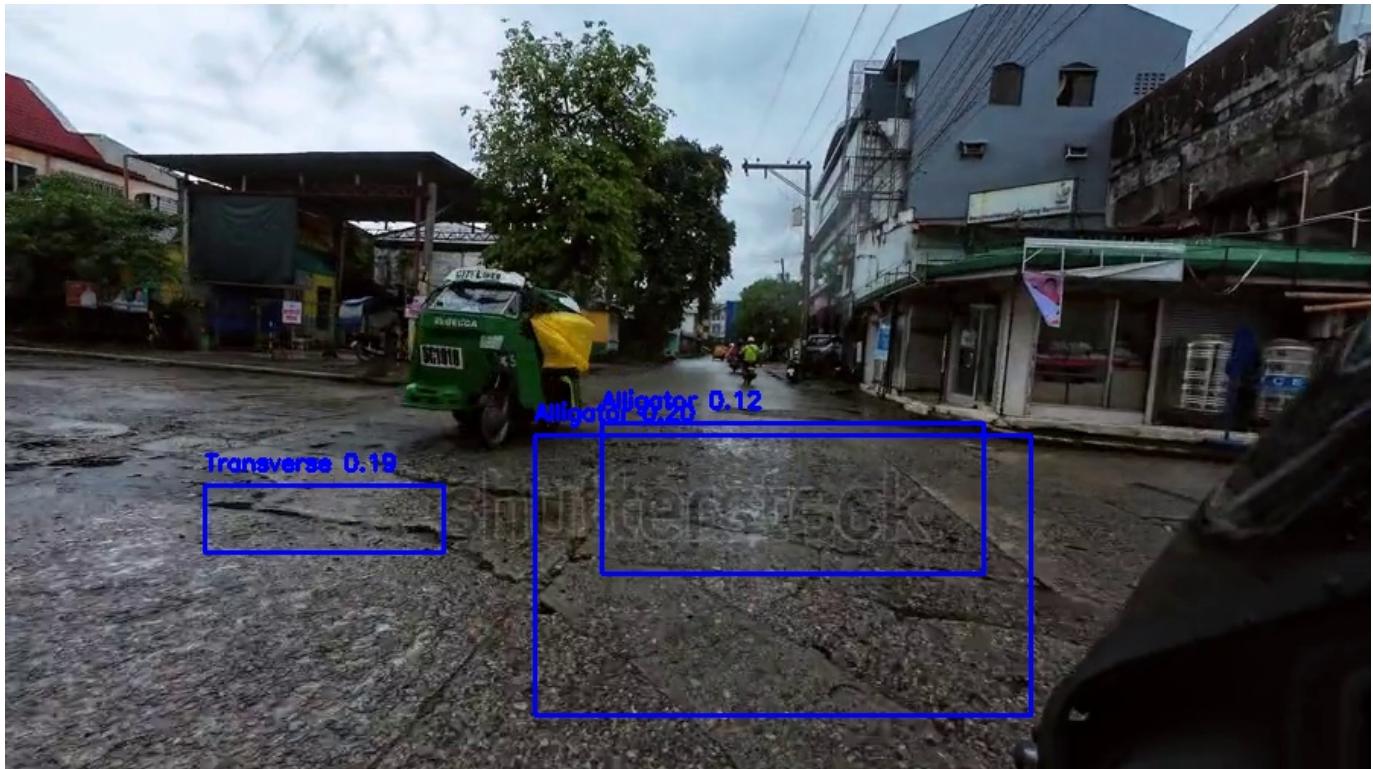
Frame 8: Detected defects - Alligator (0.20), Transverse (0.19), Alligator (0.12)

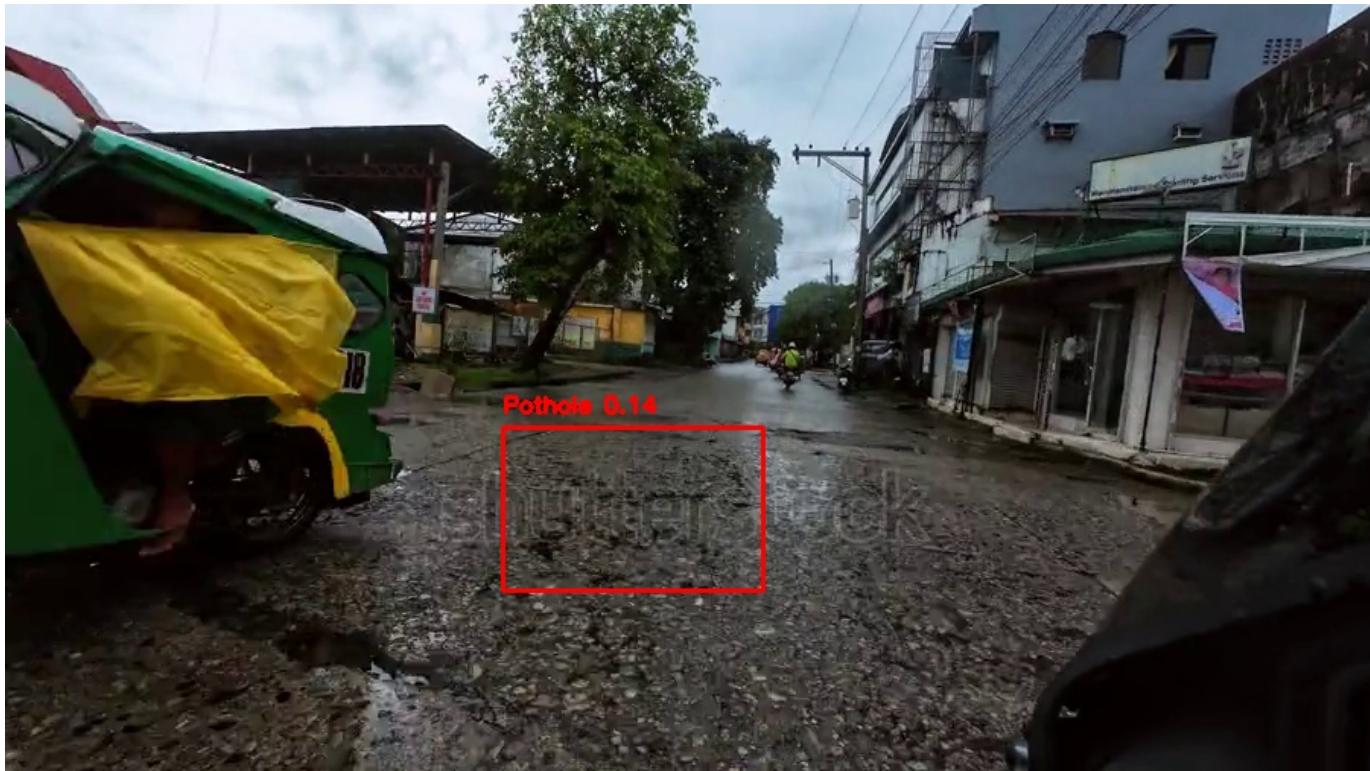
Frame 12: Detected defects - Pothole (0.14)

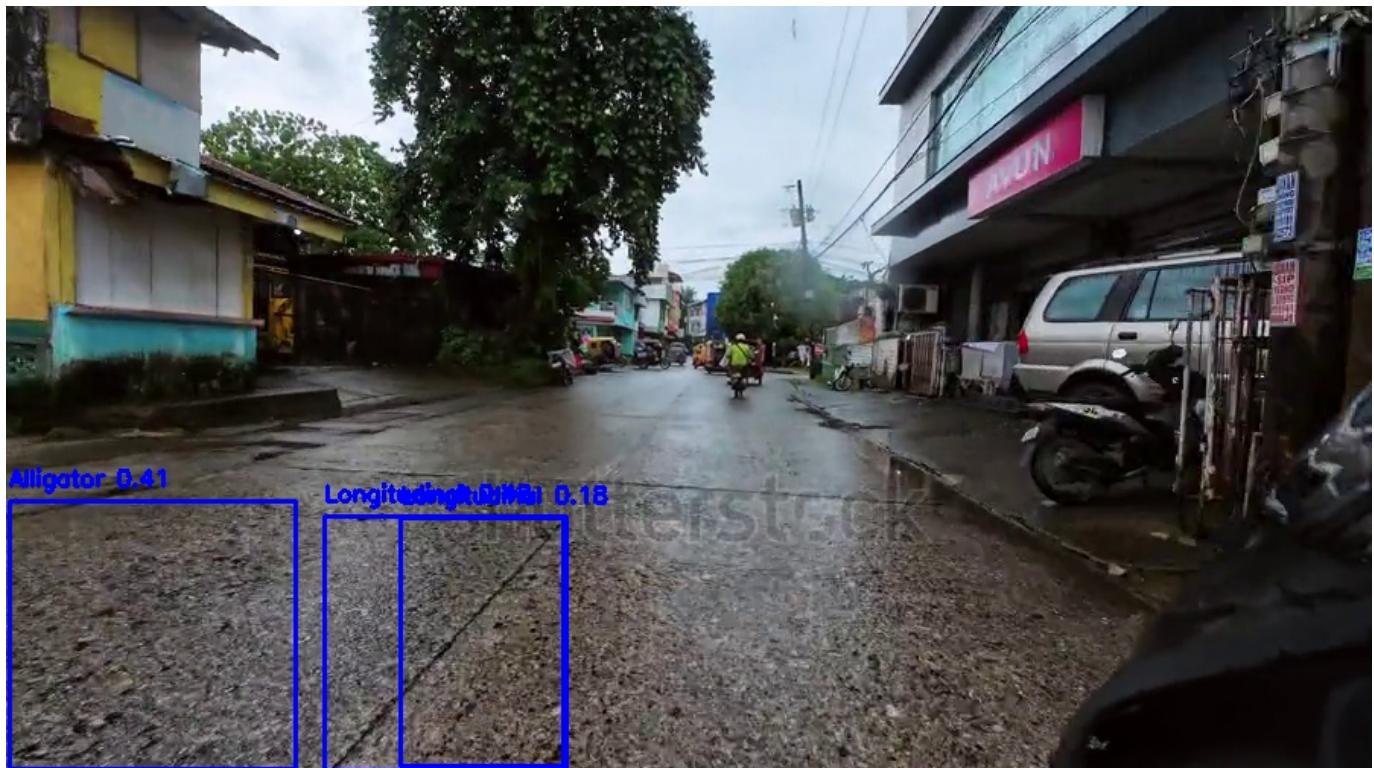
Frame 38: Detected defects - Longitudinal (0.48), Alligator (0.41), Longitudinal (0.18)
