Road Condition Analysis Report

Analysis ID: 76547b9e-223c-4eeb-9073-94e31a50294b

Road: Marine Drive in Mumbai

Date: 2025-04-24 02:59:43

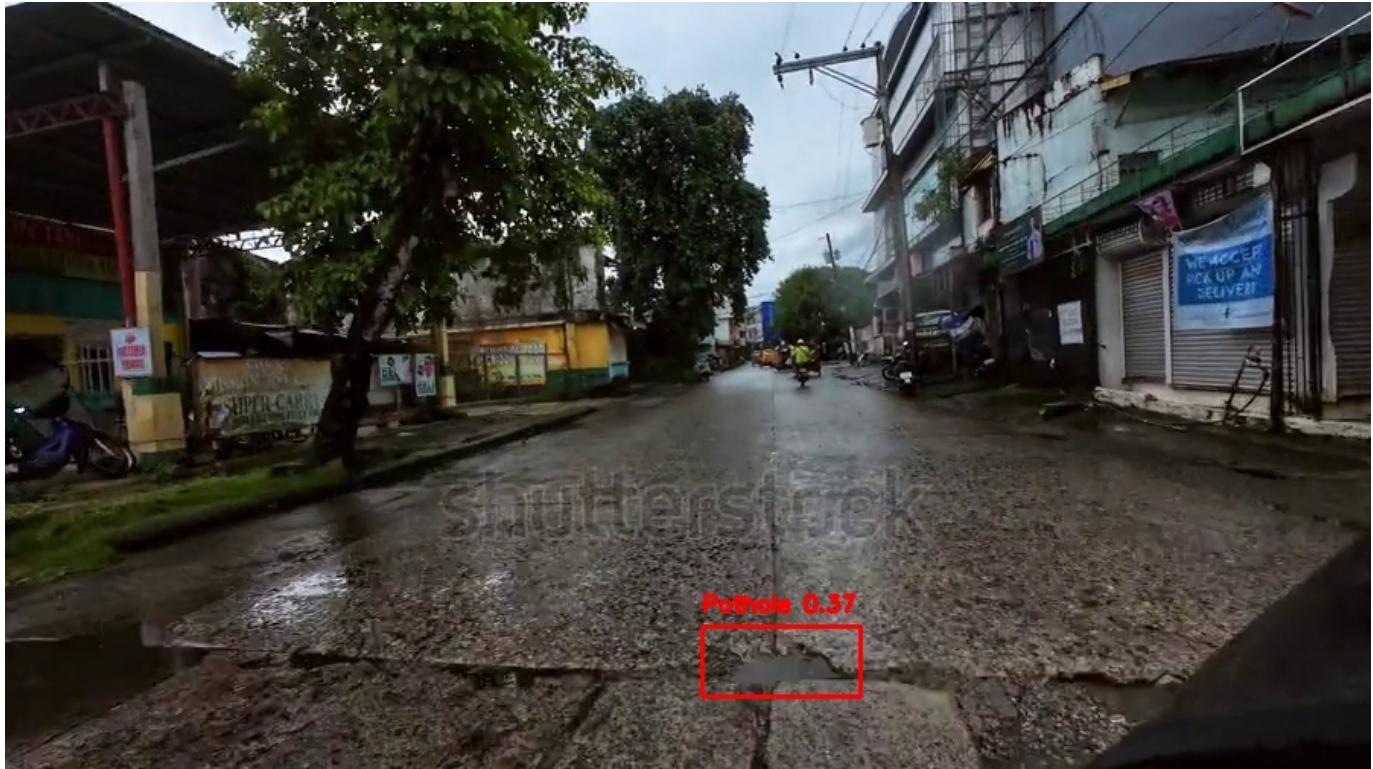
Frame 22: Detected defects - Pothole (0.37)

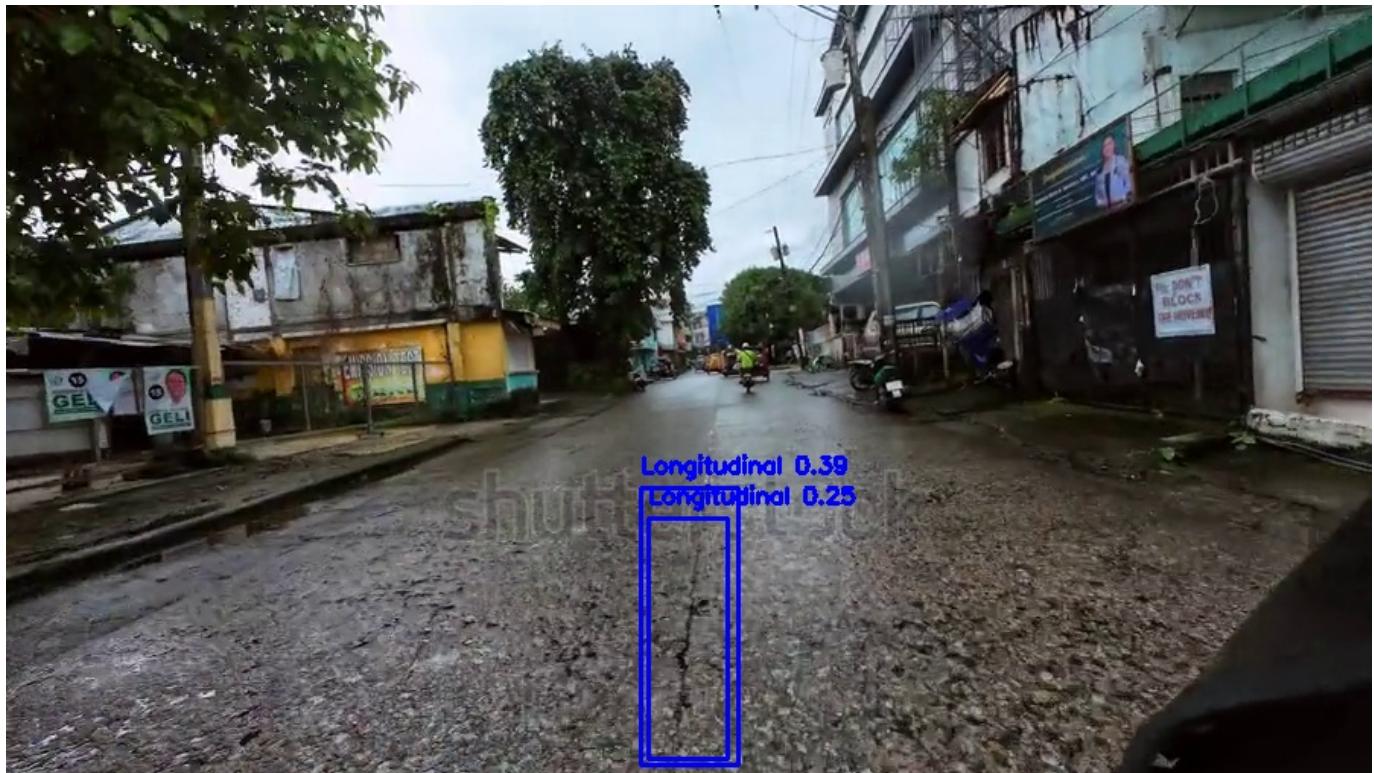
Frame 27: Detected defects - Longitudinal (0.39), Longitudinal (0.25)

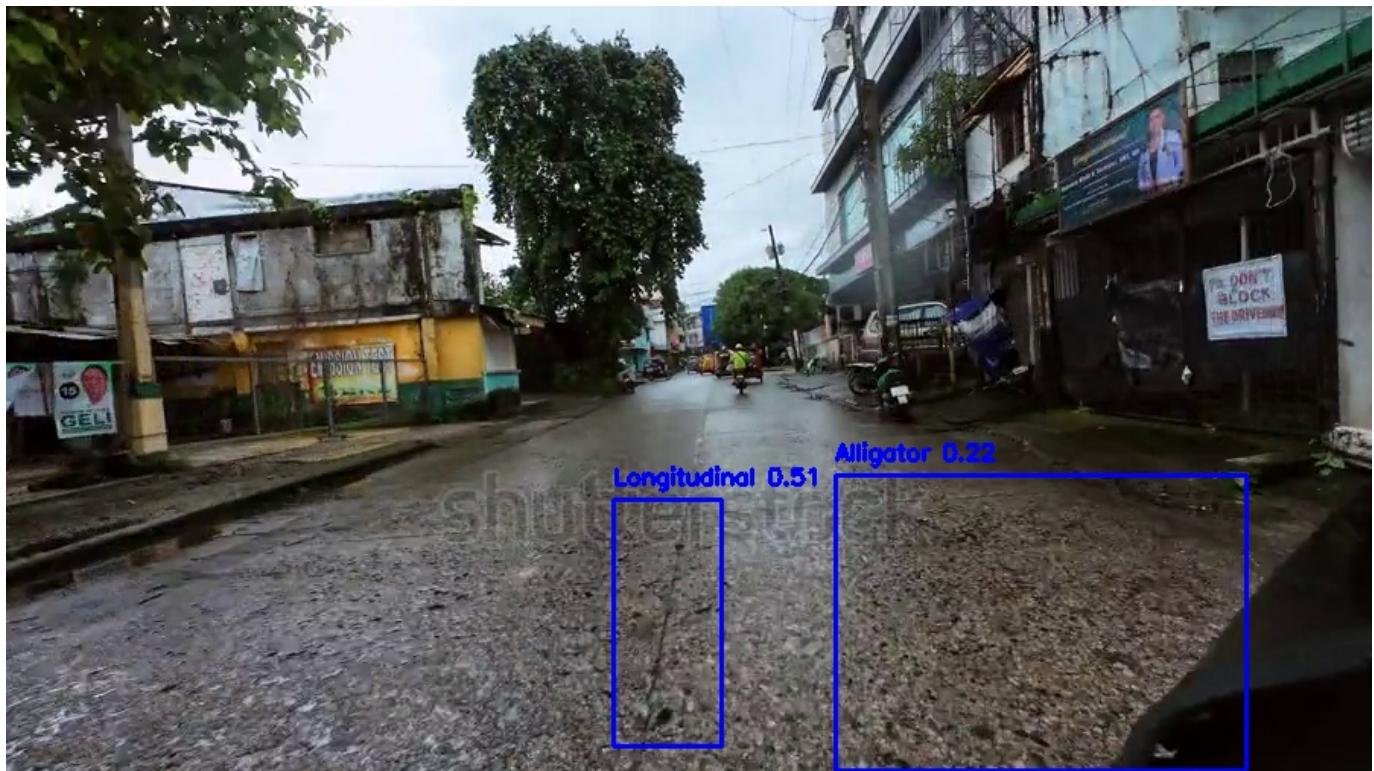
Frame 28: Detected defects - Longitudinal (0.51), Alligator (0.22)

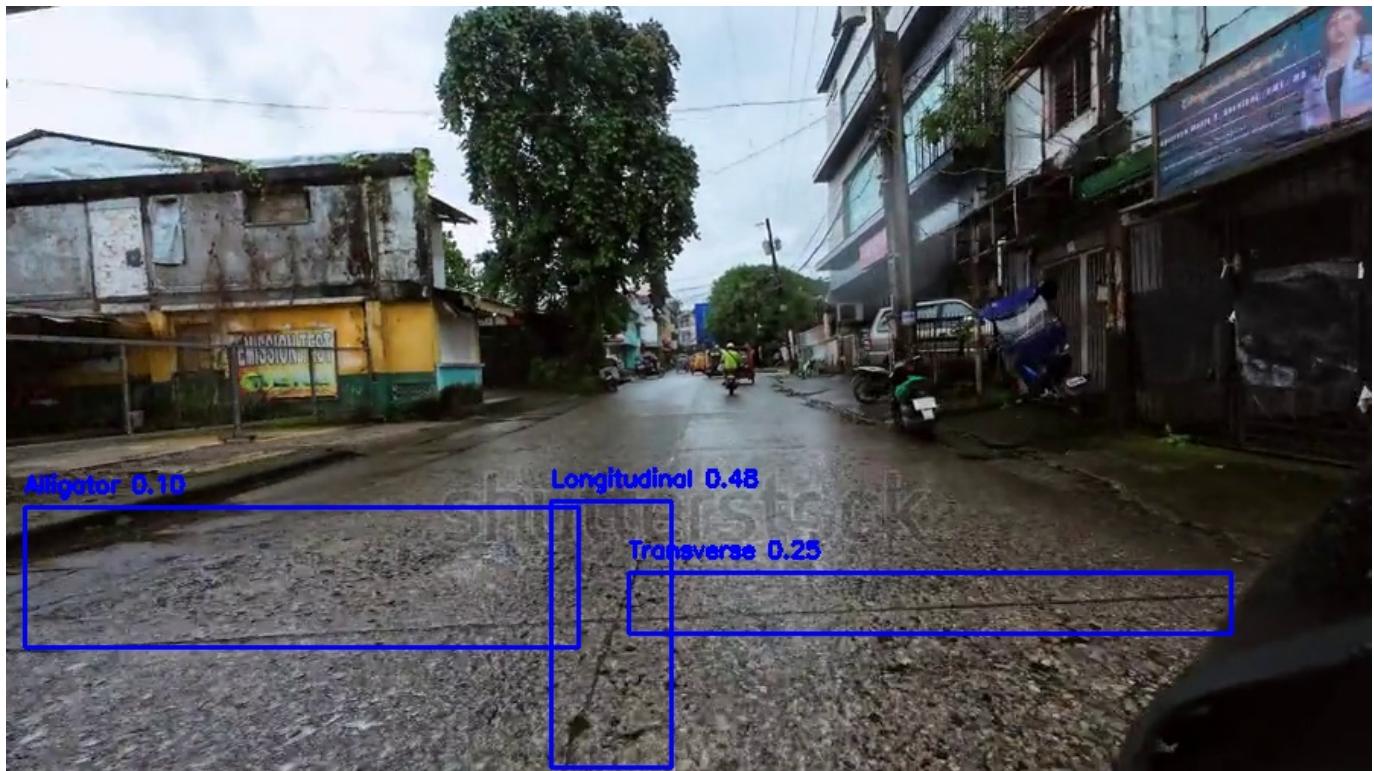
Frame 30: Detected defects - Longitudinal (0.48), Transverse (0.25), Alligator (0.10)

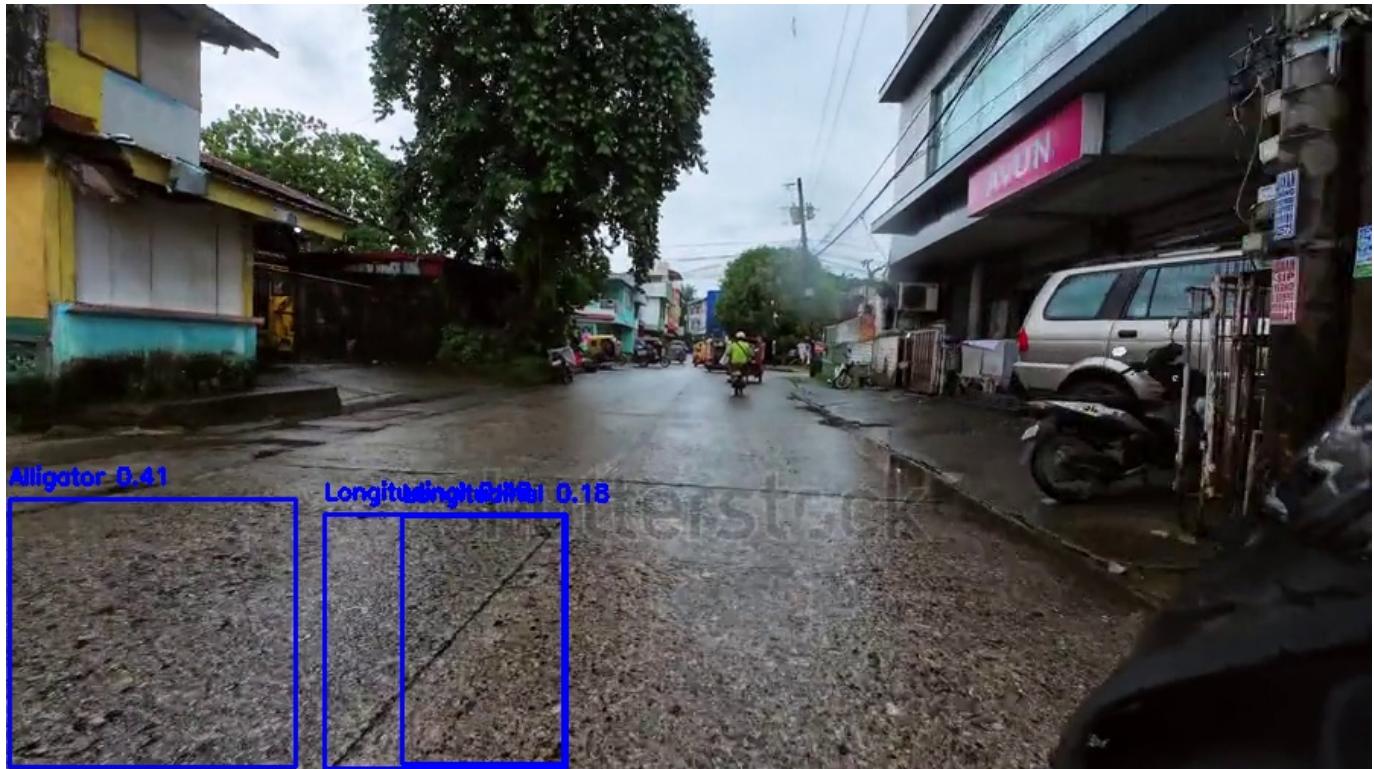
Frame 38: Detected defects - Longitudinal (0.48), Alligator (0.41), Longitudinal (0.18)

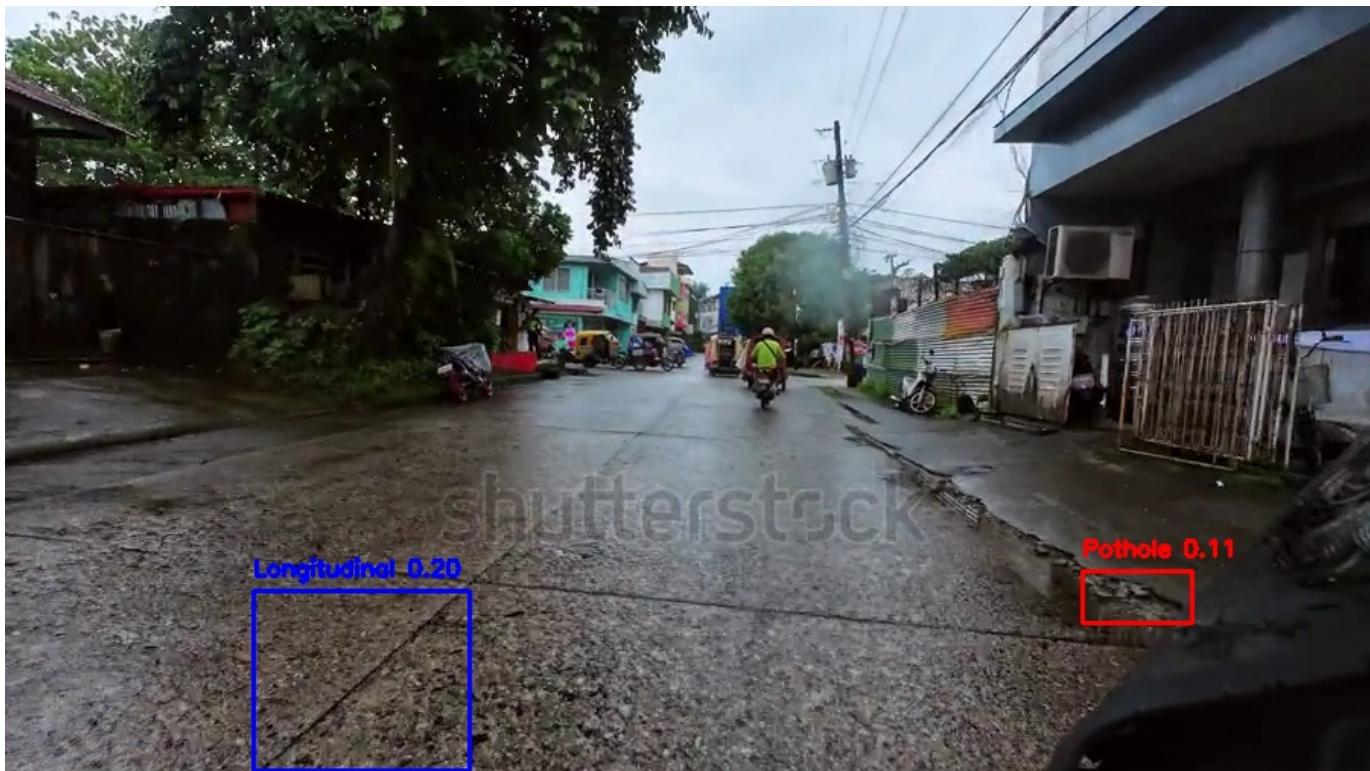
Frame 46: Detected defects - Longitudinal (0.20), Pothole (0.11)
