# Road Condition Analysis Report

Analysis ID: 57d562fb-562f-4863-b238-dc2f151e316b

Road: Marine Drive in Mumbai

Date: 2025-04-24 02:59:27

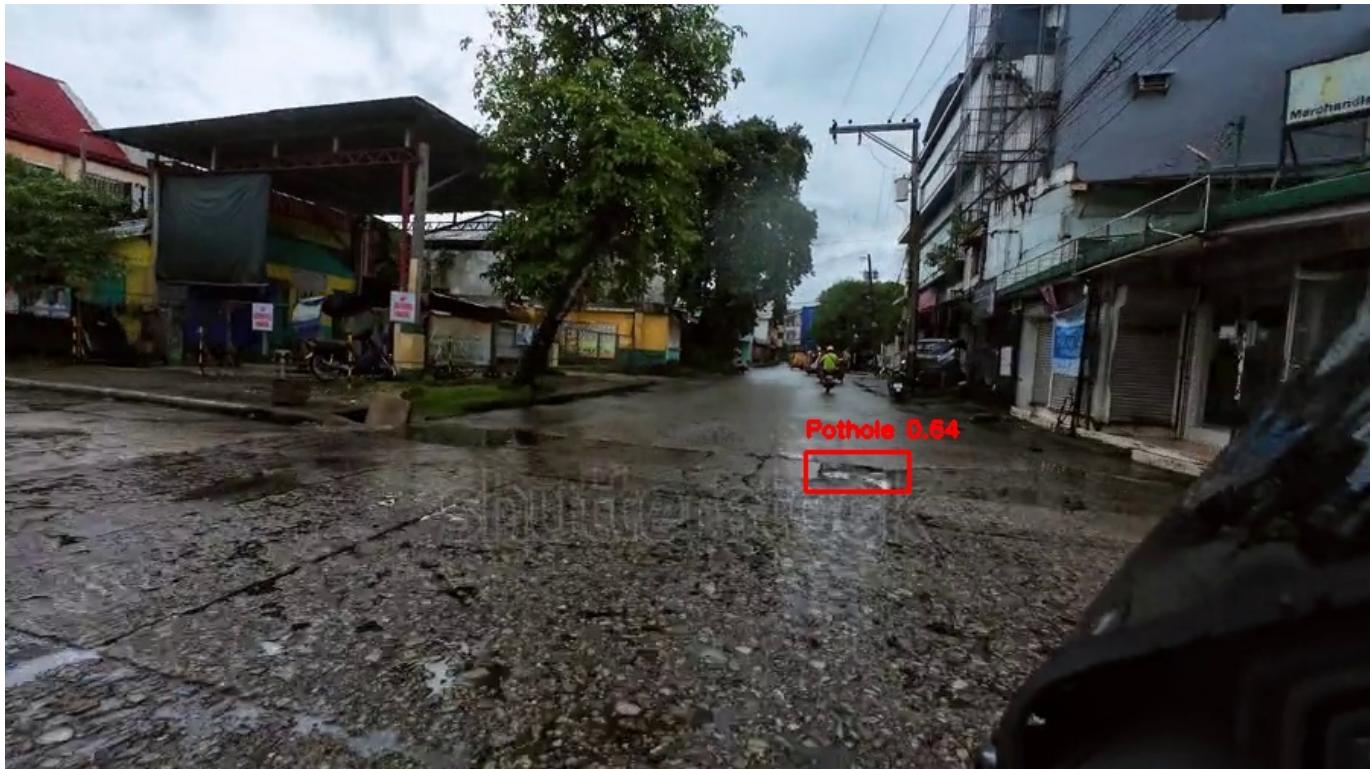
Frame 16: Detected defects - Pothole (0.64)

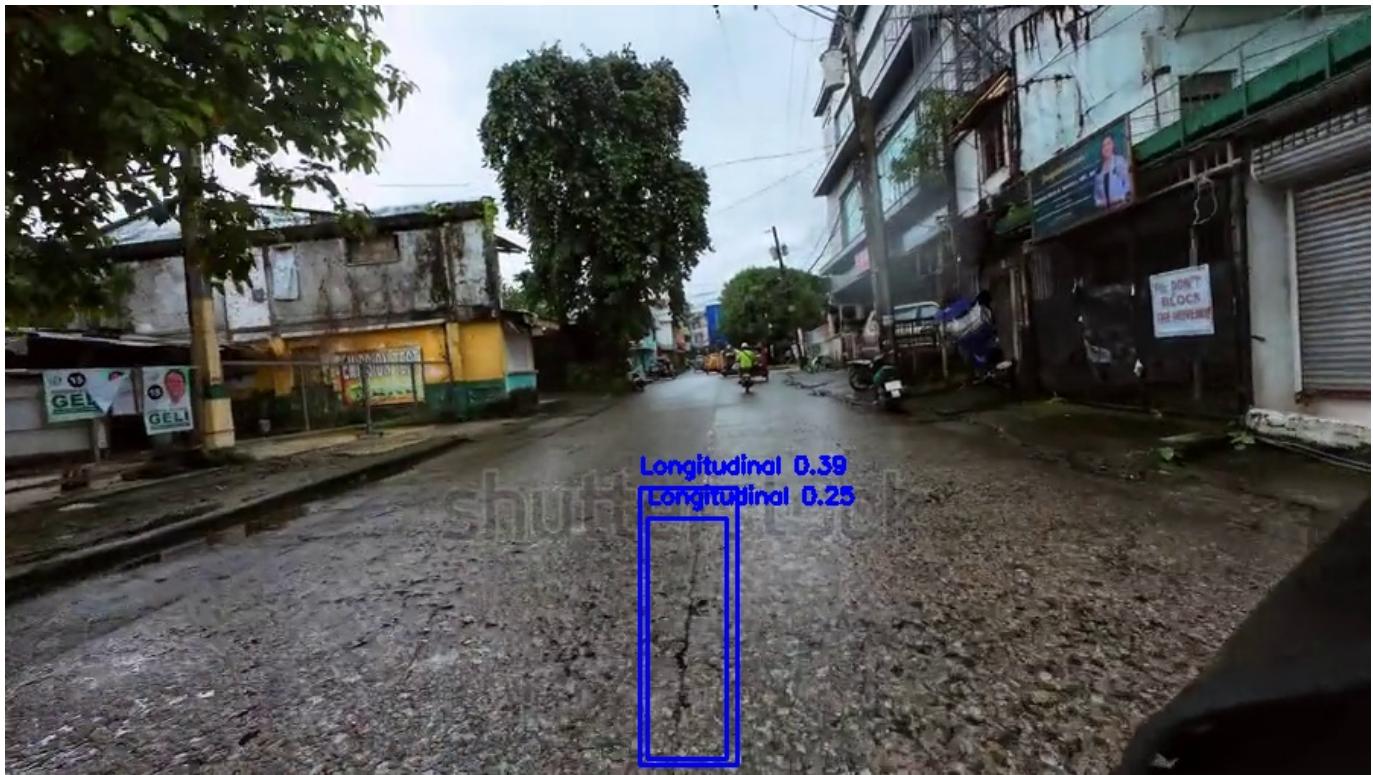
Frame 27: Detected defects - Longitudinal (0.39), Longitudinal (0.25)

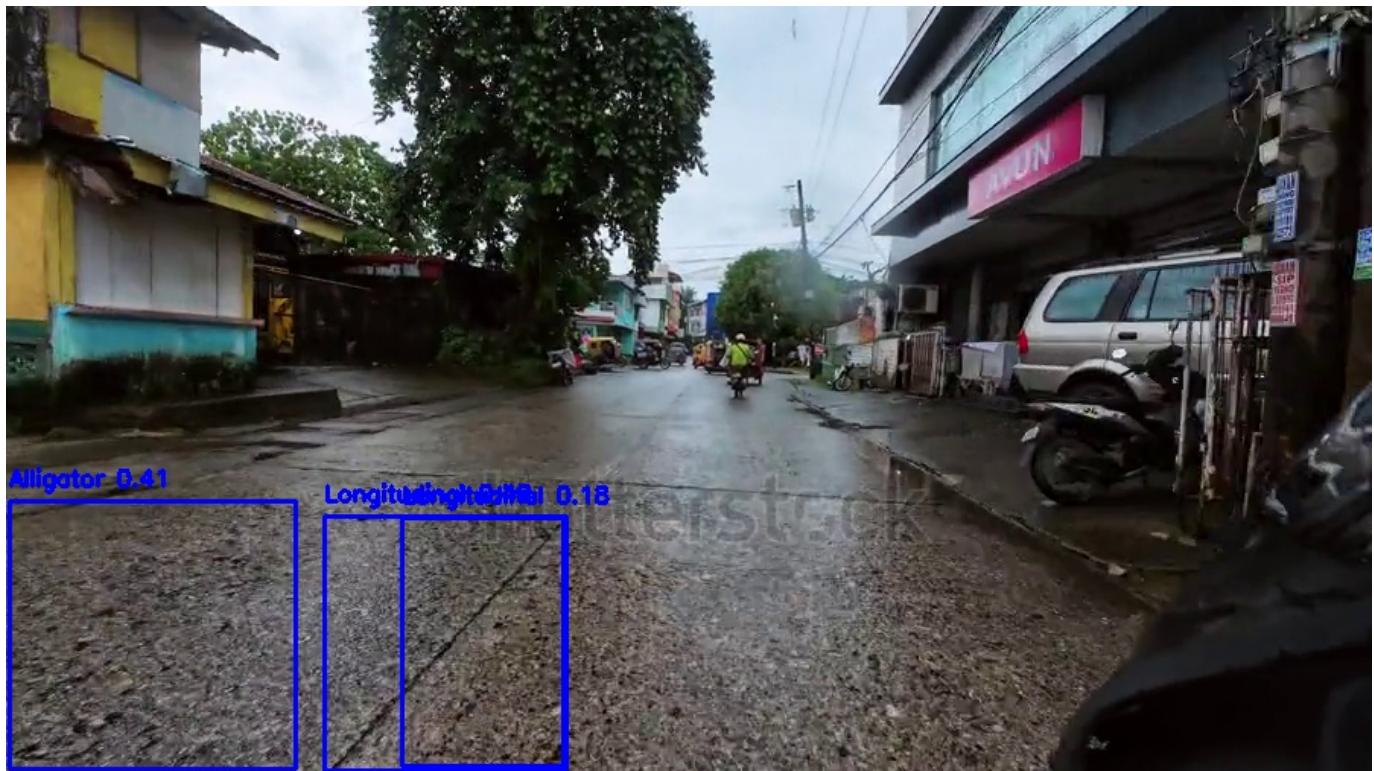
Frame 38: Detected defects - Longitudinal (0.48), Alligator (0.41), Longitudinal (0.18)
