# Road Condition Analysis Report

Analysis ID: a9f72d6f-5737-4120-b814-f45dea5b29ec

Road: Marine Drive in Mumbai

Date: 2025-04-22 20:52:25

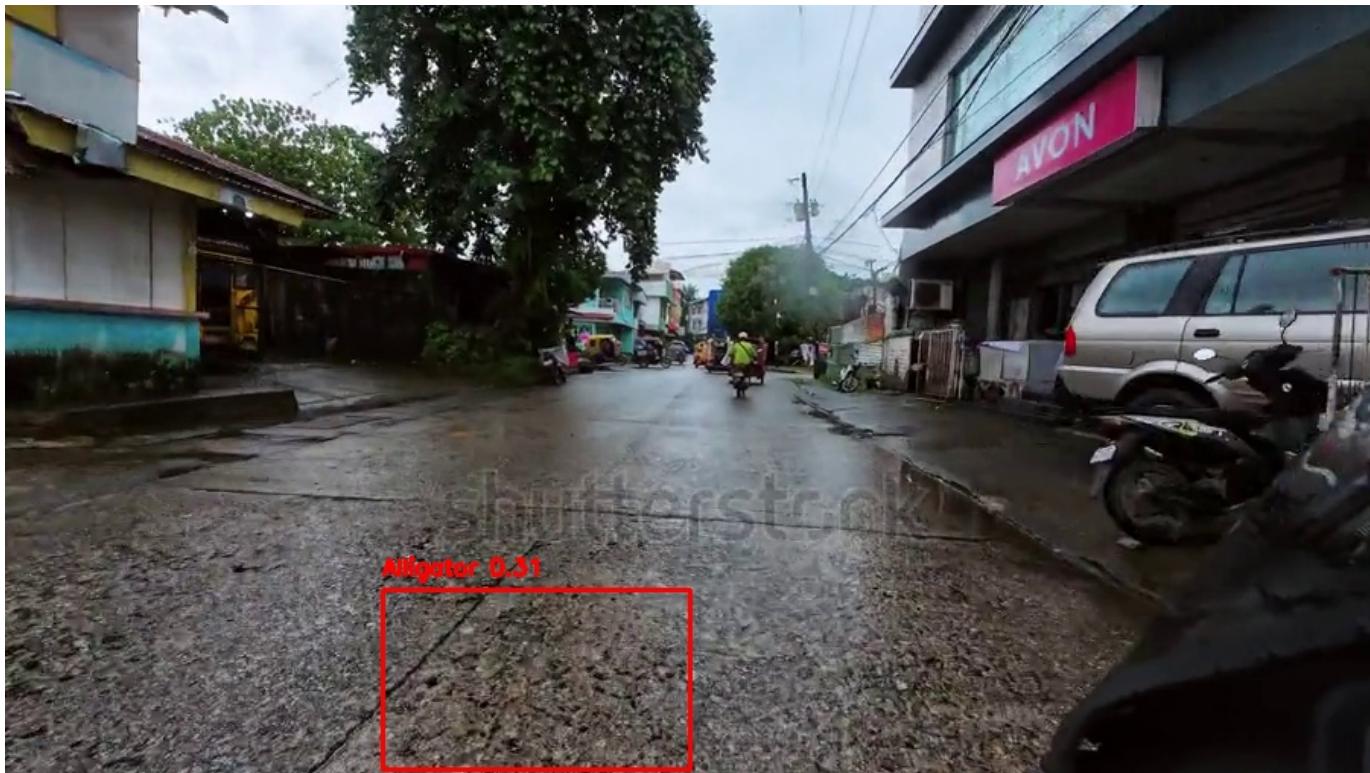
Frame 5: Detected defects - Alligator (0.31)

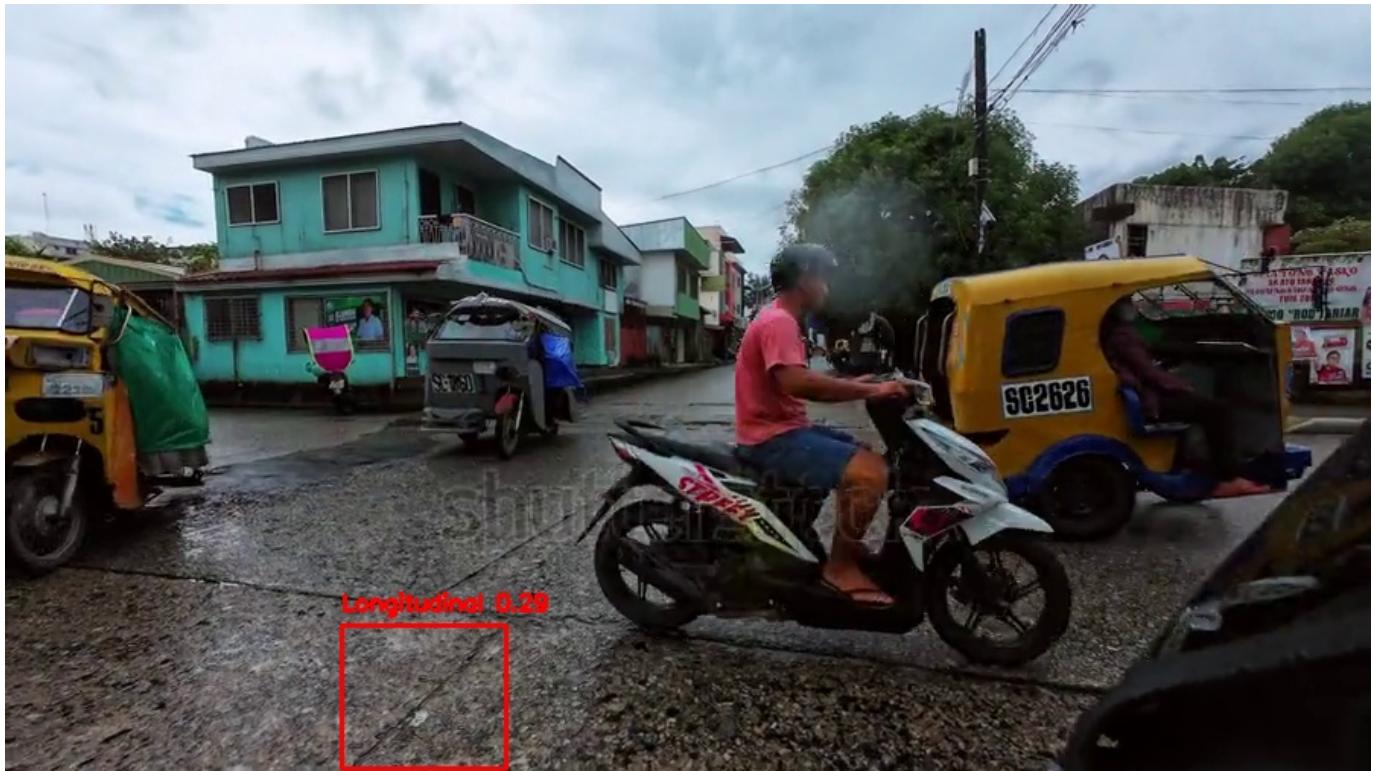
Frame 12: Detected defects - Longitudinal (0.29)

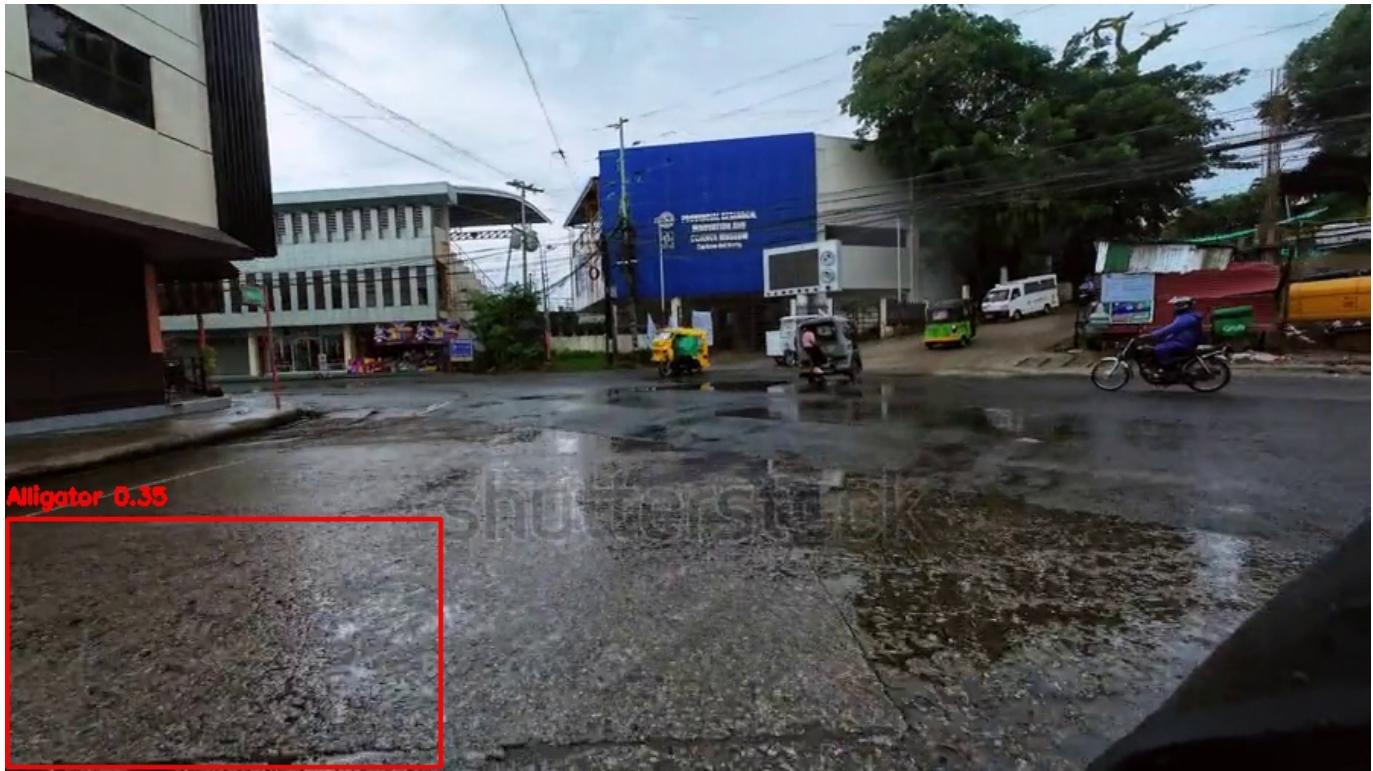
Frame 22: Detected defects - Alligator (0.35)
