# Road Condition Analysis Report

Analysis ID: 3fcabe5a-384d-4ec9-88b1-8e682c56c945

Road: MG Road in Bangalore

Date: 2025-04-24 02:59:33

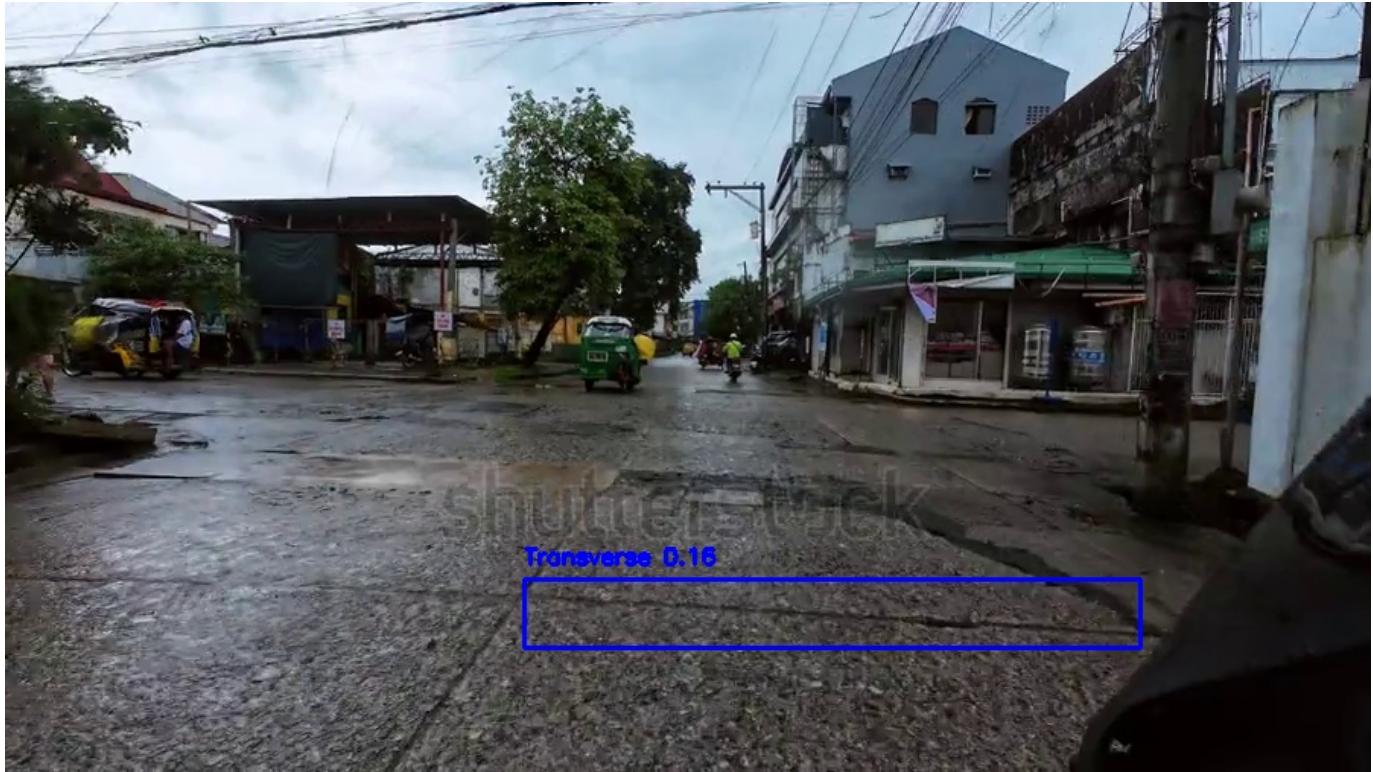
Frame 1: Detected defects - Transverse (0.16)

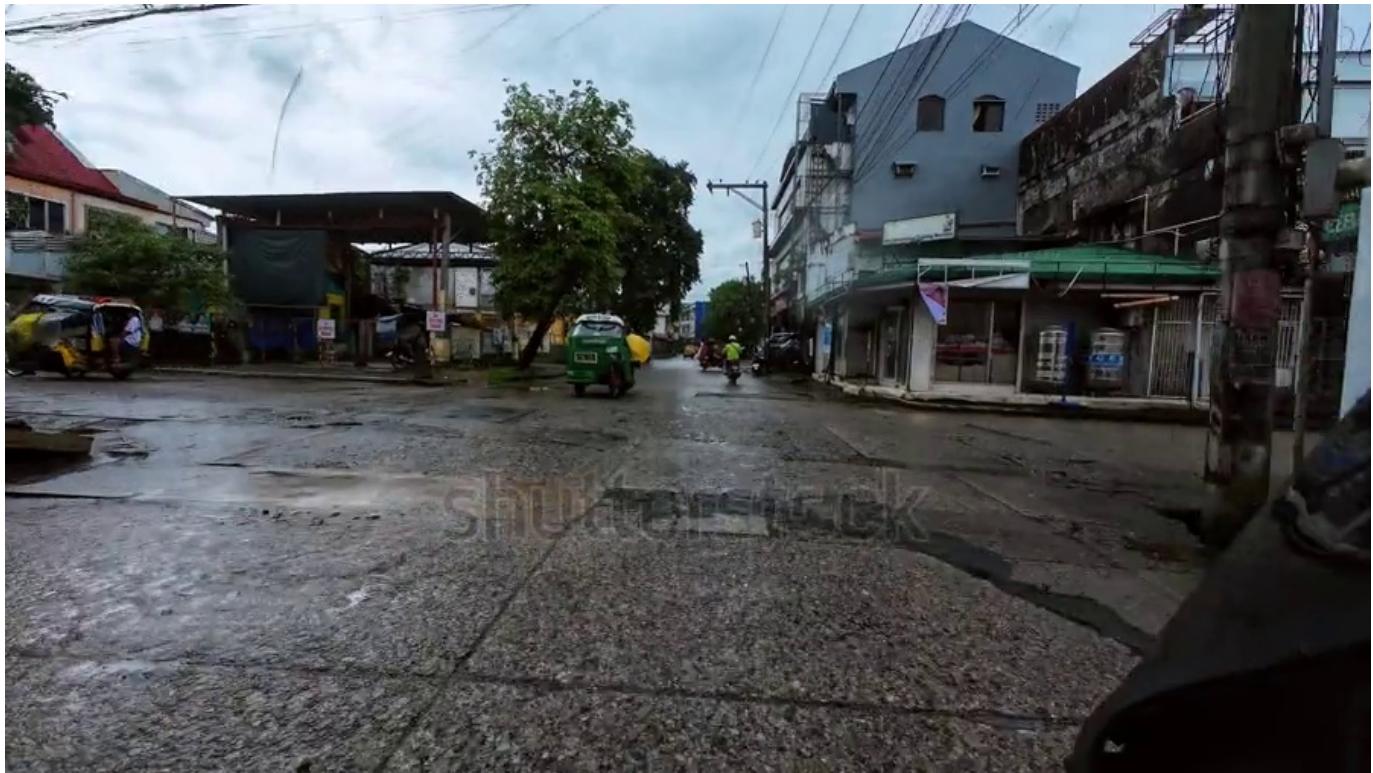
Frame 2: Detected defects -

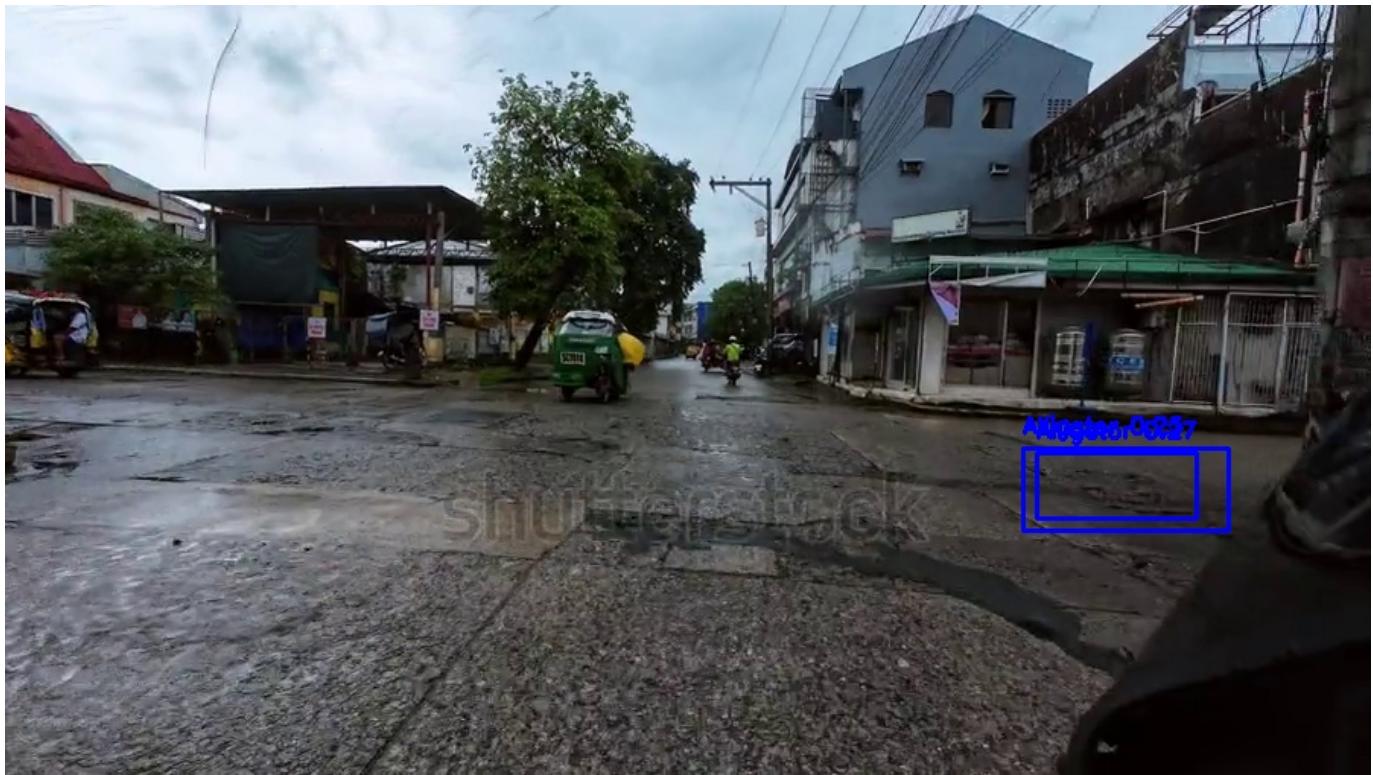
Frame 3: Detected defects - Alligator (0.27), Alligator (0.23)

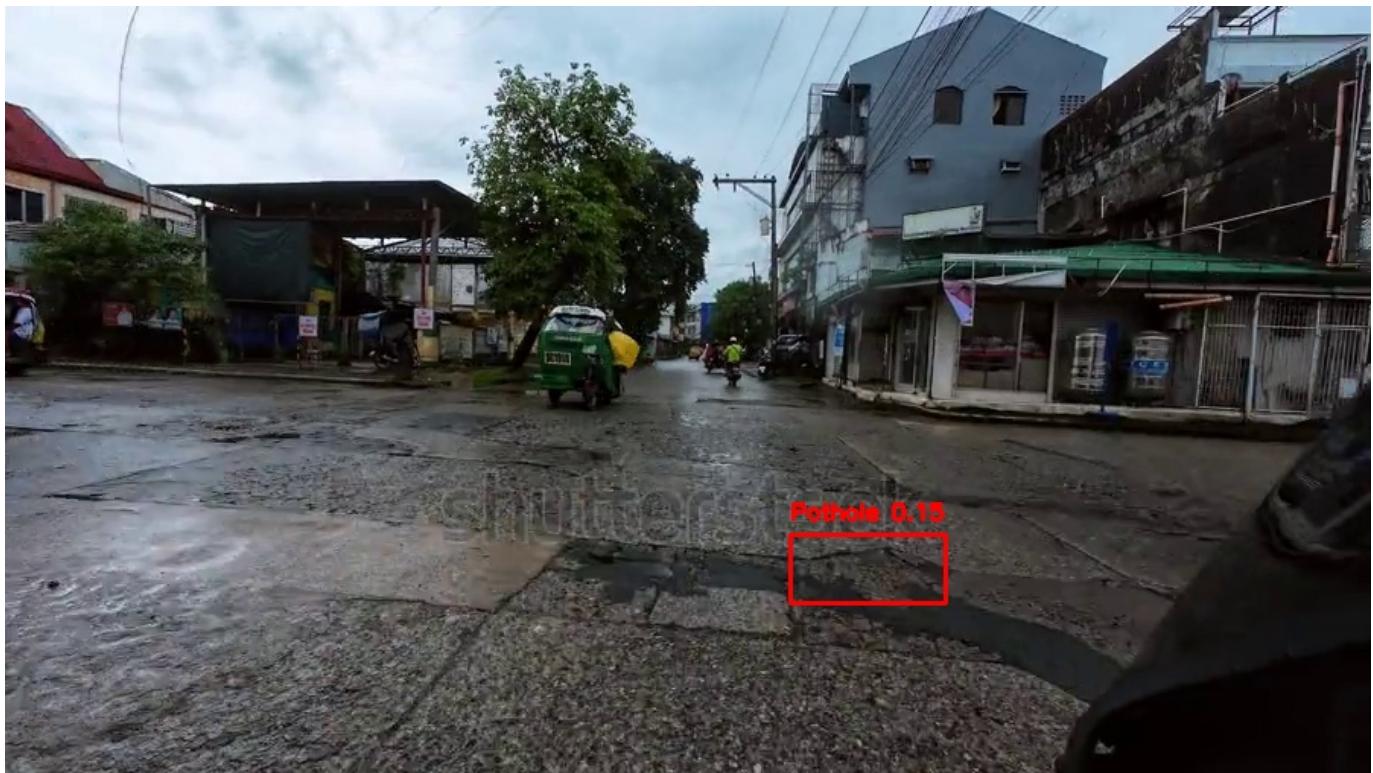
Frame 4: Detected defects - Pothole (0.15)

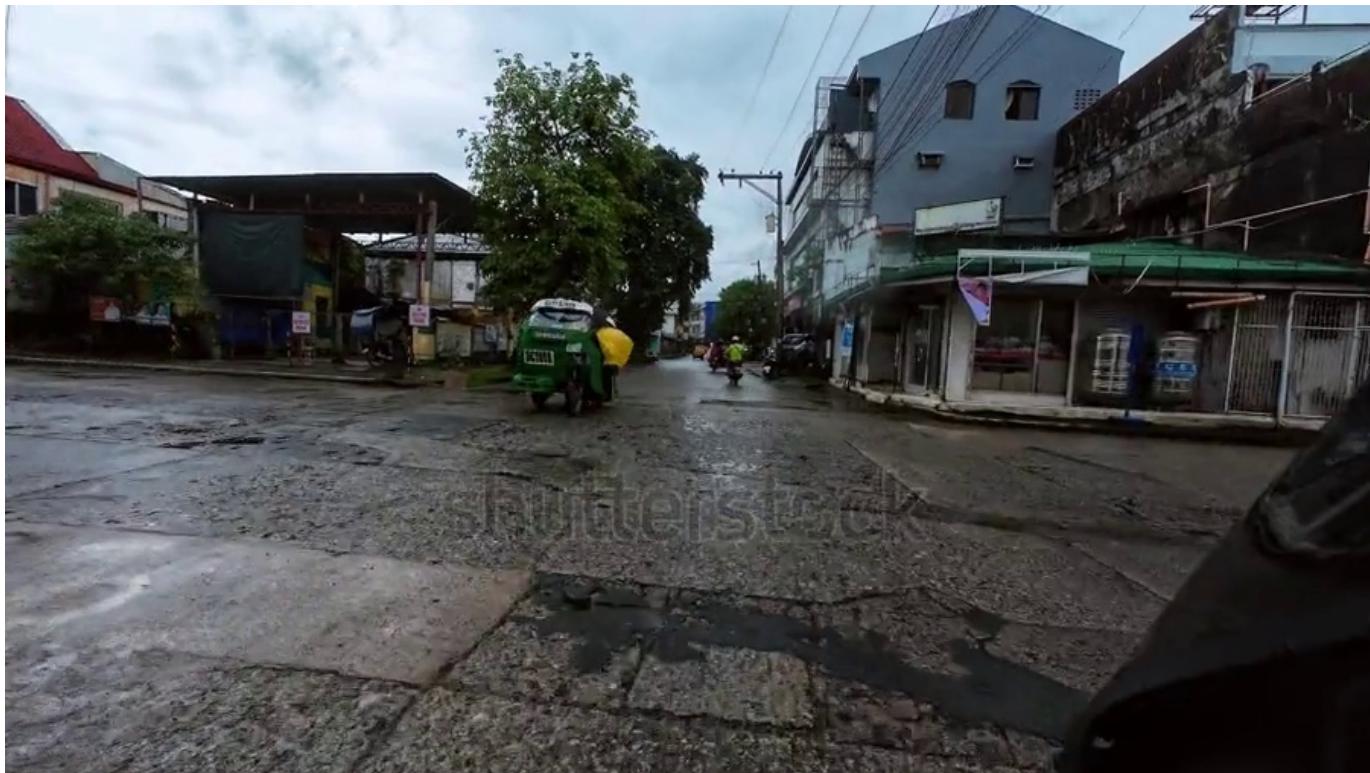
Frame 5: Detected defects -

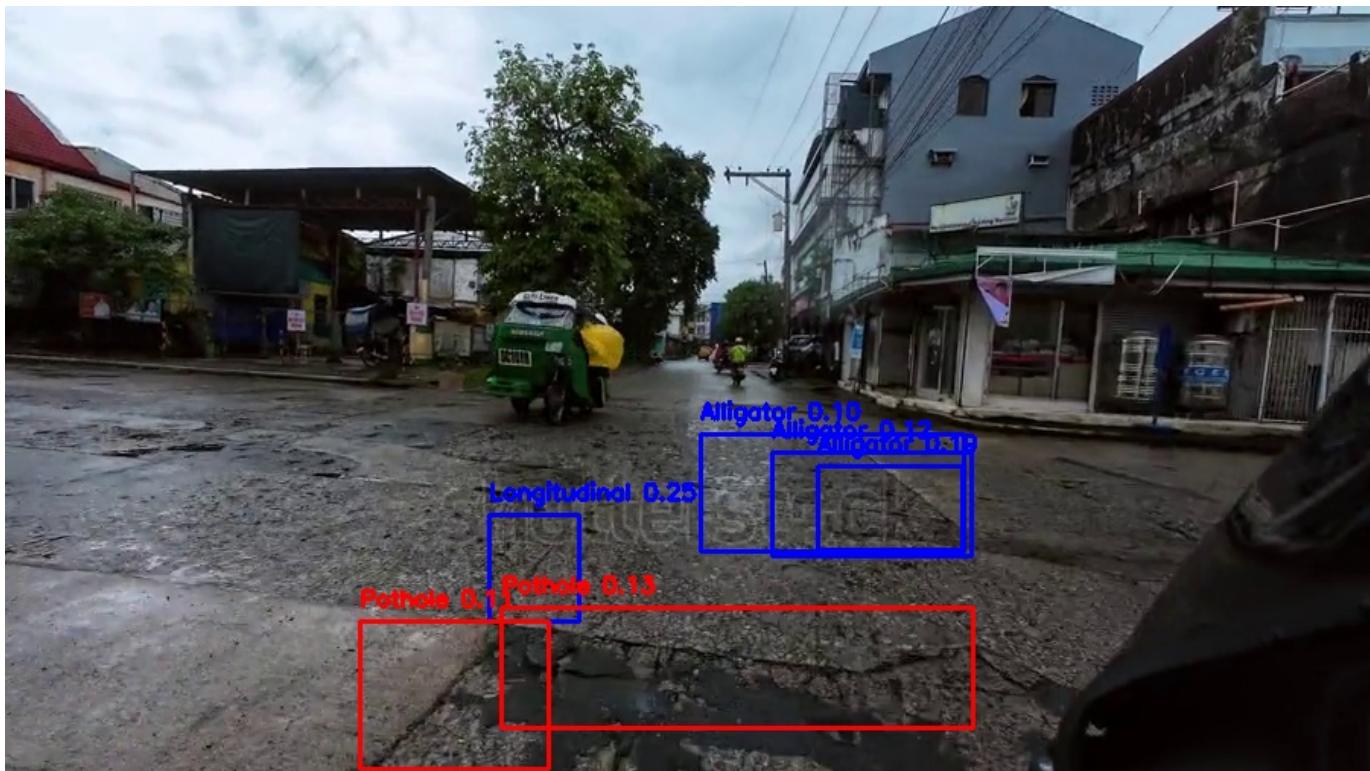
Frame 6: Detected defects - Longitudinal (0.25), Alligator (0.19), Pothole (0.13), Alligator (0.12), Pothole (0.11), Alligator (0.10)

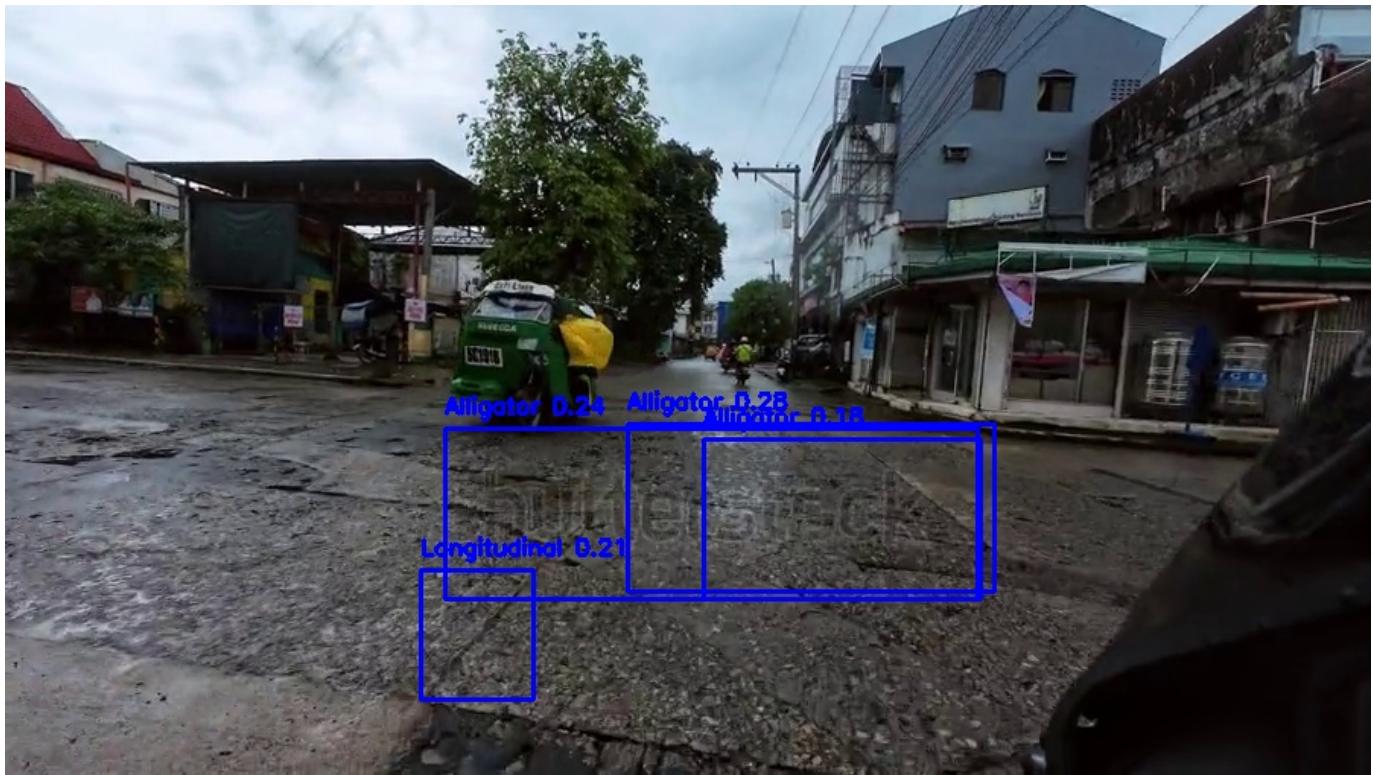
Frame 7: Detected defects - Alligator (0.28), Alligator (0.24), Longitudinal (0.21), Alligator (0.18)

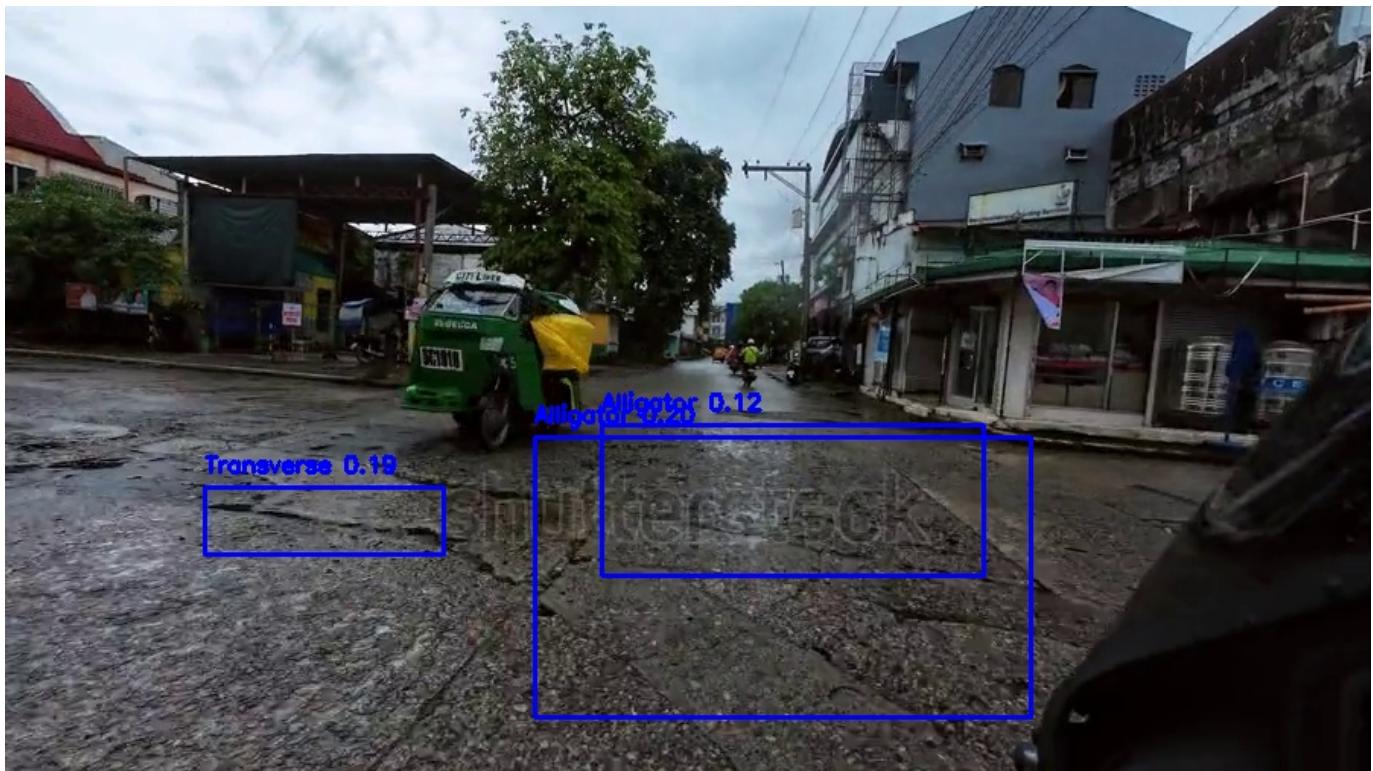
Frame 8: Detected defects - Alligator (0.20), Transverse (0.19), Alligator (0.12)

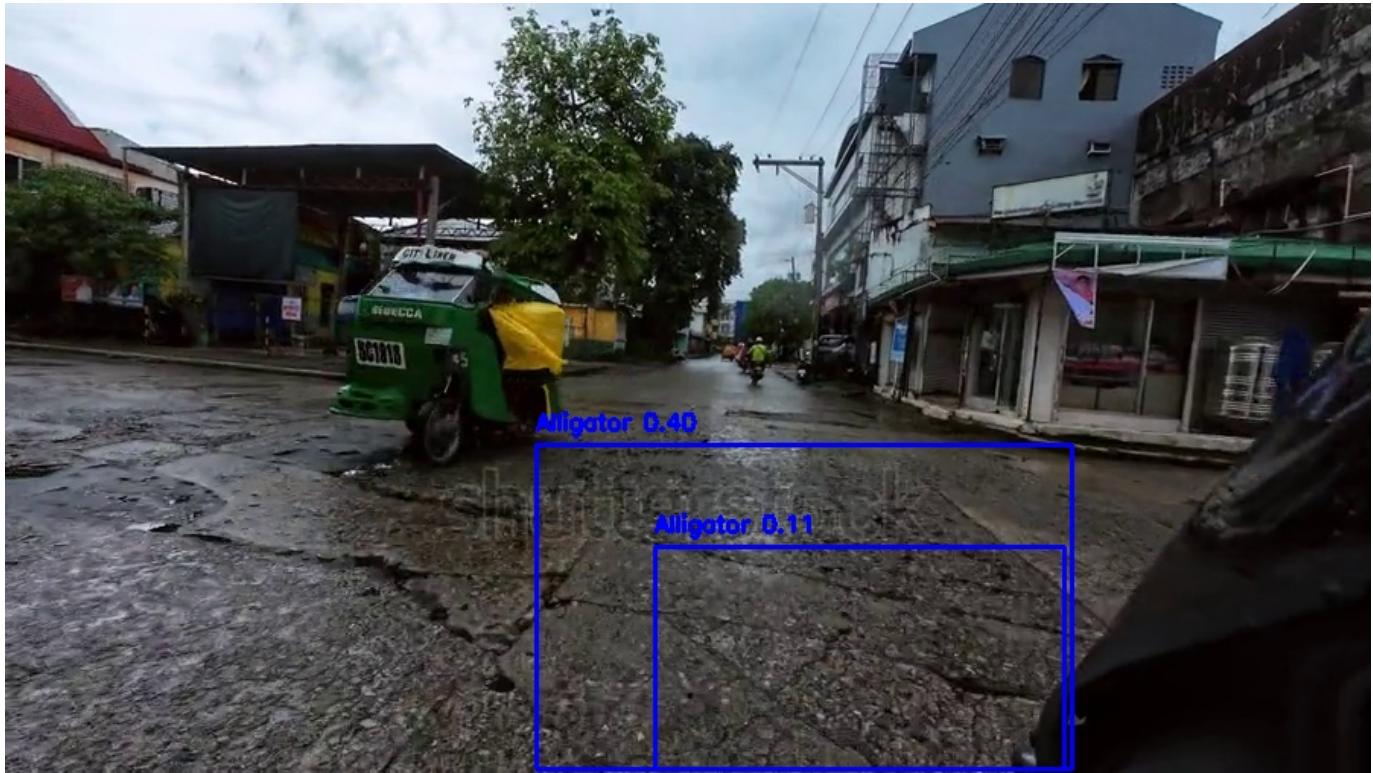
Frame 9: Detected defects - Alligator (0.40), Alligator (0.11)

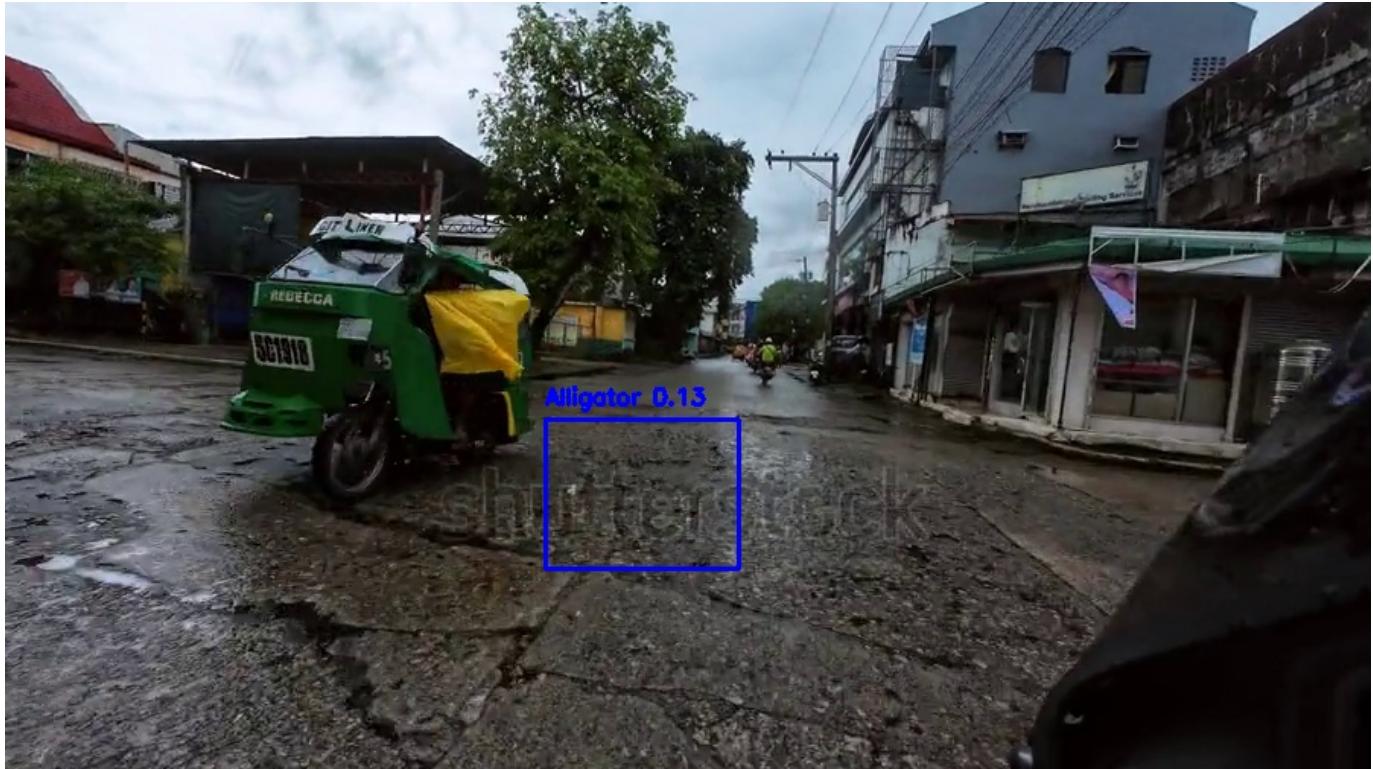
Frame 10: Detected defects - Alligator (0.13)

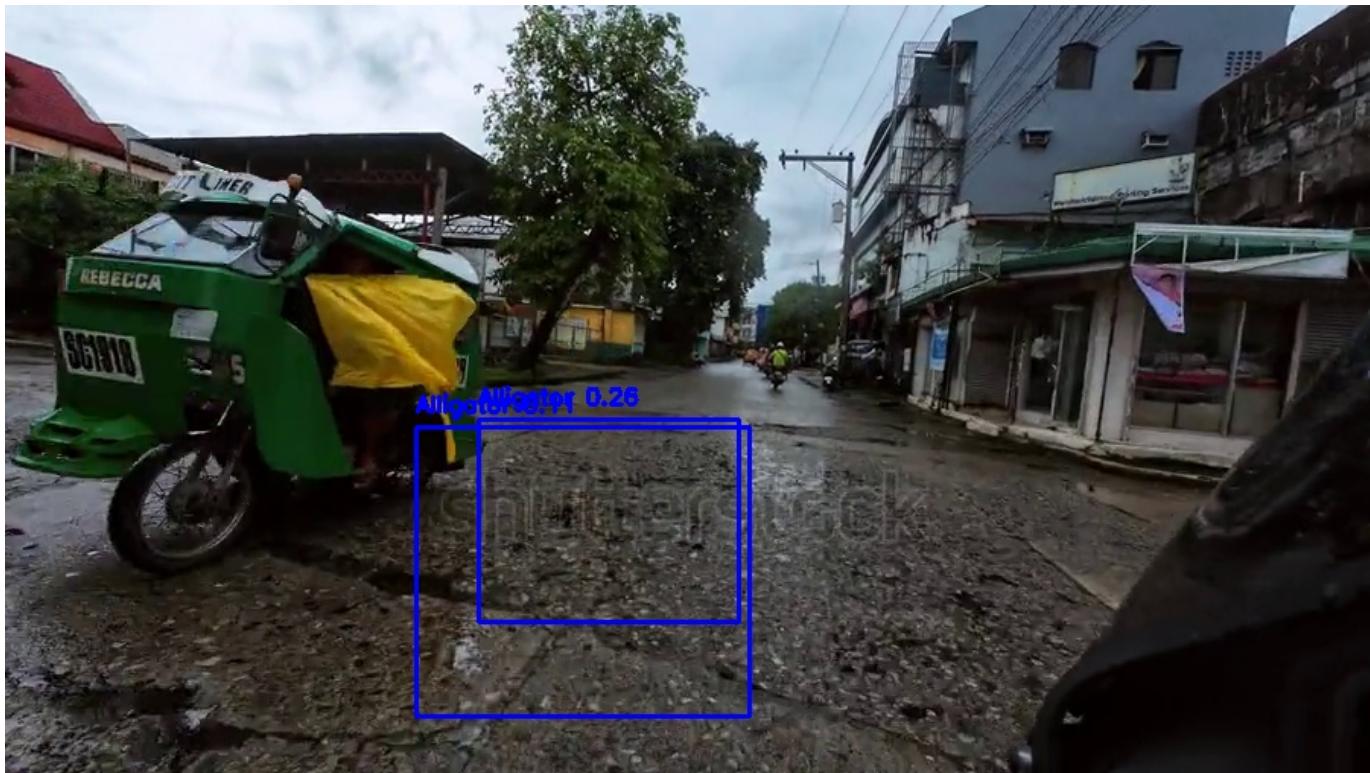
Frame 11: Detected defects - Alligator (0.26), Alligator (0.11)

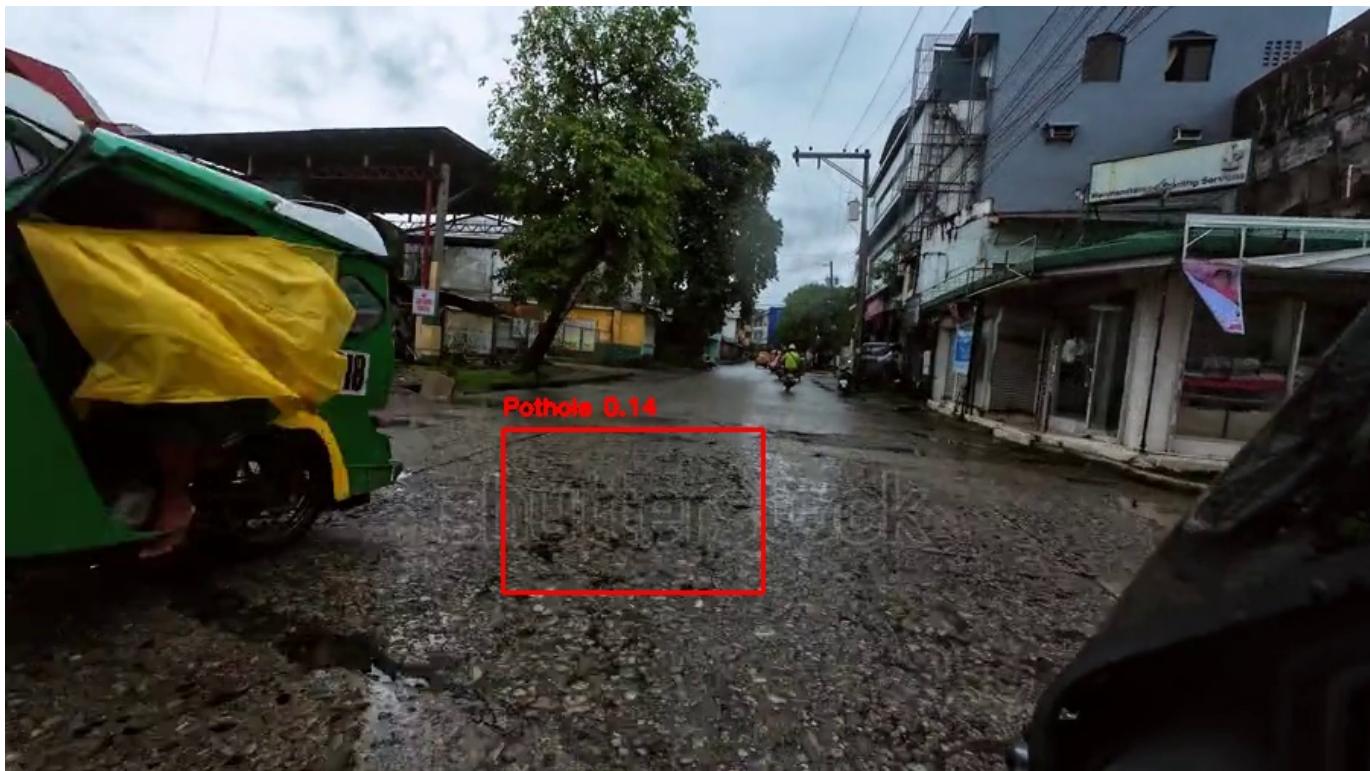
Frame 12: Detected defects - Pothole (0.14)

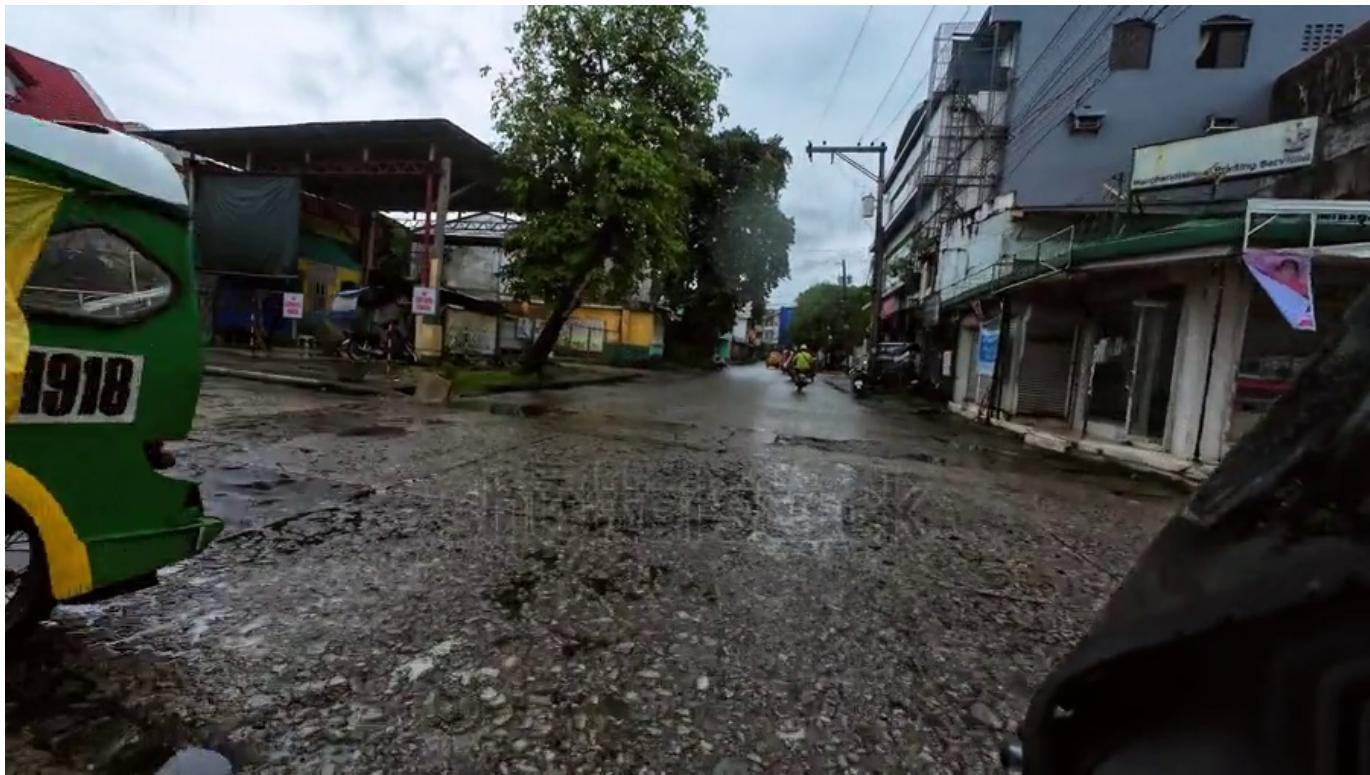
Frame 13: Detected defects -

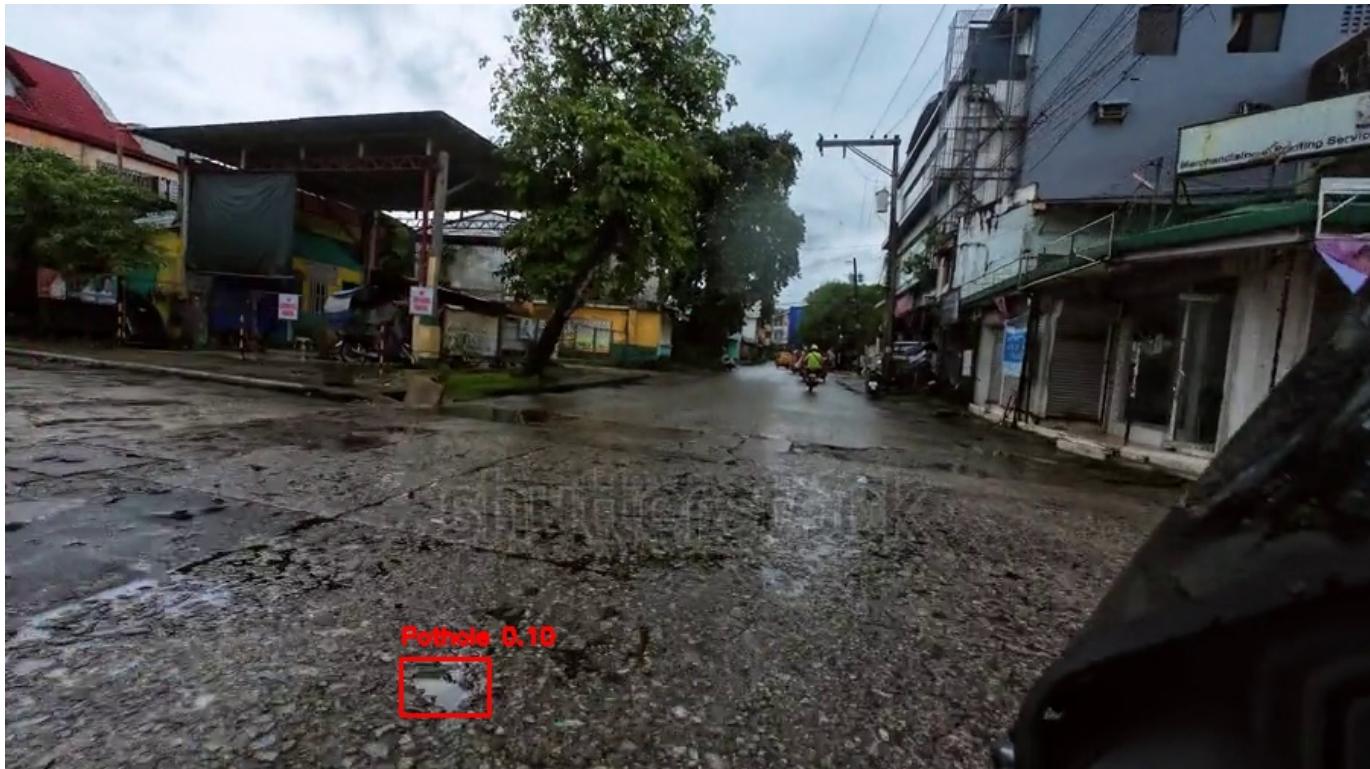
Frame 14: Detected defects - Pothole (0.10)

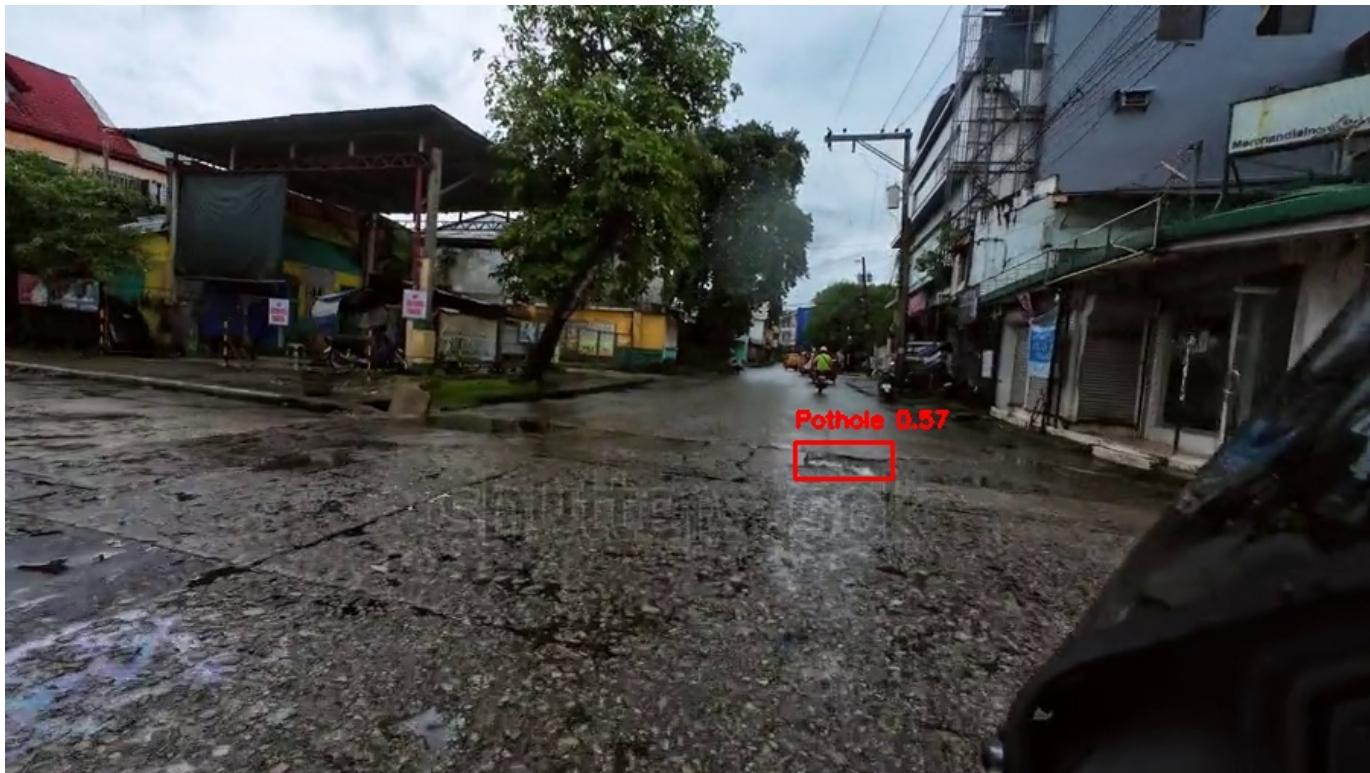
Frame 15: Detected defects - Pothole (0.57)

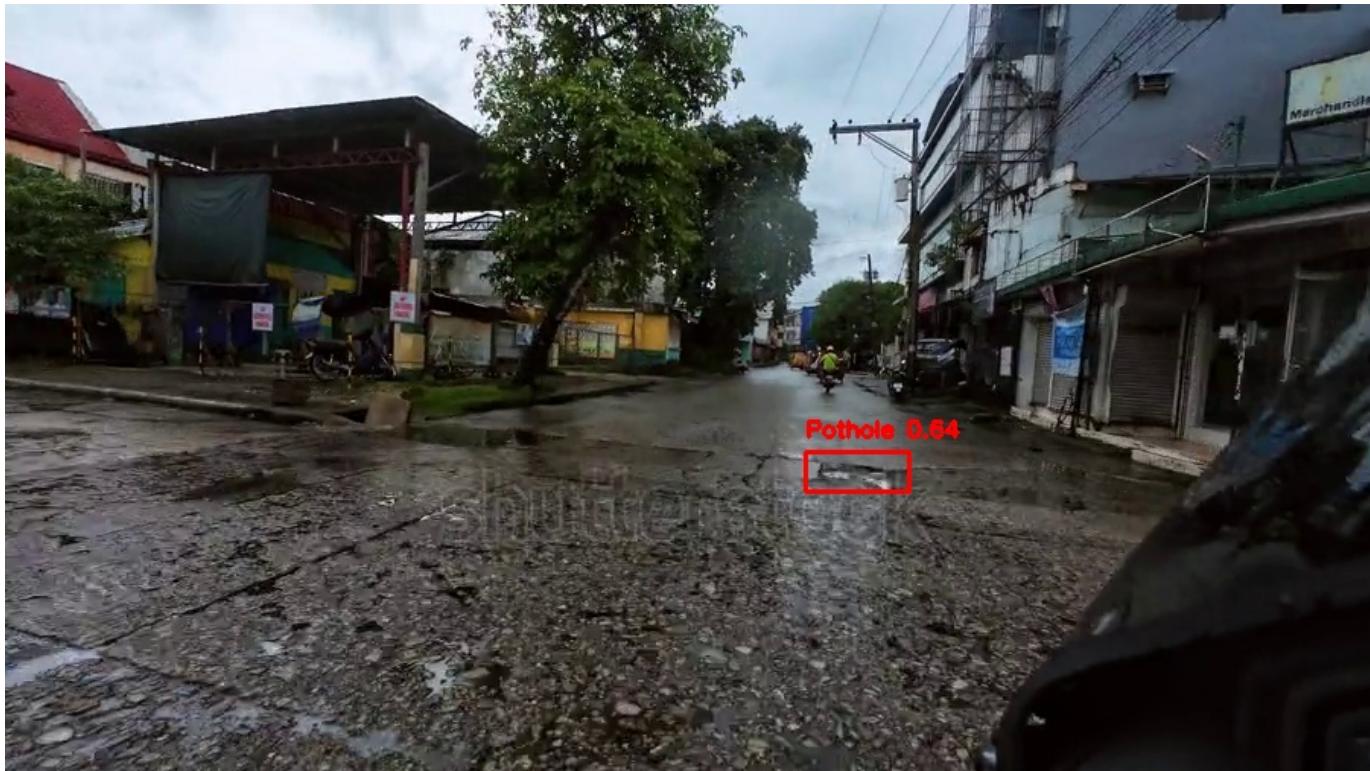
Frame 16: Detected defects - Pothole (0.64)

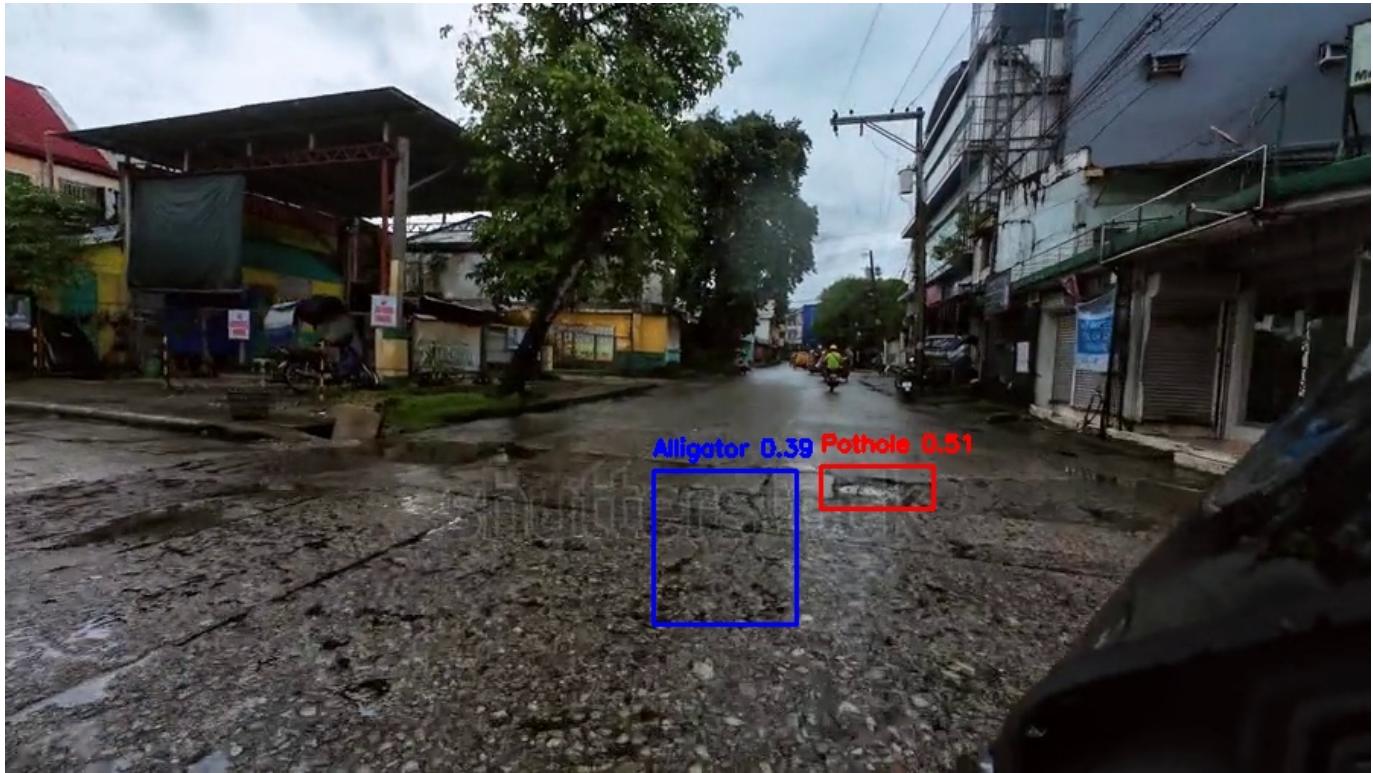
Frame 17: Detected defects - Pothole (0.51), Alligator (0.39)

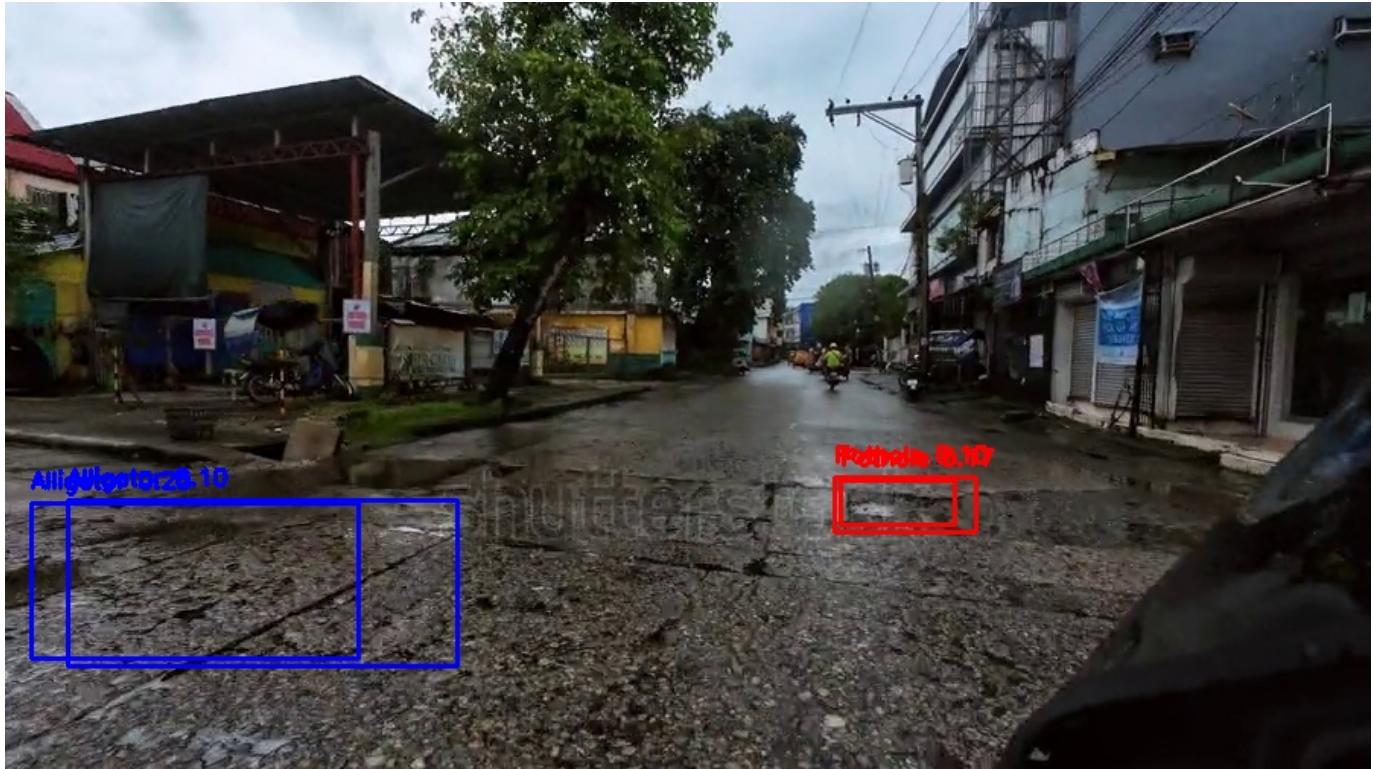
Frame 18: Detected defects - Alligator (0.25), Pothole (0.17), Pothole (0.10), Alligator (0.10)
