Road Condition Analysis Report

Road: Marine Drive in Mumbai

Date: 2025-04-22 20:57:03

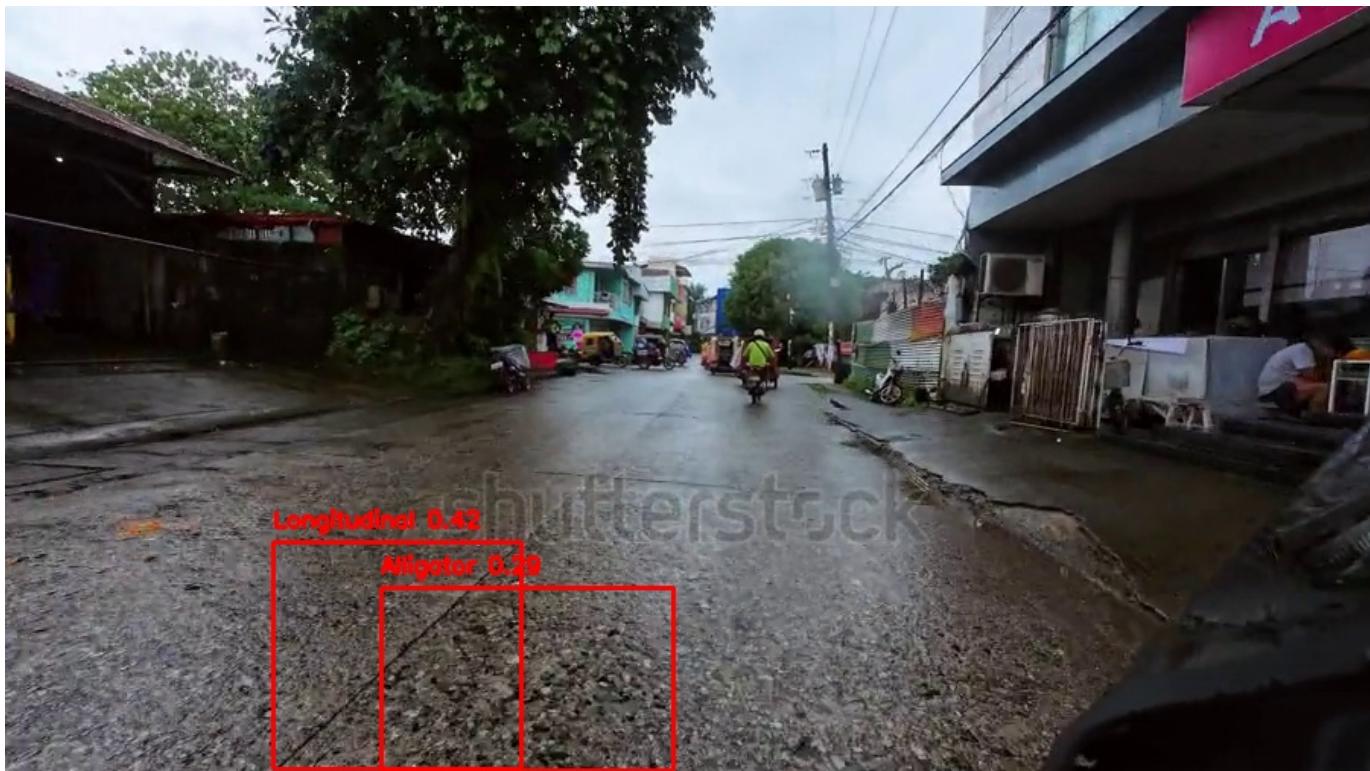
Frame 6: Detected defects - Longitudinal (0.42), Alligator (0.29)

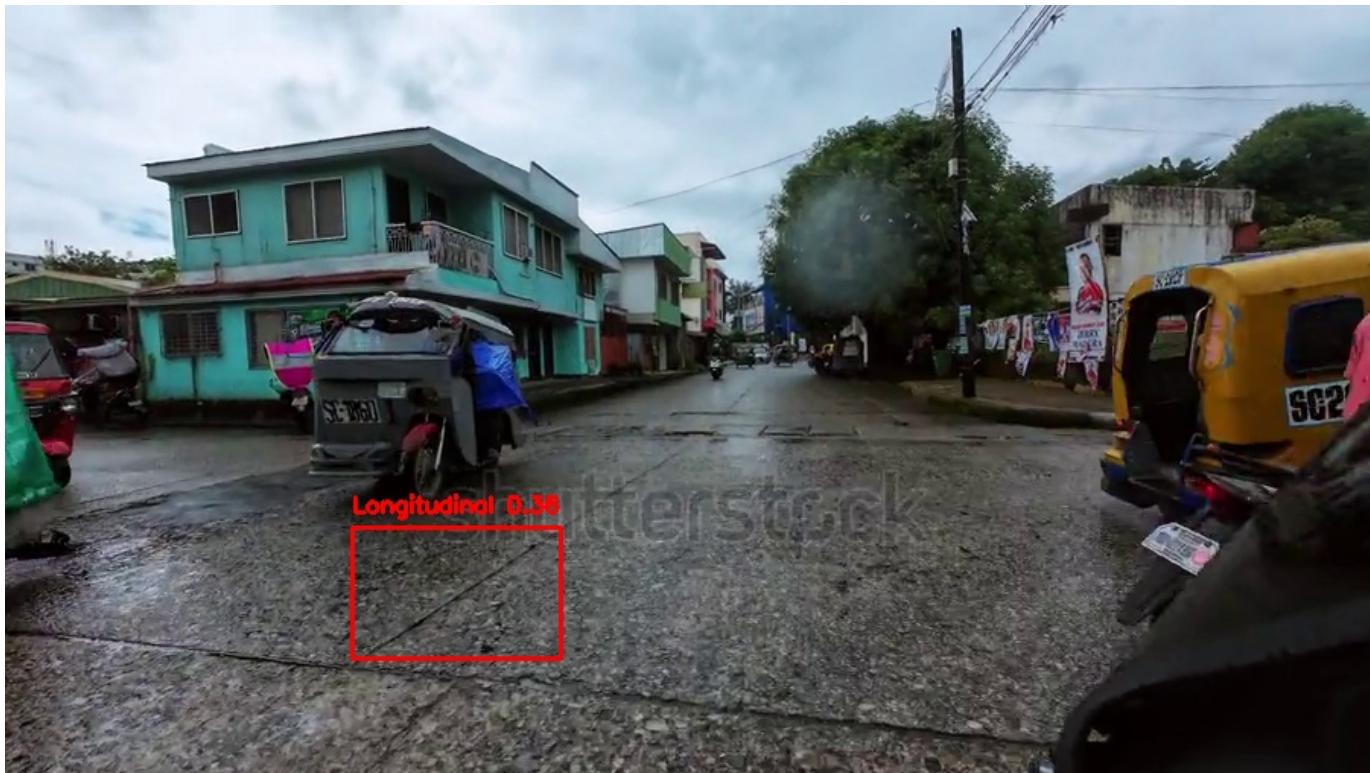
Frame 13: Detected defects - Longitudinal (0.36)

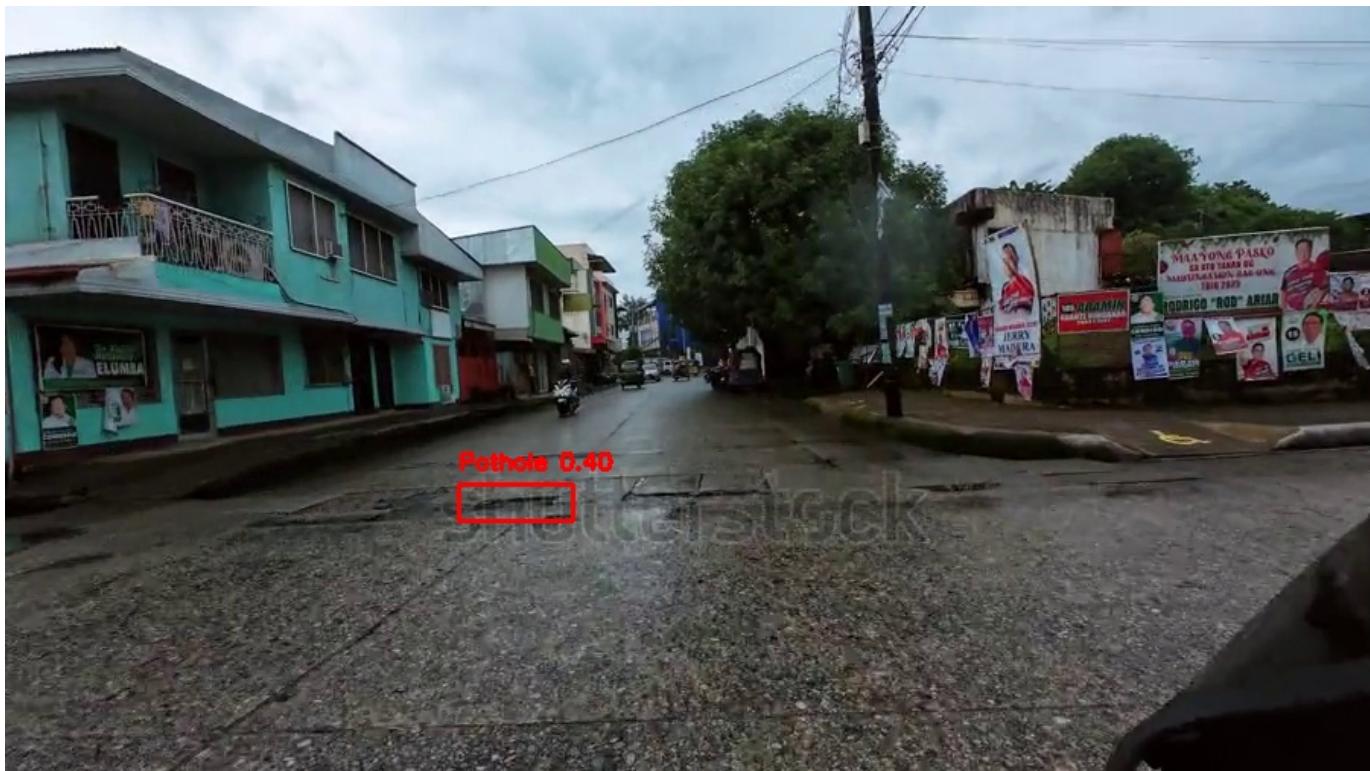
Frame 14: Detected defects - Pothole (0.40)
