# Road Condition Analysis Report

Analysis ID: dfb0fb4e-91b0-40ff-9471-0907555a3e78

Road: Marine Drive in Mumbai

Date: 2025-04-22 20:57:07

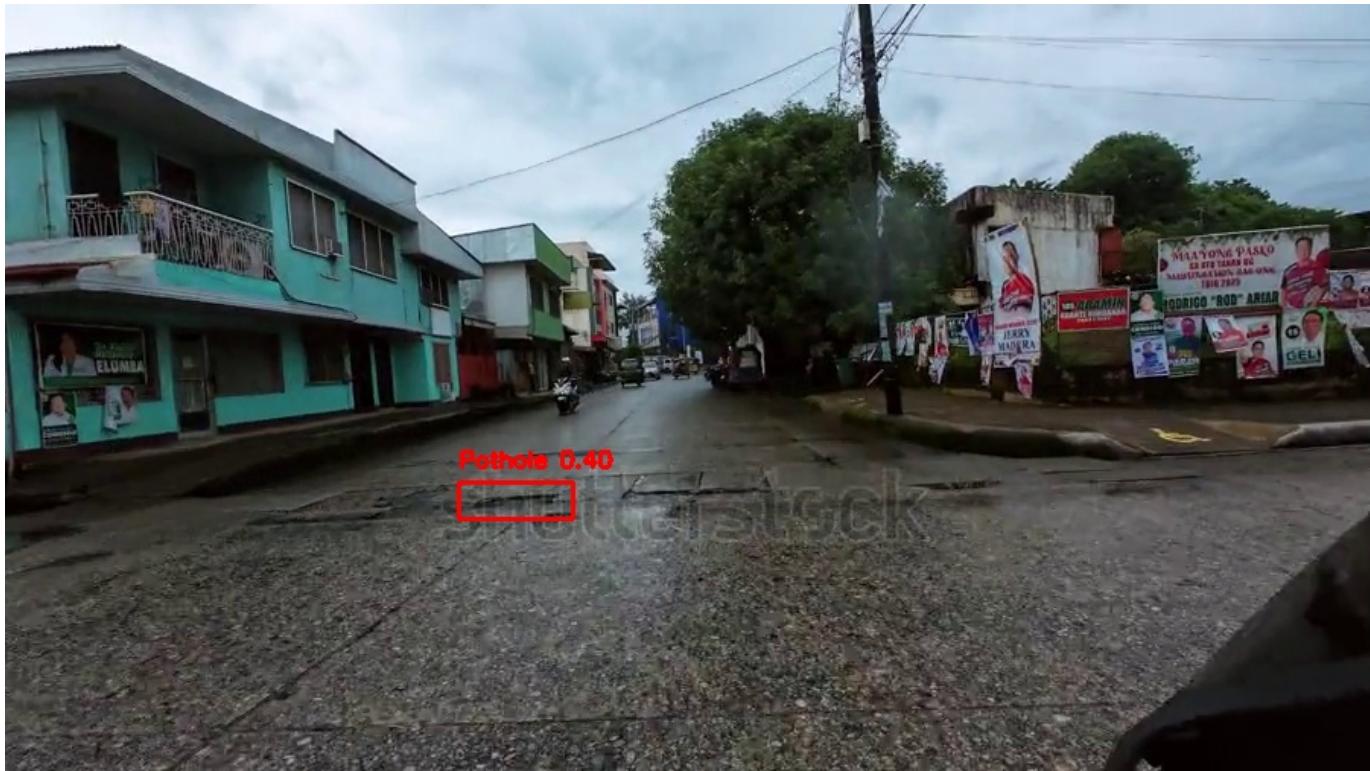
Frame 14: Detected defects - Pothole (0.40)
