# ENGINEERING CASE STUDY: Open-Circuit Fault Simulation & Failsafe Analysis

| <b>Platform:</b> 2018 Ford F-150 2.7L EcoBoost | <b>Fault Code Simulated:</b> DTC P0113 (Intake Air Temperature Circuit High) |

### F-150 2.7L EcoBoost: IAT/TIP Open-Circuit Failsafe Analysis

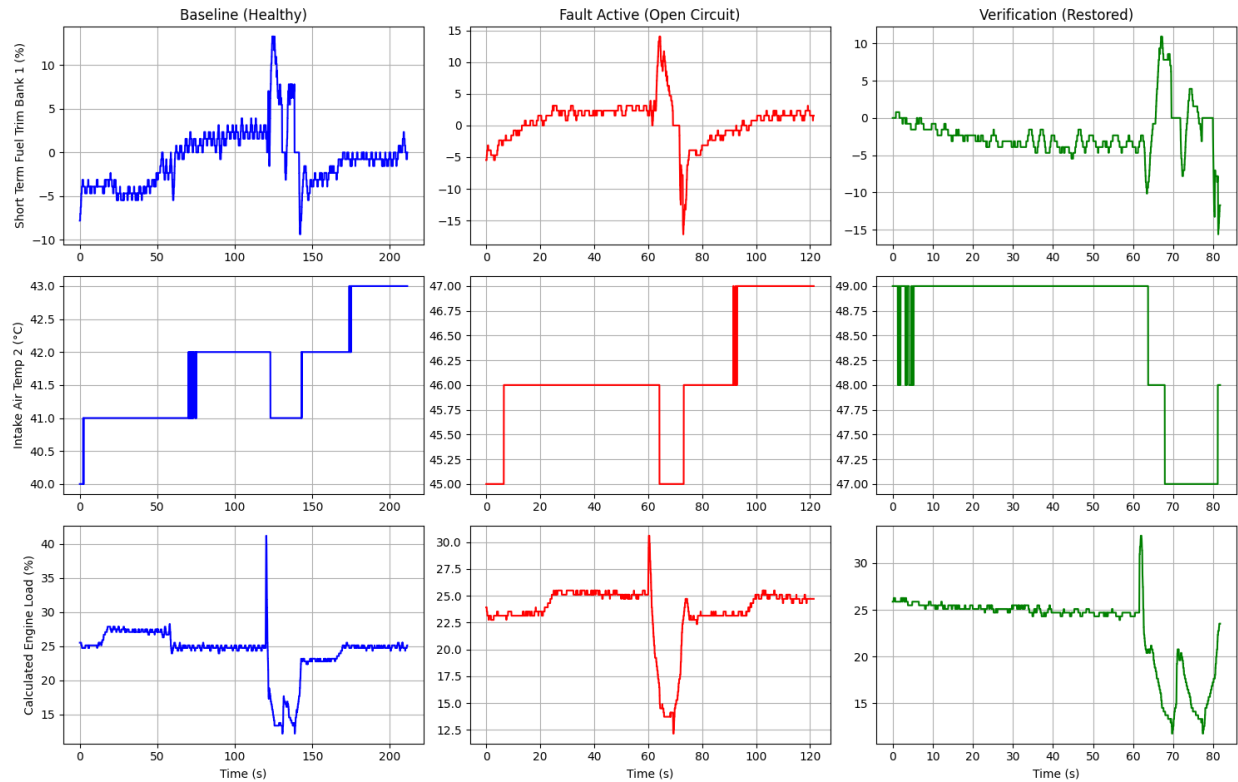
Figure 2.1: Side-by-side comparison of Baseline, Active Fault, and Verification telemetry.

- Closed-Loop Fuel Trim Compensation:** With the IAT/TIP circuit open, the PCM lost its primary air-density input and could no longer trust its speed-density fueling calculation. Rather than risk a lean-detonation event under boost, it abandoned tight stoichiometric targeting and biased SHRTFT1 from a  $-0.68\%$  baseline trim to  $+0.57\%$  under active fault, commanding a safely richer mixture. The sharpest transient enrichment (exceeding  $+12\%$  momentarily) lines up with the high-load excursion captured mid-run, showing the compensation strategy scales with instantaneous load rather than applying a single fixed offset.

- Sensor Circuit Isolation:** Because IAT/TIP and IAT2 are physically separate sensors on distinct circuits, the secondary post-intercooler sensor (IAT2) remained fully active throughout the fault window, tracking real heat soak from  $41^{\circ}\text{C}$  at baseline to  $48^{\circ}\text{C}$  during the fault and verification runs. This redundancy was the key diagnostic clue: a live, trending IAT2 signal alongside a flat, defaulted IAT/TIP reading confirmed the failure was isolated to a single open circuit rather than a shared harness ground, a PCM-side fault, or a broader sensor-suite failure.

- Verification Protocol:** Following physical restoration of the sensor connector, a Keep Alive Memory (KAM) reset was performed, and the DTC transitioned from Active to Stored/Historic. A subsequent run cycle confirmed IAT/TIP telemetry resumed active ambient tracking and SHRTFT1 stabilized to  $-2.2\%$ , closely matching the pre-fault baseline. The MIL remained
