# LONG AVENUE PEDESTRIAN AND TRAFFIC SAFETY ASSESSMENT

## COMMUNITY SAFETY REPORT

**Community Meeting: Rethinking Long Avenue  
30th Ward District of Chicago**

April 2025

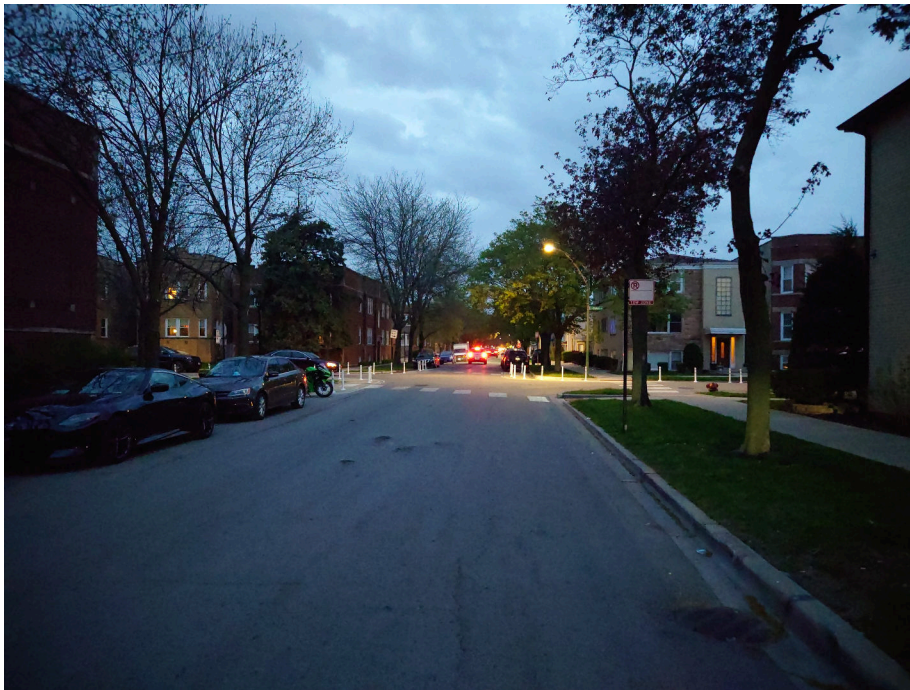
- **Absence of Pedestrian Signage:** At several intersections, including Long & Dakin, Long & Berenice, and Long & Patterson, there is no pedestrian crossing signage. These locations lack stop controls and leave pedestrians exposed to vehicle traffic with minimal warning to drivers.

Figure 1: Absence of pedestrian crossing signage at Long & Dakin. (Filed as 311 SR No. SR25-00689984)

- **Installation of MUTCD-Compliant Pedestrian Crossing Signage:** Deploy highly visible W11-2 “Pedestrian Crossing” signs at the intersections of Long & Dakin, Long & Berenice, and Long & Patterson, positioned at both driver eye-level and elevated heights wherever vegetation will not obstruct visibility; funding can be drawn from the ward’s discretionary infrastructure budget and coordinated with routine sign-repair scheduling for rapid implementation.

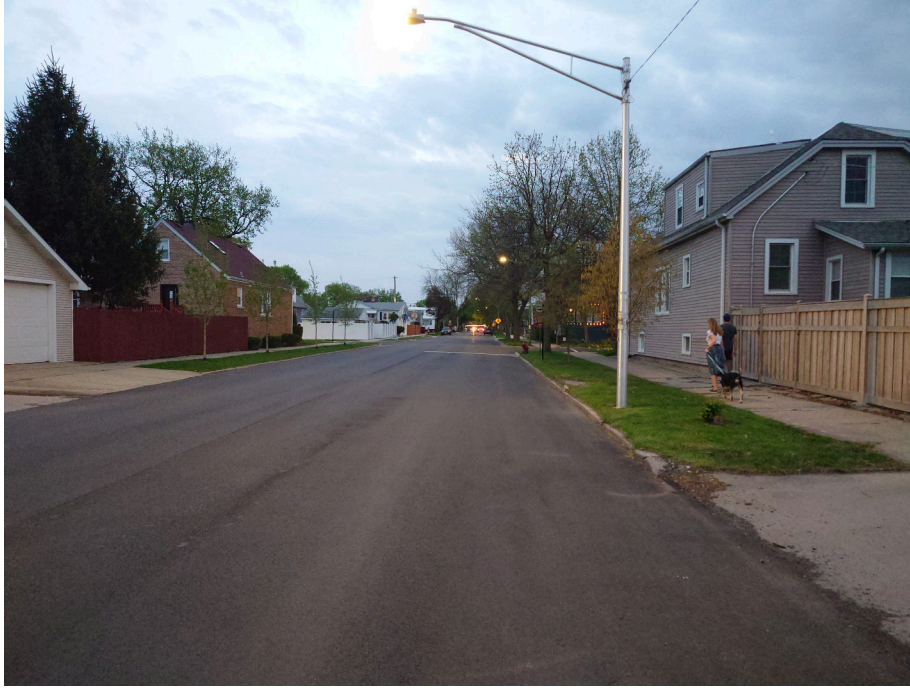
- **Obstructed Stop Sign:** At the northwest corner of North Long Avenue and West Warwick Avenue, a key stop sign is partially hidden by overgrown tree branches, reducing visibility for southbound drivers until the final approach to the intersection. This condition undermines driver compliance and increases collision risk.

Figure 2: Obstructed stop sign at the northwest corner of Long & Warwick. Vegetation blocks driver visibility traveling southbound. (Filed as 311 Service Request No. SR25-00689858)

- **Restore Full Visibility of Existing Stop Sign (Immediate):** Expedite trimming or removal of vegetation obstructing the stop sign at North Long Avenue and West Warwick Avenue to restore full visibility and ensure driver compliance.

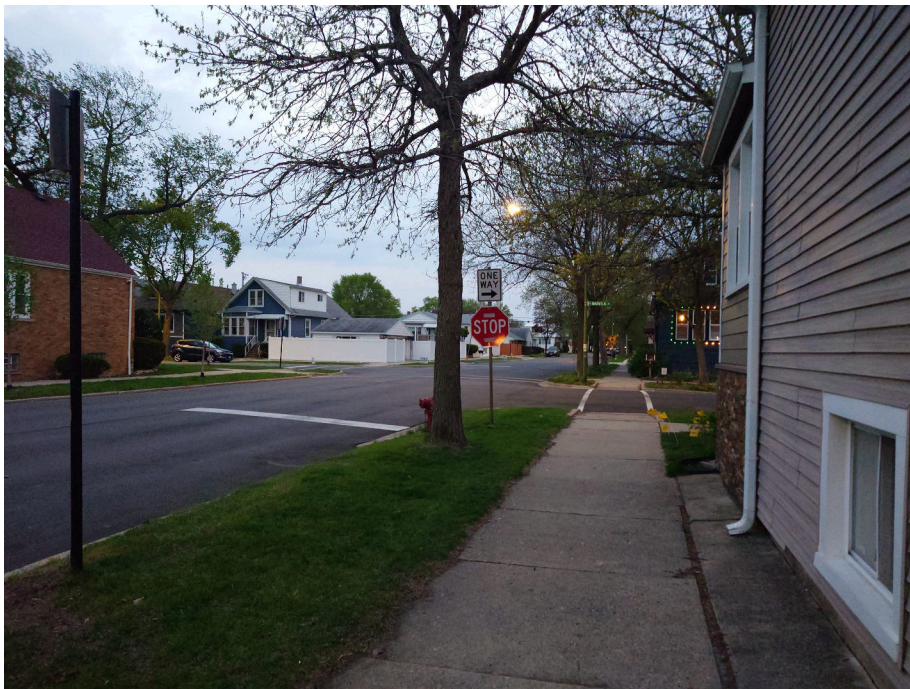
Figure 3: Close-up view showing tree obstruction directly impacting visibility of stop sign at Long & Warwick. (Filed as 311 SR No. SR25-00689858)

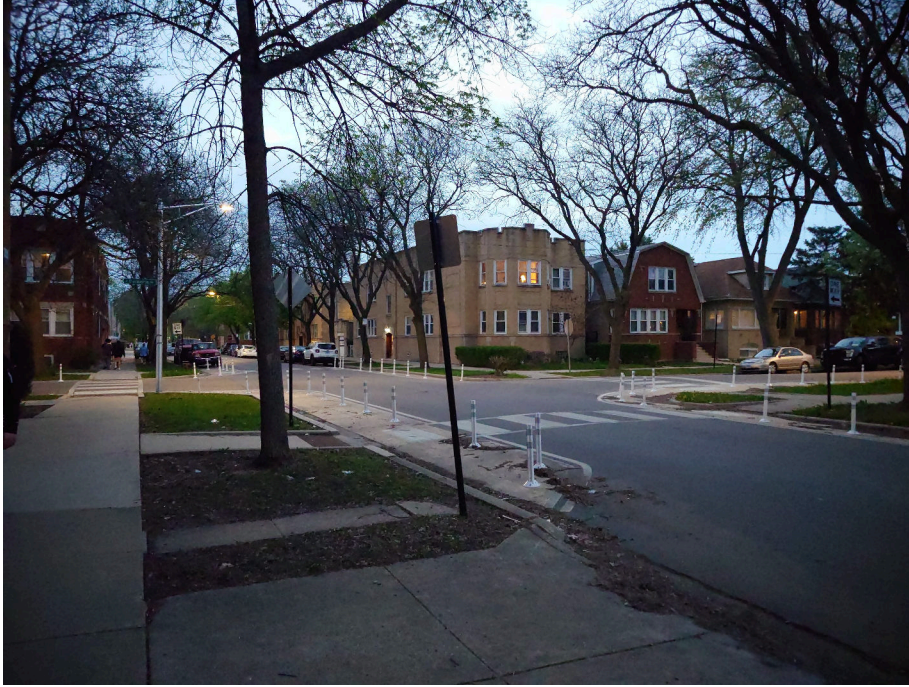
Figure 4: View facing northbound on Long and eastbound on Berenice; no pedestrian crossing signage or markings. (Filed as 311 SR No. SR25-00689968)

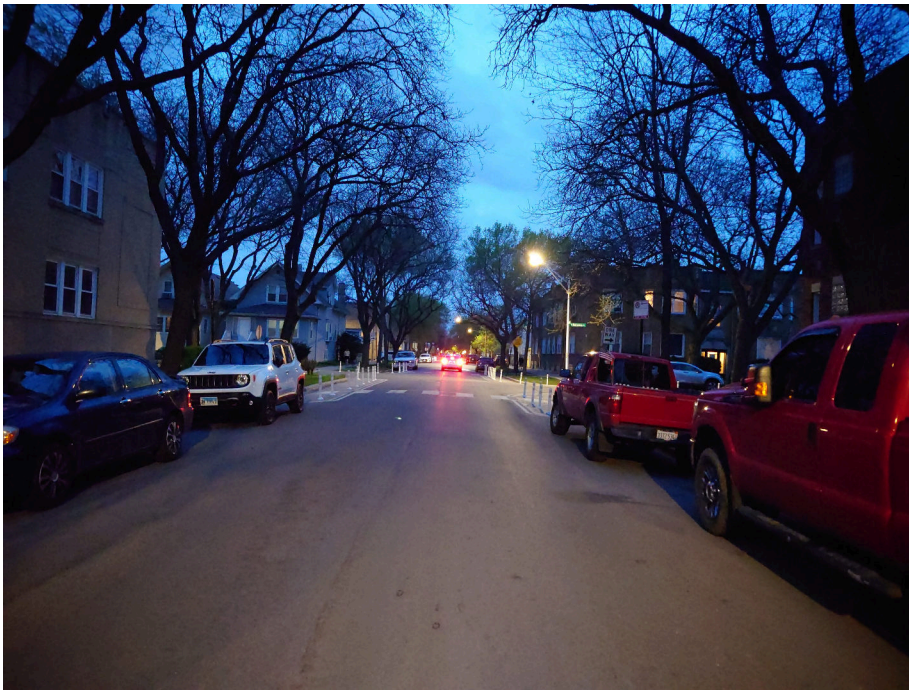
Figure 5: Northbound view on Long Avenue approaching Berenice; intersection lacks pedestrian accommodations.

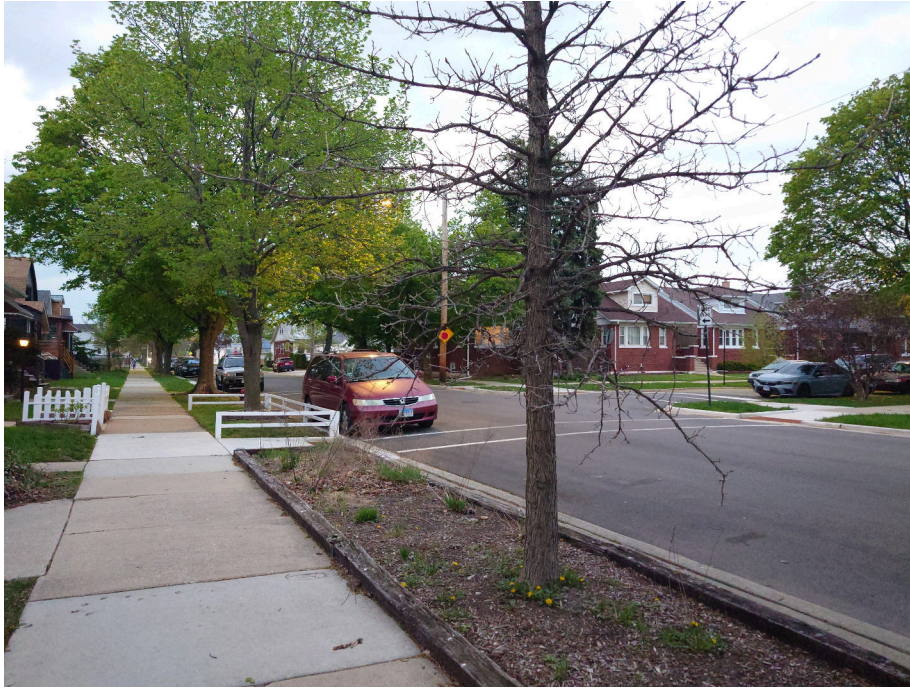
Figure 6: Wide view of Long & Patterson intersection showing absence of pedestrian crossing signage or pavement markings. (Filed as 311 SR No. SR25-00689945)

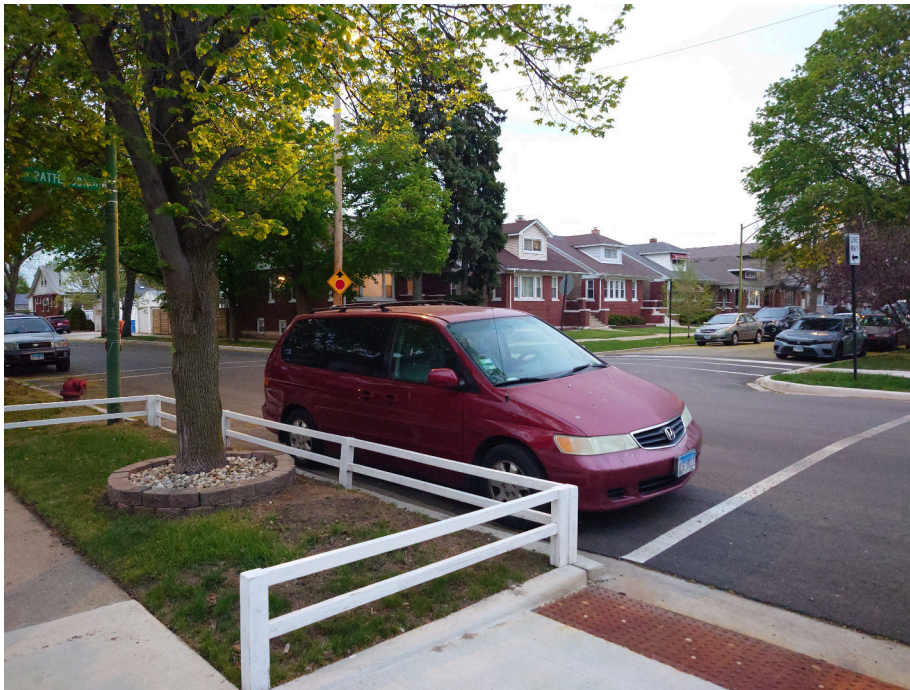
Figure 7: Closer view of Long & Patterson intersection, reinforcing absence of pedestrian safety infrastructure.
