# COLUMBIA

## ACCIDENT INVESTIGATION BOARD

REPORT VOLUME I  
AUGUST 2003

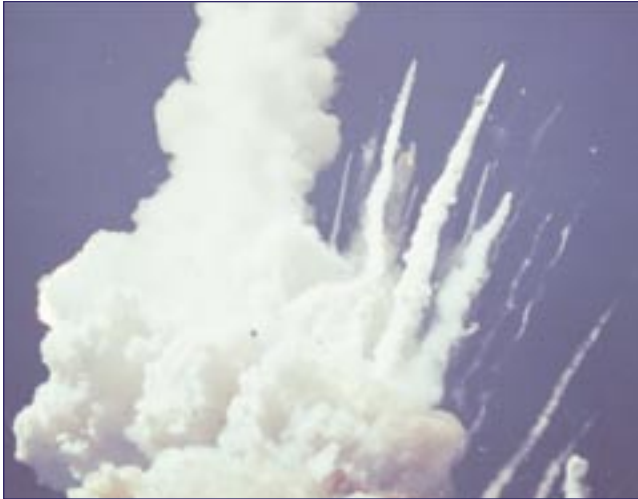
To investigate, President Reagan appointed the 13-member Presidential Commission on the Space Shuttle Challenger Accident, which soon became known as the Rogers Commission, after its chairman, former Secretary of State William P. Rogers.<sup>18</sup> Early in its investigation, the Commission identified the mechanical cause of the accident to be the failure of the joint of one of the Solid Rocket Boosters. The Commission found that the design was not well understood by the engineers that operated it and that it had not been adequately tested.

Figure 1.5-1. the Space Shuttle Challenger was lost during ascent on January 28, 1986, when an O-ring and seal in the left Solid Rocket Booster failed.

The Rogers Commission report, issued on June 6, 1986, recommended a redesign and recertification of the Solid Rocket Motor joint and seal and urged that an independent body oversee its qualification and testing. The report concluded that the drive to declare the Shuttle operational had put enormous pressures on the system and stretched its resources to the limit. Faulting NASA safety practices, the Commission also called for the creation of an independent NASA Office of Safety, Reliability, and Quality Assurance, reporting directly to the NASA Administrator, as well as structural changes in program management.<sup>20</sup> (The Rogers Commission findings and recommendations are discussed in more detail in Chapter 5.) It would take NASA 32 months before the next Space Shuttle mission was launched. During this time, NASA initiated a series of longer-term vehicle upgrades, began the construction of the Orbiter *Endeavour* to replace *Challenger*, made significant organizational changes, and revised the Shuttle manifest to reflect a more realistic flight rate.

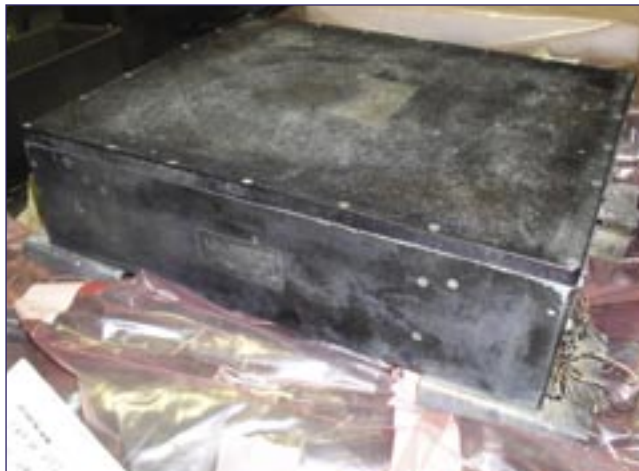
The Modular Auxiliary Data System is a supplemental instrumentation system that gathers Orbiter data for processing after the mission is completed. Inputs are almost exclusively physical sensor readings of temperatures, pressures, mechanical strains, accelerations, and vibrations. The Modular Auxiliary Data System usually records only the mission's first and last two hours (see Figure 3.6-1).

Figure 3.6-1. The Modular Auxiliary Data System recorder, found near Hemphill, Texas. While not designed to withstand impact damage, the recorder was in near-perfect condition when recovered on March 19, 2003.

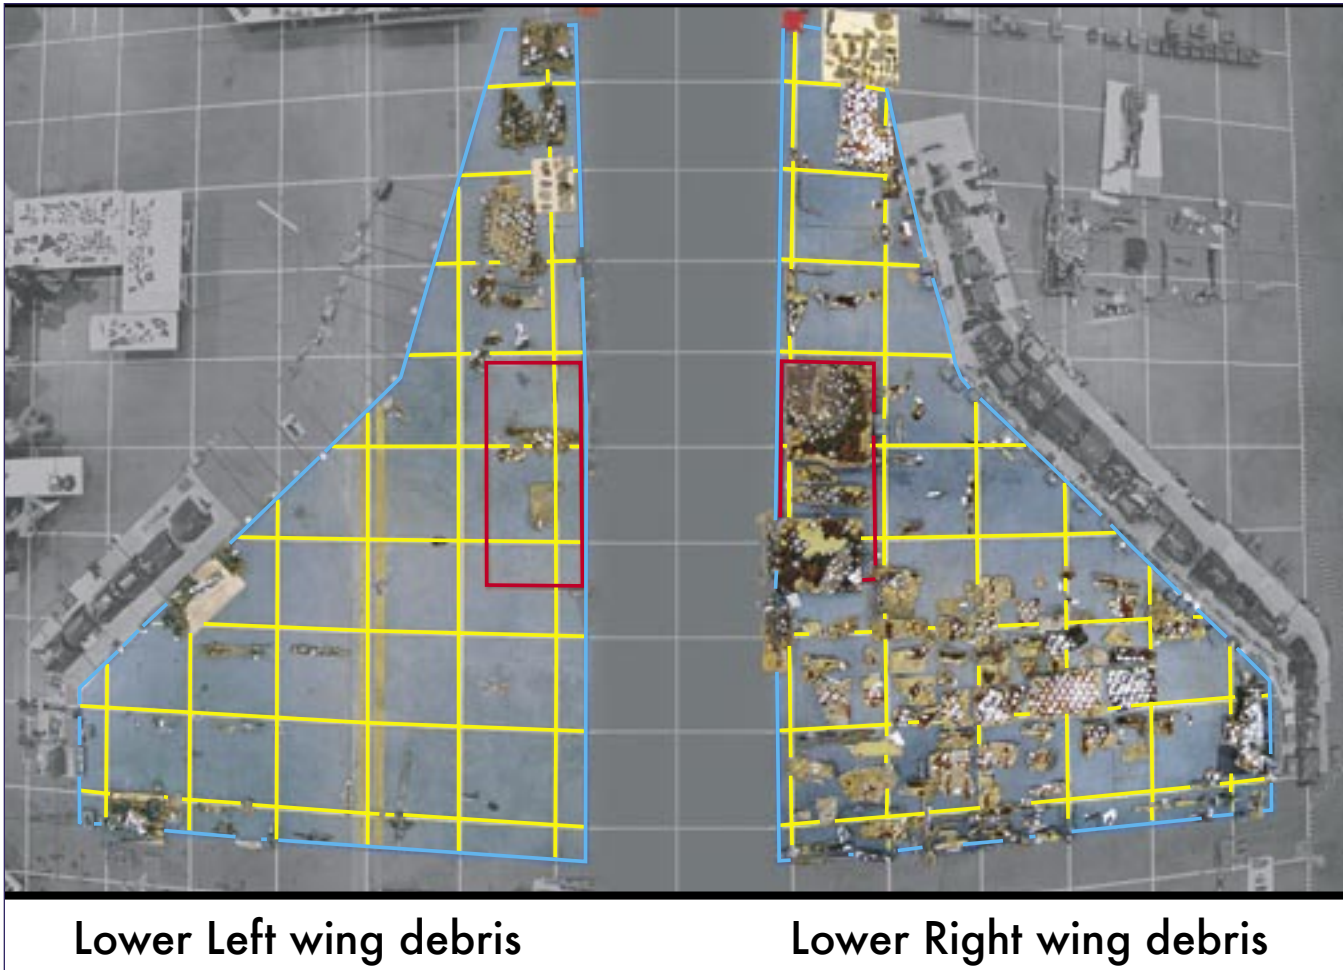
*Figure 3.7-1. Comparison of amount of debris recovered from the left and right wings of Columbia. Note the amount of debris recovered from areas in front of the wheel well (the red boxes on each wing) were similar, but there were dramatic differences in the amount of debris recovered aft of each wheel well.*

Detailed analysis of the debris revealed unique features and convincing evidence that the damage to the left wing differed significantly from damage to the right, and that significant differences existed in pieces from various areas of the left wing. While a substantial amount of upper and lower right wing structure was recovered, comparatively little of the upper and lower left wing structure was recovered (see Figure 3.7-1).

The difference in recovered debris from the Orbiter's wings clearly indicates that after the breakup, most of the left wing succumbed to both high heat and aerodynamic forces, while the right wing succumbed to aerodynamic forces only. Because the left wing was already compromised, it was the first area of the Orbiter to fail structurally. Pieces were exposed to higher heating for a longer period, resulting in more heat damage and ablation of left wing structural material. The left wing was also subjected to superheated air that penetrated directly into the mid-body of the wing for a substantial period. This pre-heating likely rendered those components unable to absorb much, if any, of the post-breakup heating. Those internal and external structures were likely vaporized during post-breakup re-entry. Finally, the left wing likely lost significant amounts of the Thermal Protection System prior to breakup due to the effect of internal wing heating on the Thermal Protection System bonding materials, and this further degraded the left wing's ability to resist the high heat of re-entry after it broke up.

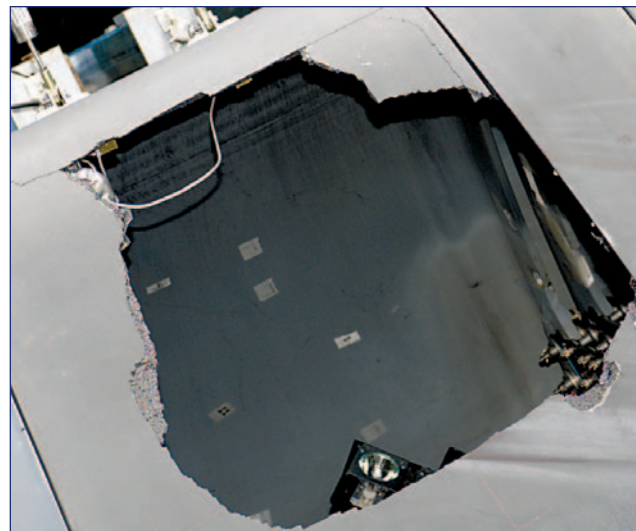
Figure 3.8-9. The large impact hole in Panel 8 from the final test.

The impact created a hole roughly 16 inches by 17 inches, which was within the range consistent with all the findings of the investigation (see Figure 3.8-9). Additionally, cracks in the panel ranged up to 11 inches in length (Figure 3.8-10). The T-seal between panels 8 and 9 also failed at the lower outboard mounting lug.

Three large pieces of the broken panel face sheet (see Figure 3.8-11) were retained within the wing. The two largest pieces had surface areas of 86 and 75 square inches. While this test cannot exactly duplicate the damage *Columbia* incurred, pieces such as these could have remained in the wing cavity for some time, and could then have floated out of the damaged wing while the Orbiter was maneuvering in space. This scenario is consistent with the event observed on Flight Day 2 (see Section 3.5).

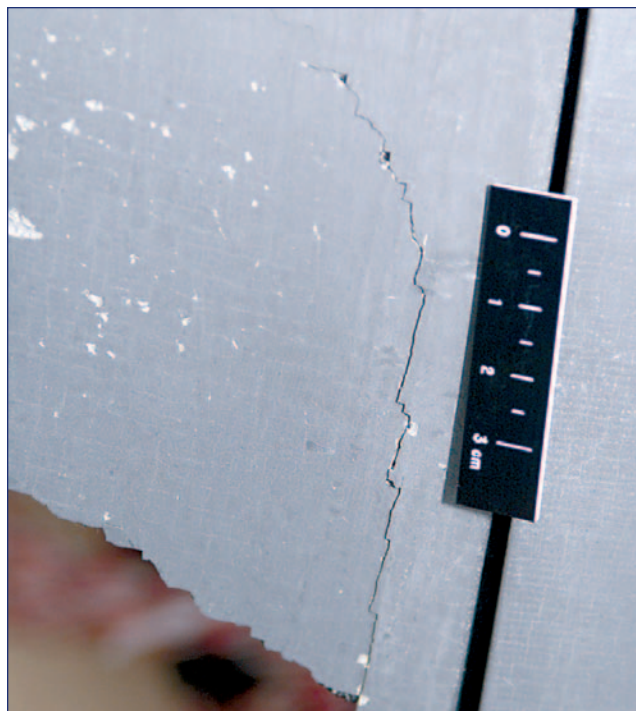
Figure 3.8-10. Numerous cracks were also noted in RCC Panel 8.

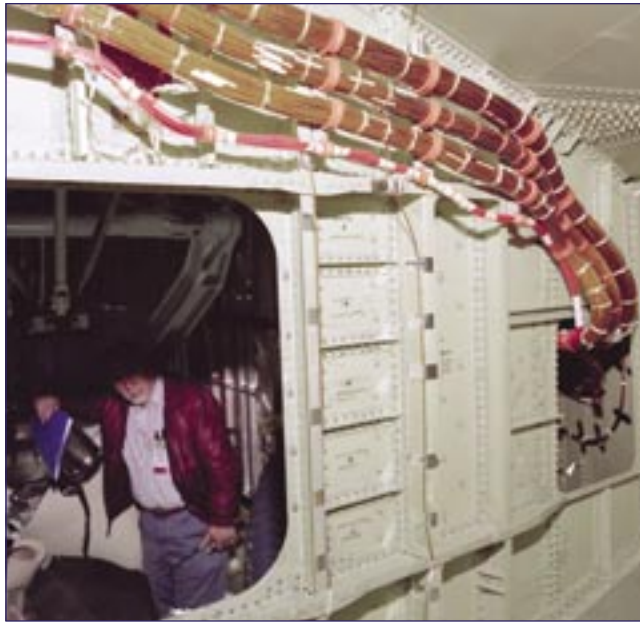
Figure 4.2-3. Typical wiring bundle inside Orbiter wing.

A typical wiring bundle is shown in Figure 4.2-3. Wiring nonconformances are corrected by rerouting, reclamping, or installing additional insulation such as convoluted tubing, insulating tape, insulating sheets, heat shrink sleeving, and abrasion pads (see Figure 4.2-4). Testing has shown that wiring bundles usually stop arc tracking when wires are physically separated from one another. Further testing under conditions simulating the Shuttle's wiring environment demonstrated that arc tracking does not progress beyond six inches. Based on these results, Boeing recommended that NASA separate all critical paths from larger wire bundles and individually protect them for a minimum of six inches beyond their separation points.<sup>4</sup> This recommendation is being adopted through modifications performed during scheduled Orbiter Major Modifications. For example, analysis of telemetered data from 14 of *Columbia's* left wing sensors (hydraulic line/wing skin/wheel temperatures, tire pressures, and landing gear downlock position indication) provided failure signatures supporting the scenario of left-wing thermal intrusion, as opposed to a catastrophic failure (extensive arc tracking) of Kapton wiring. Actual NASA testing in the months following the accident, during which wiring bundles were subjected to intense heat (ovens, blowtorch, and arc jet), verified the failure signature analyses. Finally, extensive testing and analysis in years prior to STS-107 showed that, with the low currents and low voltages associated with the Orbiter's instrumentation system (such as those in the left wing), the probability of arc tracking is commensurately low.

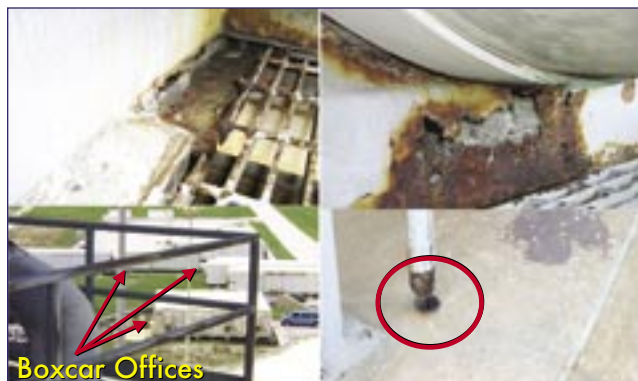
Board investigators have identified deteriorating infrastructure associated with the launch pads, Vehicle Assembly Building, and the crawler transporter. Figures 5.5-5 and 5.5-6 depict some of this deterioration. For example, NASA has installed nets, and even an entire sub-roof, inside the Vehicle Assembly Building to prevent concrete from the building’s ceiling from hitting the Orbiter and Shuttle stack. In addition, the corrosion-control challenge results in zinc primer

on certain launch pad areas being exposed to the elements. When rain falls on these areas, it carries away zinc, runs onto the leading edge of the Orbiter's wings, and causes pinholes in the Reinforced Carbon-Carbon panels (see Chapter 3).

Figure 5.5-5 and 5.5-6. Examples of the seriously deteriorating infrastructure used to support the Space Shuttle Program. At left is Launch Complex 39A, and at right is the Vehicle Assembly building, both at the Kennedy Space Center.

In 2000, NASA identified 100 infrastructure items that demanded immediate attention. NASA briefed the Space Flight Advisory Committee on this "Infrastructure Revitalization" initiative in November of that year. The Committee concluded that "deteriorating infrastructure is a serious, major problem," and, upon touring several Kennedy Space Center facilities, declared them "in deplorable condition."<sup>67</sup> NASA subsequently submitted a request to the White House Office of Management and Budget during Fiscal Year 2002 budget deliberations for \$600 million to fund the infrastructure initiative. No funding was approved.

In Fiscal Year 2002, Congress added \$25 million to NASA's budget for Vehicle Assembly Building repairs. NASA has reallocated limited funds from the Shuttle budget to pressing infrastructure repairs, and intends to take an integrated look at infrastructure as part of its new Shuttle Service Life Extension Program. Nonetheless, like Space Shuttle upgrades, infrastructure revitalization has been mired by the uncertainty surrounding the Shuttle Program's lifetime. Considering that the Shuttle will likely be flying for many years to come, NASA, the White House, and Congress alike now face the specter of having to deal with years of infrastructure neglect.

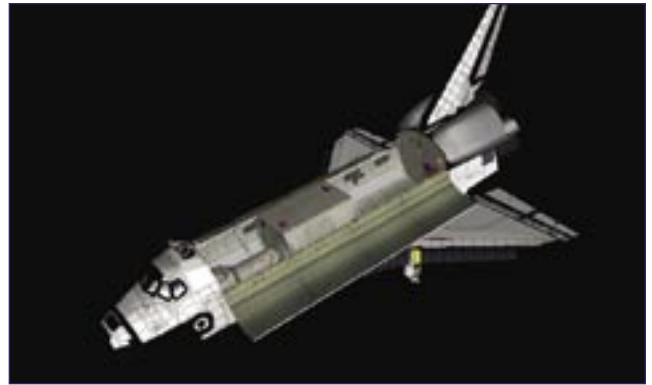
The repair option (see Figure 6.4-1), while logistically viable using existing materials onboard *Columbia*, relied on so many uncertainties that NASA rated this option "high risk." To complete a repair, the crew would perform a spacewalk to fill an assumed 6-inch hole in an RCC panel with heavy metal tools, small pieces of titanium, or other metal scavenged from the crew cabin. These heavy metals, which would help protect the wing structure, would be held in place during

Figure 6.4-1. The speculative repair option would have sent astronauts hanging over the payload bay door to reach the left wing RCC panels using a ladder scavenged from the crew module.
