Description: Clay apron feeder left geared motor

Sample ID: 26124405207

Asset Class: Gear Drive

Model: SL2PLB08516/FS/223.8/IEC 225 C

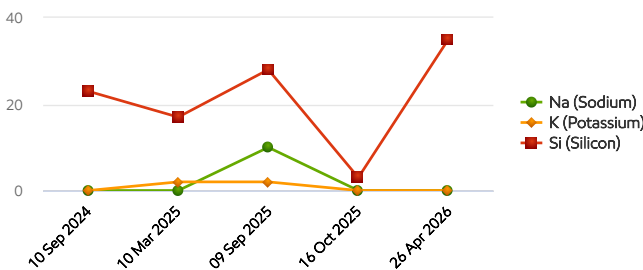
## Contaminants

| | | Caution | |
|---|--|---|---|
| <p>CAUTION - ELEVATED SILICON LEVEL. Determine source of Silicon (Si) and take corrective action. If the silicon level is elevated for the first time with no history of an increasing trend, then resample immediately to confirm condition. If wear metals levels are low, then the silicon likely exists in a non-abrasive form. Possible sources of non-abrasive silicon include: a. Defoamants; b. Sealant compounds. If wear metal levels are elevated, then the silicon likely exists in an abrasive form. Possible sources of abrasive silicon include: a. Abrasive dirt remaining in equipment due to ineffective purification and / or filtration; b. Faulty seals, breather, fill caps; c. Improper sampling techniques that result in dirt contaminating the sample. The oil may be unfit for continued use and should be monitored closely for further condition regressions. Prolonged usage of lubricants with elevated levels of abrasive silicon can cause severe wear and damage to the equipment. Inspect the equipment for signs of excessive wear. Change the oil immediately if the condition escalates. Contact your ExxonMobil representative for further assistance if necessary.</p> | | | |
