Description: **Rotary feeder Gear Box**

Model: Z108-M160L4

| | Unit ID: <b>R2.322.RF090</b> | Asset ID: <b>40110631</b> |

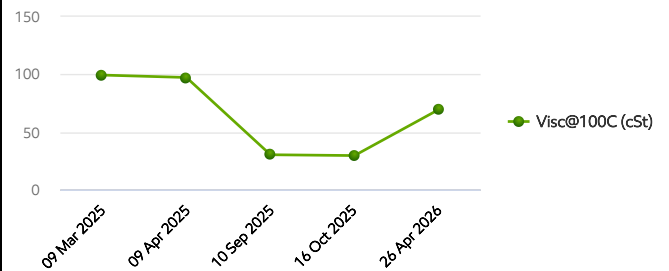
## Viscosity

| | Visc@100C (cSt) | 99.4 | 97.3 | 30.2 | 29.5 | 69.4 |

| <p>ACTION REQUIRED - REDUCED OIL VISCOSITY. Determine cause of reduced oil viscosity and take corrective action. Reduced viscosities can impair the lubricant's ability to protect the equipment. Possible causes of reduced viscosity include: a. Initial fill or contact with oil that has a lower viscosity; b. Contamination with a fuel or solvent; c. Incorrectly labeled sampled. Inspect the system for signs of fuel or coolant ingress. Resample the oil after corrective actions have been implemented. If the condition continues or escalates, recharge the system with new oil. Contact your ExxonMobil representative for further assistance if necessary.</p> | | |
