### SweynTooth: Unleashing Mayhem over Bluetooth Low Energy

\*\*ISingapore University of Technology and Design\*\*

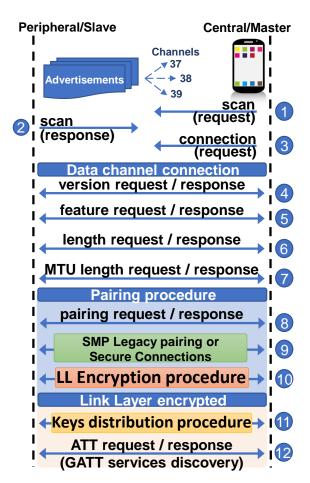
Figure 1: BLE messages exchange diagram

This particular finding allows a partial security bypass. During the BLE secure connection pairing (stage 2), it is possible to bypass the DHCheck of a particular SoC vendor by starting the encryption setup early. The flaw was found in Texas Instrument CC2640R2 SMP implementation and allows the DHCheck to be skipped by starting the LL Encryption Procedure earlier (c.f. step 10 of Figure 1).

Following Figure 13.b, the peripheral installs the LTK being generated in the current unfinished pairing process and allows the central to perform encryption of the link with such LTK while also skipping the Key distribution procedure (c.f. step 11 in Figure 1). The additional security checks performed by f6 function is not verified and hence the legitimacy of the IO Capabilities (IOCap) is not verified.

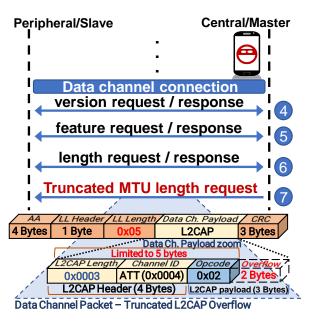
Figure 6: Truncated L2CAP vulnerability

sults due to a lack of checks during processing an L2CAP packet. If the total length of the packet (i.e.  $LL\ Length$ ) has a value lower than  $L2CAP\ Length + 4$  for a valid payload, then the truncated bytes are copied beyond the underlying reception buffer. Figure 6 shows an example of a maximum transmission unit (MTU). The MTU captures a length request, which has  $LL\ Length$  of seven bytes and  $L2CAP\ Length$  of three bytes. If the peripheral receives a malicious MTU length request with  $LL\ Length$  of five bytes instead, the  $L2CAP\ reception$  buffer is overflown by two bytes (i.e.  $L2CAP\ Length + 4 - LL\ Length$ ). Therefore, the attacker can selectively choose the number of bytes to overflow by sending the correct  $L2CAP\ payload$  and the malformed  $LL\ Length$  combination to the peripheral.

**Impact:** An attacker in radio range can use this attack to perform denial of service and crash the device. However, a careful sequence of packets could be sent by the attacker to force the peripheral into writing certain contents to peripheral memory adjacent to the L2CAP reception buffer. In the worst-case scenario, this attack could be a front door to perform remote execution on products using *Dialog DA14580* SoC.

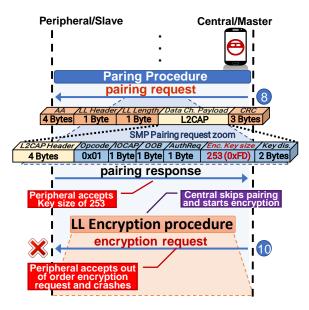
Figure 11: Key Size Overflow

The Key Size Overflow vulnerability was found in all *Telink Semiconductor* BLE SDKs. This causes an overflow in the device memory, resulting in a crash. However, the problem

During the start of the pairing procedure, the central device sends a *Pairing request* packet containing the maximum allowed key size to be negotiated at the end of the pairing procedure. The maximum key size is standardised to be within 7 to 16 bytes and any deviation from that should be rejected with a *pairing failure* response. However, Telink peripheral actually accepts a *maximum encryption key size* up to 255 by answering the central device with a *paring response* instead. Despite this first problem, the peripheral rejects the pairing during at later exchanges of the pairing procedure without abnormal behaviour. The second and final problem that finally triggers the vulnerability, arises because the peripheral accepts the *LL Encryption procedure* to occur before the pairing procedure even starts, albeit failing at later stage.

By combining the two mentioned problems it is possible to force the peripheral into allocating the over sized key buffer length which was negotiated during the *pairing request*. Depicted in Figure 11, the central device sends the invalid *pairing request*, waits for *pairing response* and sends an *encryption request*. The request is accepted and a buffer overflow occurs in peripheral's memory as its firmware tries to allocate the oversized key.

**Impact:** This vulnerability allows an attacker in radio to perform buffer overflow and crash Telink SoCs products with pairing support enabled, which is a common practice in several BLE products. While this vulnerability doesn't expose easy control over the overflown buffer, an exploit could be carefully constructed to overwrite memory contents adjacent to the key buffer if the the memory layout of the product's firmware is known. In the worst case, it could be possible to

overwrite buffers that store encryption nonce would allow the attacker to bypass encryption and leak user information.

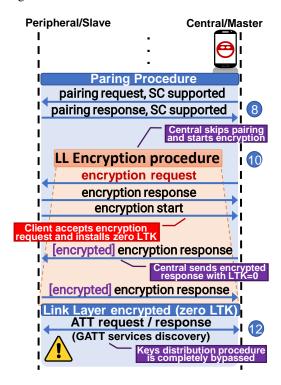
Figure 12: Zero LTK Installation

This critical vulnerability is a variation of one of the Key Size Overflow. It affects all products using Telink SMP implementation with support for secure connection enabled. It was verified that when the Telink peripheral accepts an out of order encryption request from the central, the encryption procedure is successful with a LTK which is zero. The LTK size, usually of 16 bytes, is agreed during the *pairing request/response* exchange.

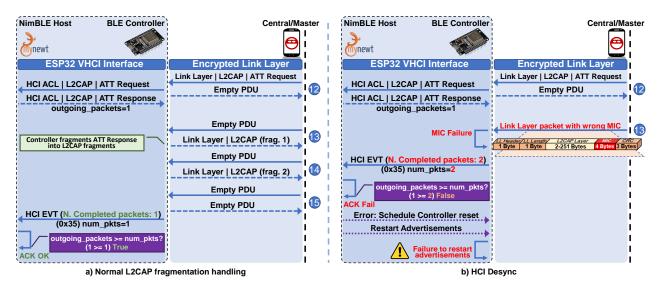
Figure 14: HCI Desync deadlock

This denial of service (DoS) vulnerability explores a desynchronization between the Espressif Systems ESP32 BLE controller and the host running other Bluetooth related protocols. It was found that in a particular case, the HCI event, which indicates completed packets, returns the number of scheduled packet fragments by the controller instead of the number of packets solicited by the host. This is not a big issue by itself (albeit non-compliant to Bluetooth Core Specification 5.2 Vol 4, Part E, Section 7.3.40 [17]). However, when the host runs the Apache mynewt-nimble stack, the default behaviour is to try to recover the host by restarting the stack due to a possible de-synchronisation with the controller. When nimble tries to re-enable advertisements due to the faulty behaviour, the controller fails to do so as it was not really

The source of this vulnerability is not on the Mynewt-nimble central implementation itself, but on the ESP32 controller implementation which returns the wrong packet number in a corner-case scenario as shown below. The figure to the left shows a normal encrypted connection when the peripheral fragments packets from the peripheral host. The attacker needs to send a precise invalid packet. This causes an MIC error on the same connection event that the first fragment is supposed to be delivered by the peripheral. Normally, the HCI packet completion event returns 1 to indicate that one packet has been acknowledged. When the attack is performed, such HCI event returns 2 and enters a faulty detection code on nimble stack. This disables advertisements at a later stage on the peripheral's default sample code.

**Impact:** The Impact is denial of service by means of disabling the bluetooth advertisement of ESP32 peripherals which are using Nimble as the BLE host layer implementation. The attack requires encryption and pairing support enabled on the peripheral to be successful. ESP32 peripherals that are *not* using the default *just-works* pairing have reduced risk in terms of an attacker in radio range to directly start the attack. However, triggering an MIC failure can be accomplished while using an active BLE sniffing tool that offers hijacking, such as *btle-jack* [3].
