SweynTooth: Unleashing Mayhem over Bluetooth Low Energy

Matheus E. Garbelini¹; Sudipta Chattopadhyay¹; Chundong Wang¹

ISingapore University of Technology and Design

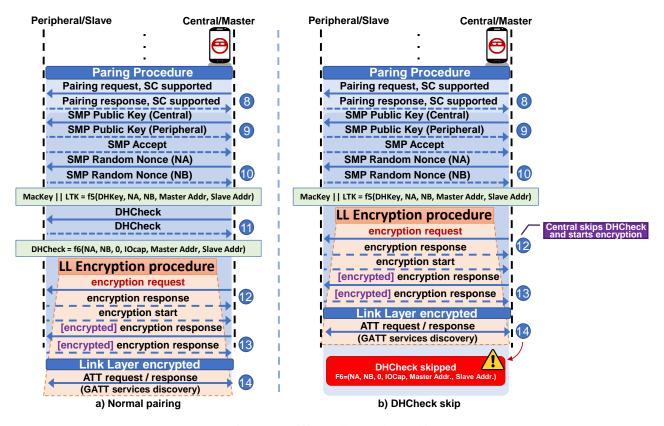
Figure 13: Diffie-Hellman Check Skip

This particular finding allows a partial security bypass. During the BLE secure connection pairing (stage 2), it is possible to bypass the DHCheck of a particular SoC vendor by starting the encryption setup early. The flaw was found in Texas Instrument CC2640R2 SMP implementation and allows the DHCheck to be skipped by starting the LL Encryption Procedure earlier (c.f. step 10 of Figure 1).

Following Figure 13.b, the peripheral installs the LTK being generated in the current unfinished pairing process and allows the central to perform encryption of the link with such LTK while also skipping the Key distribution procedure (c.f. step 11 in Figure 1). The additional security checks performed by f6 function is not verified and hence the legitimacy of the IO Capabilities (IOCap) is not verified.

Impact: Due to the requirements of the initial pairing procedure to be completed, this vulnerability can be reduced to

a non-compliance as it cannot be exploited over-the-air (as it would require a compromised central BLE implementation to start the attack). Specifically, the attacker needs the private key associated with the public key exchanged in the beginning of the pairing procedure. This was to generate the LTK of the current pairing session to go through the *numeric comparison/just work/pass key* pairing models.
