### SweynTooth: Unleashing Mayhem over Bluetooth Low Energy

Matheus E. Garbelini<sup>1</sup>; Sudipta Chattopadhyay<sup>1</sup>; Chundong Wang<sup>1</sup>

\*\*ISingapore University of Technology and Design\*\*

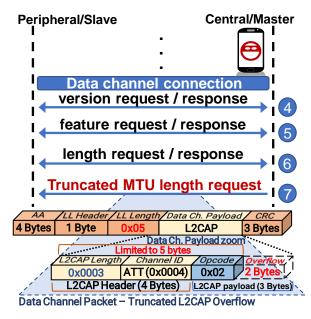
Figure 6: Truncated L2CAP vulnerability

The Truncated L2CAP vulnerability is present on Dialog DA14580 devices running SDK 5.0.4 or earlier. The flaw results due to a lack of checks during processing an L2CAP packet. If the total length of the packet (i.e. LL Length) has a value lower than L2CAP Length + 4 for a valid payload, then the truncated bytes are copied beyond the underlying reception buffer. Figure 6 shows an example of a maximum transmission unit (MTU). The MTU captures a length request, which has LL Length of seven bytes and L2CAP Length of three bytes. If the peripheral receives a malicious MTU length request with LL Length of five bytes instead, the L2CAP reception buffer is overflown by two bytes (i.e.  $L2CAP \ Length + 4 - LL \ Length$ ). Therefore, the attacker can selectively choose the number of bytes to overflow by sending the correct L2CAP payload and the malformed LL Length combination to the peripheral.

**Impact:** An attacker in radio range can use this attack to perform denial of service and crash the device. However, a careful sequence of packets could be sent by the attacker to force the peripheral into writing certain contents to peripheral memory adjacent to the L2CAP reception buffer. In the worst-case scenario, this attack could be a front door to perform remote execution on products using *Dialog DA14580* SoC.

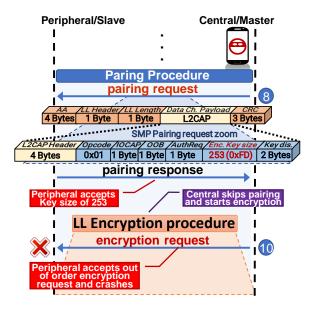
Figure 11: Key Size Overflow

The Key Size Overflow vulnerability was found in all *Telink Semiconductor* BLE SDKs. This causes an overflow in the device memory, resulting in a crash. However, the problem that allows this vulnerability is a combination of multiple issue found during the pairing procedure of devices using Telink SMP implementation.

During the start of the pairing procedure, the central device sends a *Pairing request* packet containing the maximum allowed key size to be negotiated at the end of the pairing procedure. The maximum key size is standardised to be within 7 to 16 bytes and any deviation from that should be rejected with a *pairing failure* response. However, Telink peripheral actually accepts a *maximum encryption key size* up to 255 by answering the central device with a *paring response* instead. Despite this first problem, the peripheral rejects the pairing during at later exchanges of the pairing procedure without abnormal behaviour. The second and final problem that finally triggers the vulnerability, arises because the peripheral accepts the *LL Encryption procedure* to occur before the pairing procedure even starts, albeit failing at later stage.

By combining the two mentioned problems it is possible to force the peripheral into allocating the over sized key buffer length which was negotiated during the *pairing request*. Depicted in Figure 11, the central device sends the invalid *pairing request*, waits for *pairing response* and sends an *encryption request*. The request is accepted and a buffer overflow occurs in peripheral's memory as its firmware tries to allocate the oversized key.

**Impact:** This vulnerability allows an attacker in radio to perform buffer overflow and crash Telink SoCs products with

pairing support enabled, which is a common practice in several BLE products. While this vulnerability doesn't expose easy control over the overflown buffer, an exploit could be carefully constructed to overwrite memory contents adjacent to the key buffer if the the memory layout of the product's firmware is known. In the worst case, it could be possible to overwrite buffers that store encryption nonce would allow the attacker to bypass encryption and leak user information.

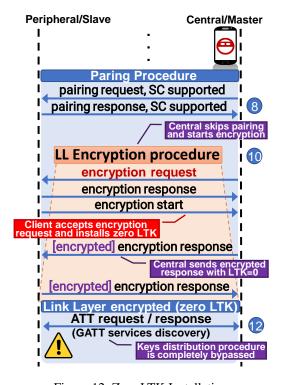
Figure 12: Zero LTK Installation

This critical vulnerability is a variation of one of the Key Size Overflow. It affects all products using Telink SMP implementation with support for secure connection enabled. It was verified that when the Telink peripheral accepts an out of order encryption request from the central, the encryption procedure is successful with a LTK which is zero. The LTK size, usually of 16 bytes, is agreed during the *pairing request/response* exchange.

Following Figure 10, the rogue central sends a *pairing request* with secure connections pairing indicated and waits for a *pairing response*. Next, the central skips the secure connections pairing procedure and starts the encryption procedure by sending a *encryption request*. Due to the lack of validation in peripheral's implementation, the central receives a *encryption start* from the peripheral and sends an encrypted *encryption response* back. This response is relevant because the periph-

eral validates it against the session key SK, which is derived from a valid LTK. Interestingly, the peripheral's LTK is initialized as zero. This allows the central to easily derive the SK to send the correct encrypted *encryption response* to the peripheral, hence successfully completing the encryption procedure. The SK (hiddenly mentioned in Bluetooth Core Specification as sessionKey [18]) is generated by the cryptographic function of Equation 1.

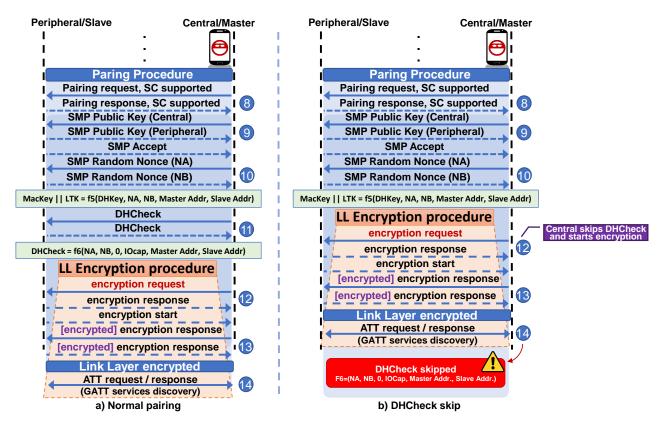
Figure 13: Diffie-Hellman Check Skip

This particular finding allows a partial security bypass. During the BLE secure connection pairing (stage 2), it is possible to bypass the DHCheck of a particular SoC vendor by starting the encryption setup early. The flaw was found in Texas Instrument CC2640R2 SMP implementation and allows the DHCheck to be skipped by starting the LL Encryption Procedure earlier (c.f. step 10 of Figure 1).

It is worthwhile to mention that, in Secure Connection Pairing, the LTK is actually generated before the DHCheck is complete. However, such a key (i.e. LTK) is normally discarded if something goes wrong during the DHCheck for security reasons. A normal DHCheck exchange (Figure 13.a) and the DHCheck skip (Figure 13.b) are shown in the figures below.

Following Figure 13.b, the peripheral installs the LTK being generated in the current unfinished pairing process and allows the central to perform encryption of the link with such LTK while also skipping the Key distribution procedure (c.f.

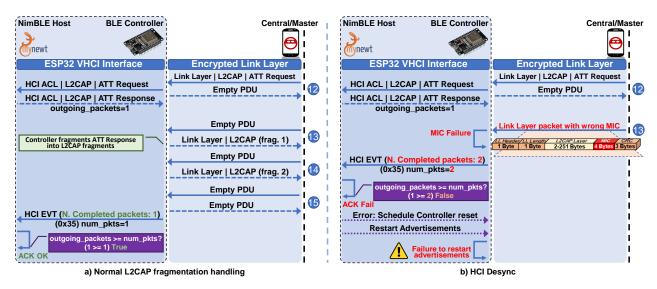
Figure 14: HCI Desync deadlock

This denial of service (DoS) vulnerability explores a desynchronization between the Espressif Systems ESP32 BLE controller and the host running other Bluetooth related protocols. It was found that in a particular case, the HCI event, which indicates completed packets, returns the number of scheduled packet fragments by the controller instead of the number of packets solicited by the host. This is not a big issue by itself (albeit non-compliant to Bluetooth Core Specification 5.2 Vol 4, Part E, Section 7.3.40 [19]). However, when

the host runs the Apache mynewt-nimble stack, the default behaviour is to try to recover the host by restarting the stack due to a possible de-synchronisation with the controller. When nimble tries to re-enable advertisements due to the faulty behaviour, the controller fails to do so as it was not really de-synchronized to start with.

The source of this vulnerability is not on the Mynewtnimble central implementation itself, but on the ESP32 controller implementation which returns the wrong packet number in a corner-case scenario as shown below. The figure to the left shows a normal encrypted connection when the peripheral fragments packets from the peripheral host. The attacker needs to send a precise invalid packet. This causes an MIC error on the same connection event that the first fragment is supposed to be delivered by the peripheral. Normally, the HCI packet completion event returns 1 to indicate that one packet has been acknowledged. When the attack is performed, such HCI event returns 2 and enters a faulty detection code on nimble stack. This disables advertisements at a later stage on the peripheral's default sample code.

**Impact:** The Impact is denial of service by means of disabling the bluetooth advertisement of ESP32 peripherals which are using Nimble as the BLE host layer implementation. The attack requires encryption and pairing support enabled on the peripheral to be successful. ESP32 peripherals that are *not* using the default *just-works* pairing have reduced risk in terms of an attacker in radio range to directly start the attack. However, triggering an MIC failure can be accomplished while using an active BLE sniffing tool that offers hijacking, such as *btle-jack* [3].
