# Laundry room — zone by zone

Current condition matched to the proposed enhancement, area by area

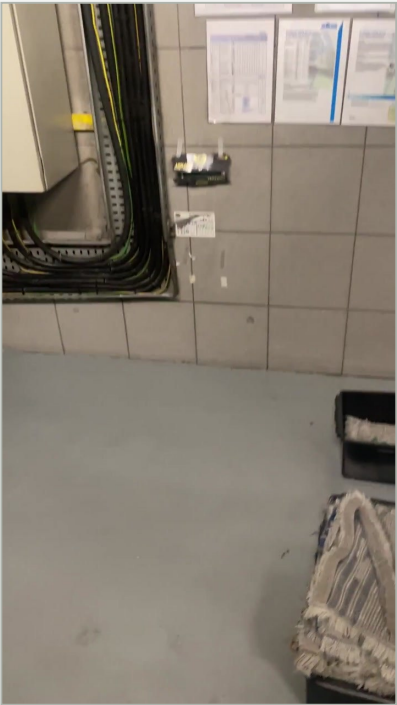
Entry wall, 0:00–0:02 in the walkthrough

Paper against a live board is the cheapest fire risk in the room to remove — and the first thing an auditor photographs.

- A distribution board with heavy cabling entering, and roughly fifteen A4 sheets taped to the tile directly beside it.
- Open lint trays, a woven sack and a plastic storage box on the floor beneath the board.
- No keep-clear zone marked or maintained in front of the board.

- Strip the paper wall entirely. Combustible material does not belong against a live board.
- Clear the floor beneath and in front of it, then paint a keep-clear zone on the resin.
- Replace the paper with the printed kit: one KEEP CLEAR — ELECTRICAL PANEL sign at a fixed height.
- Documents move to the framed DAILY CHECKS board in the alcove (Zone 03).

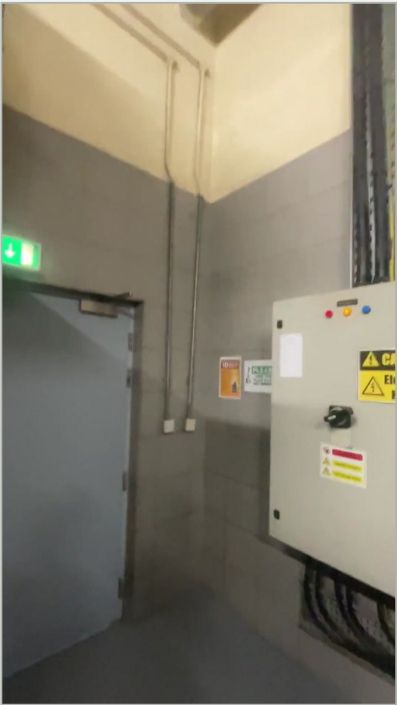
Corner by the fire-rated door, 0:03

Nothing on this page costs money, and it is the highest-consequence zone in the report.

- A green running-man exit sign over a fire-rated door — this room is on an escape route.
- A second distribution board, Caution — Electrical Hazard, with cabling entering below.
- Small safety notices taped at inconsistent heights beside the board.

- Treat the whole floor as an escape route: nothing stored on it that is not on wheels.
- Mark a keep-clear zone at this board as well as the first.
- Replace taped notices with the same printed signs at one consistent height throughout.
- This zone costs nothing and is the most likely single inspection failure in the room.

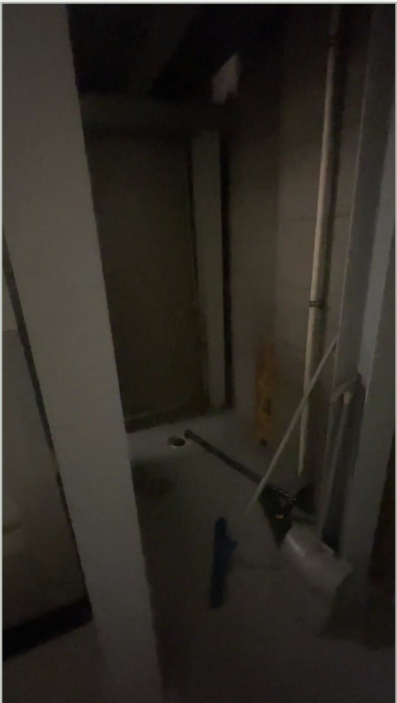
Side alcove, 0:05–0:07. Shown unedited: this is how dark it is.

One fitting. It is the only line in this brief that makes another entire zone usable.

- Mop, squeegee, bucket and a floor gully already live here — the space is in use.
- No light fitting at all, so nothing else can be stored or found in it.
- Because it is unusable, the cleaning kit and paperwork spill into the main room.

- Fit one LED batten. That single fitting is what unlocks the whole zone.
- Then mount, in one aligned run: shadow board, PPE station, banded chemical shelf, framed DAILY CHECKS board.
- Everything currently cluttering the main room and the board wall has a home here.
- One fitting at about AED 60 — the best value line in the entire brief.

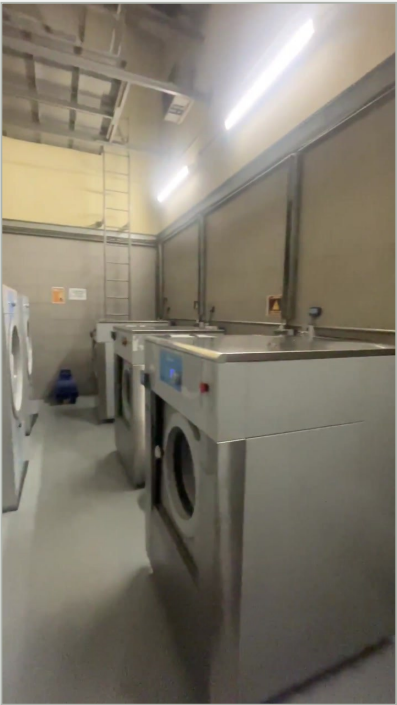
Main run, 0:10–0:12

- Two fluorescent batten for the full length of a room roughly four metres tall; the far end is genuinely dark.
- High-level cable trays and mesh carrying a heavy layer of settled lint and dust.
- No floor zoning, no walkway, no machine identification. A blue drum parked loose against the wall.

Light is what makes a clean room read as clean. Two batten in a four-metre room cannot do it.

- Twelve IP65 LED batten at 4000K, evenly spaced — no dark corners, no dark far end.
- Deep clean the high-level steelwork, then paint every service one uniform matt light grey.
- Paint a yellow walkway line one metre out from the machine faces; add W1/W2 ID plates.
- Aluminium coved trim at the machine bases so lint has nowhere to lodge.

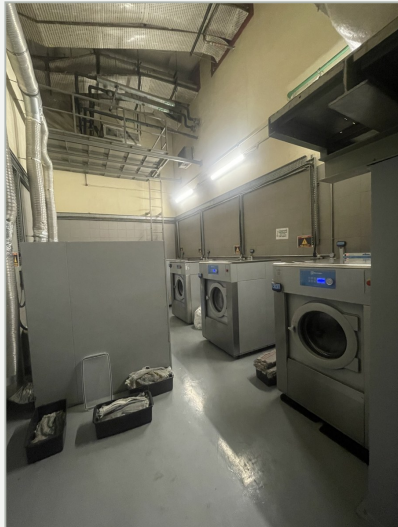
# Staging side — clutter where the linen zone should be

*There is no staging zone here today. Render 3 is not an upgrade of this wall — it is the zone this wall does not yet have.*

- A large grey panel and a wire frame stored upright against the wall, with open lint trays along the base.
- No marked bays, no staging zone, and no visible clean/soiled separation anywhere on this side.
- The wall carries services and a tiled dado but no signage system at all.

- Remove the stored panel and frame from the room — they are the largest single obstruction in it.
- This wall is where the linen staging zone goes: painted bays on the resin floor, one trolley per bay.
- SOILED / CLEAN / RETURN signage colour-coded above each bay, so segregation is visible rather than assumed.
- Replace trolley liners rather than frames, and retire anything torn.

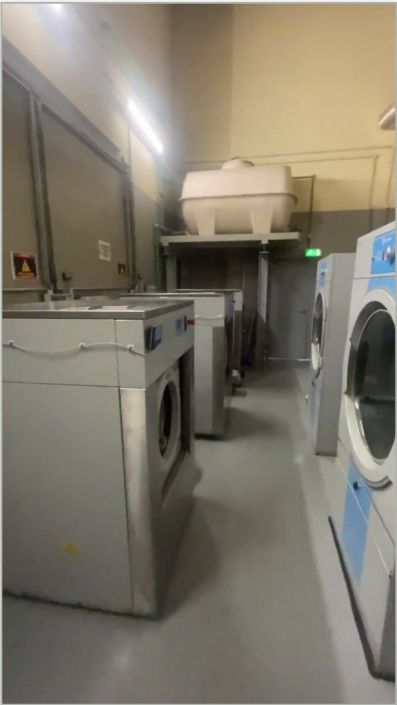
Far end of the run, 0:23

Everything else in Tier 3 waits on this. Do not order the chemical shelf until the tank is identified.

- A large white bulk tank on a raised steel frame, above head height, over the working area.
- A second green exit sign sits directly below and beside it — tank over an escape route.
- Contents, secondary containment, fixing and fill method all unverified from the footage.

- Establish what the tank holds before committing to anything in Tier 3.
- If chemical: it needs secondary containment and a check on what sits beneath it.
- If water: it needs a check on frame loading and fixing.
- Either outcome, keep the route beneath it clear and lit — the hero render shows the target condition.

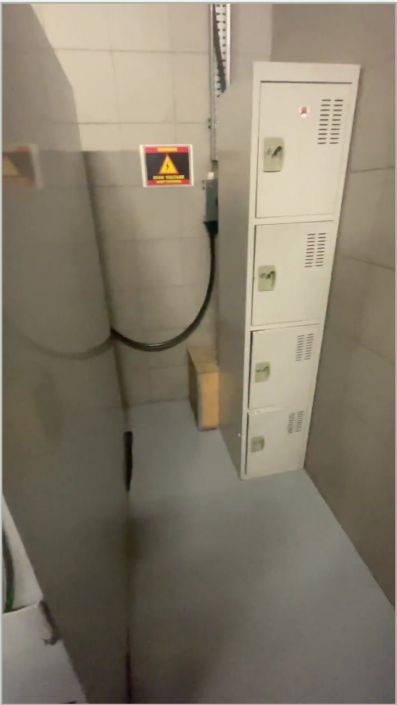
Rear area, 0:15–0:20

- Stacked washer/dryer columns against large-format grey tile — a different space at a different finish standard.
- A staff locker unit, a cardboard box on the floor, and a blue drum in the corner.
- Loose black cable draped down the wall and lying across the floor beneath an isolator.

- Not covered by this brief, which prices the main machine room only.
- Two items apply regardless: lift the draped cable onto P-clips, and get the box off the floor.
- Say the word and this area gets surveyed and priced separately.
