# Laundry room — zone by zone

Current condition matched to the proposed enhancement, area by area

Seven zones identified from the walkthrough video and the site photographs. Each is paired with the concept render that shows its target condition, the specific interventions that apply to it, and where it sits in the four-tier budget.

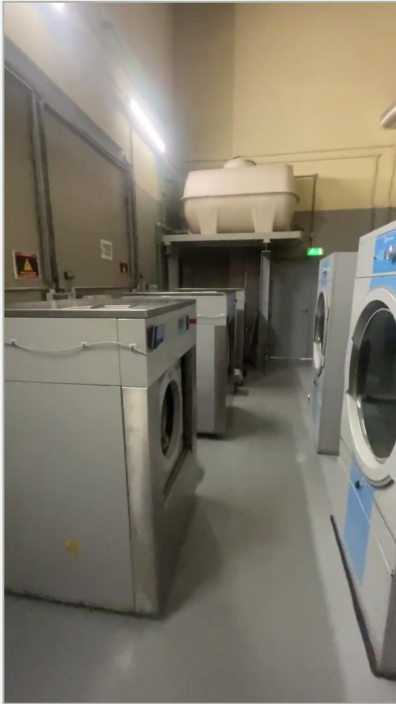
Far end of the run, 0:23

Everything else in Tier 3 waits on this. Do not order the chemical shelf until the tank is identified.

- A large white bulk tank on a raised steel frame, above head height, over the working area.
- A second green exit sign sits directly below and beside it — tank over an escape route.
- Contents, secondary containment, fixing and fill method all unverified from the footage.

- Establish what the tank holds before committing to anything in Tier 3.
- If chemical: it needs secondary containment and a check on what sits beneath it.
- If water: it needs a check on frame loading and fixing.
- Either outcome, keep the route beneath it clear and lit — the hero render shows the target condition.
