# Laundry room — zone by zone

Current condition matched to the proposed enhancement, area by area

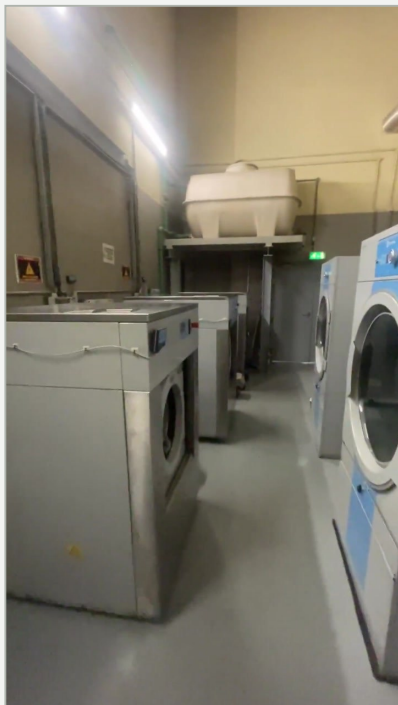
Far end of the run, 0:23

Everything else in Tier 3 waits on this. Do not order the chemical shelf until the tank is identified.

- A large white bulk tank on a raised steel frame, above head height, over the working area.
- A second green exit sign sits directly below and beside it — tank over an escape route.
- Contents, secondary containment, fixing and fill method all unverified from the footage.

- Establish what the tank holds before committing to anything in Tier 3.
- If chemical: it needs secondary containment and a check on what sits beneath it.
- If water: it needs a check on frame loading and fixing.
- Either outcome, keep the route beneath it clear and lit — the hero render shows the target condition.
