# Laundry room — zone by zone

Current condition matched to the proposed enhancement, area by area

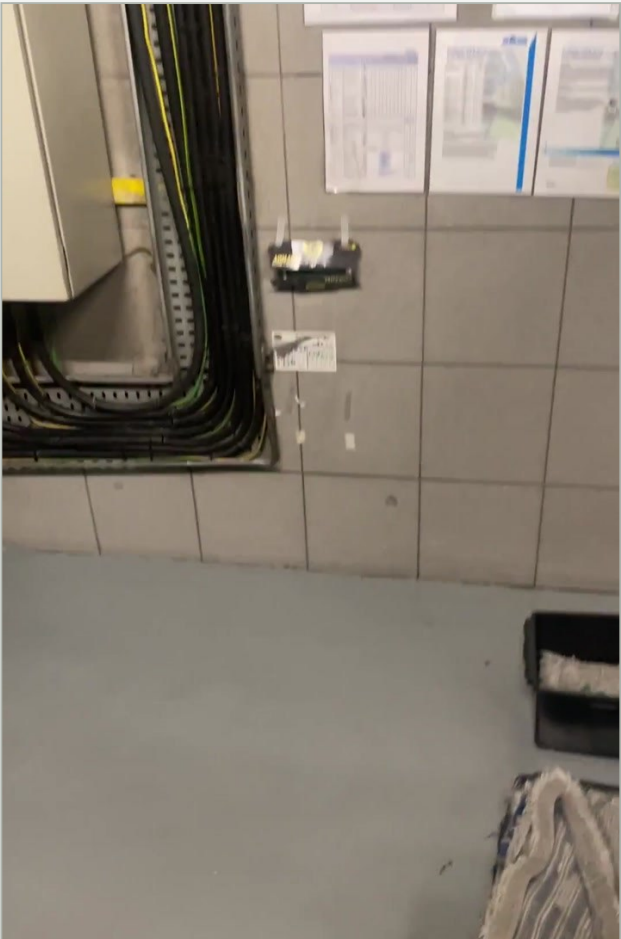
Entry wall, 0:00–0:02 in the walkthrough

- A distribution board with heavy cabling entering, and roughly fifteen A4 sheets taped to the tile directly beside it.
- Open lint trays, a woven sack and a plastic storage box on the floor beneath the board.
- No keep-clear zone marked or maintained in front of the board.

*Paper against a live board is the cheapest fire risk in the room to remove — and the first thing an auditor photographs.*

- Strip the paper wall entirely. Combustible material does not belong against a live board.
- Clear the floor beneath and in front of it, then paint a keep-clear zone on the resin.
- Replace the paper with the printed kit: one KEEP CLEAR — ELECTRICAL PANEL sign at a fixed height.
- Documents move to the framed DAILY CHECKS board in the alcove (Zone 03).

- Zone 02 — clear the escape route. Green exit signage means the floor is not storage.
- Zone 01 — strip the paper wall off the distribution board and mark keep-clear zones at both boards.
- Zone 06 — establish what the overhead bulk tank contains before committing to Tier 3.

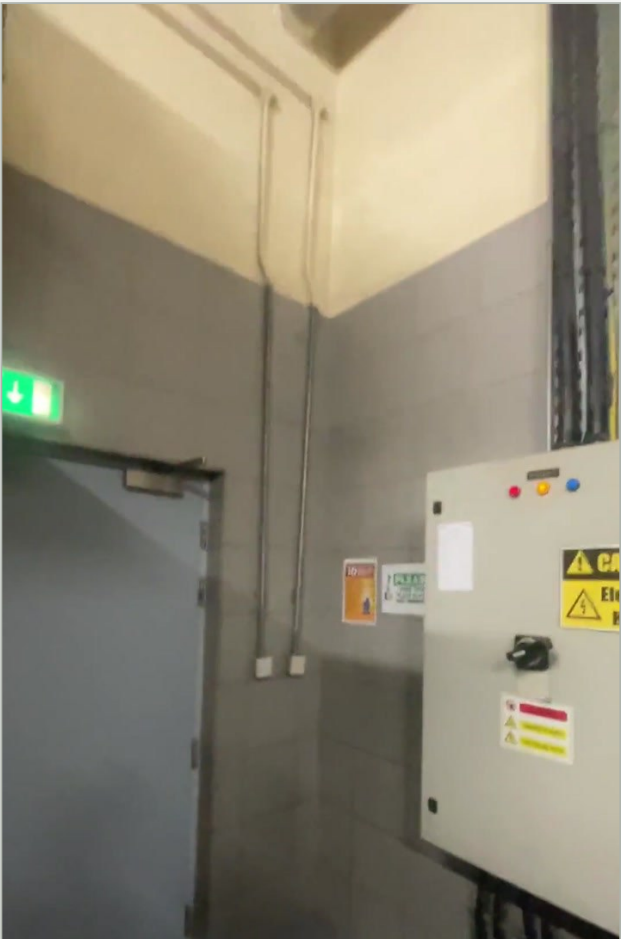
Corner by the fire-rated door, 0:03

- A green running-man exit sign over a fire-rated door — this room is on an escape route.
- A second distribution board, Caution — Electrical Hazard, with cabling entering below.
- Small safety notices taped at inconsistent heights beside the board.

Nothing on this page costs money, and it is the highest-consequence zone in the report.

- Treat the whole floor as an escape route: nothing stored on it that is not on wheels.
- Mark a keep-clear zone at this board as well as the first.
- Replace taped notices with the same printed signs at one consistent height throughout.
- This zone costs nothing and is the most likely single inspection failure in the room.

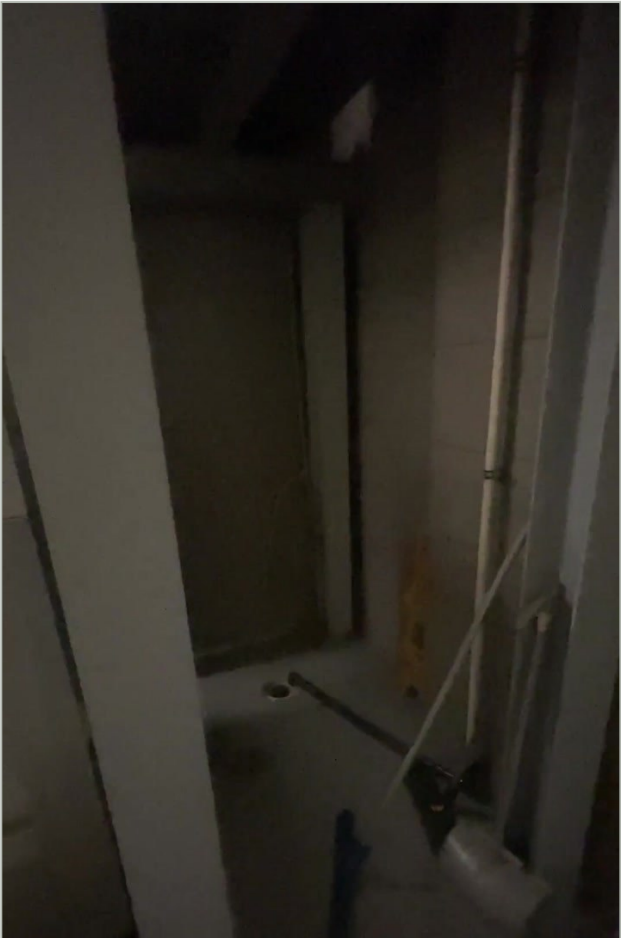
Side alcove, 0:05–0:07. Shown unedited: this is how dark it is.

- Mop, squeegee, bucket and a floor gully already live here — the space is in use.
- No light fitting at all, so nothing else can be stored or found in it.
- Because it is unusable, the cleaning kit and paperwork spill into the main room.

One fitting. It is the only line in this brief that makes another entire zone usable.

- Fit one LED batten. That single fitting is what unlocks the whole zone.
- Then mount, in one aligned run: shadow board, PPE station, banded chemical shelf, framed DAILY CHECKS board.
- Everything currently cluttering the main room and the board wall has a home here.
- One fitting at about AED 60 — the best value line in the entire brief.

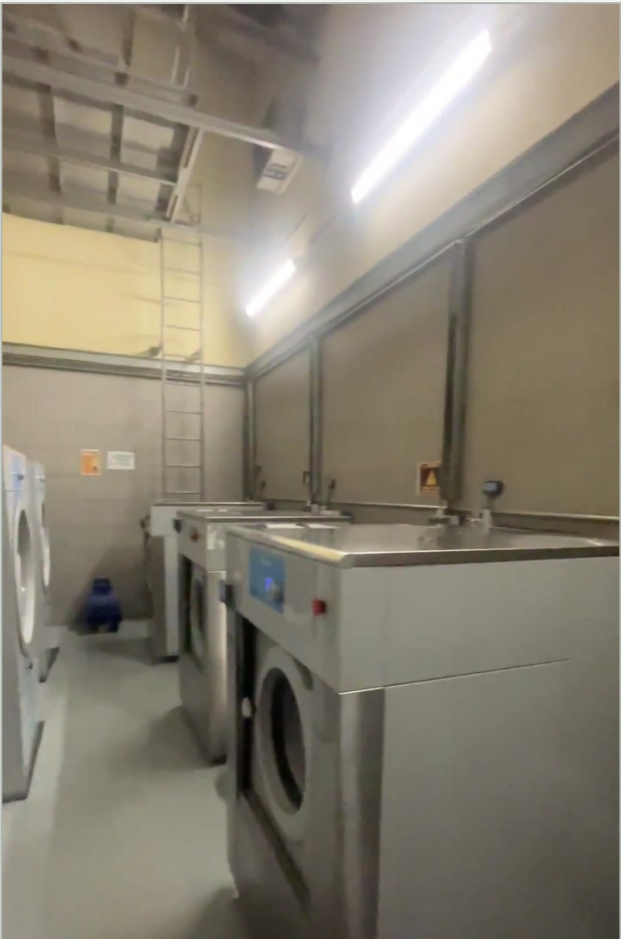
Main run, 0:10–0:12

- Two fluorescent battens for the full length of a room roughly four metres tall; the far end is genuinely dark.
- High-level cable trays and mesh carrying a heavy layer of settled lint and dust.
- No floor zoning, no walkway, no machine identification. A blue drum parked loose against the wall.

Light is what makes a clean room read as clean. Two battens in a four-metre room cannot do it.

- Twelve IP65 LED battens at 4000K, evenly spaced — no dark corners, no dark far end.
- Deep clean the high-level steelwork, then paint every service one uniform matt light grey.
- Paint a yellow walkway line one metre out from the machine faces; add W1/W2 ID plates.
- Aluminium coved trim at the machine bases so lint has nowhere to lodge.

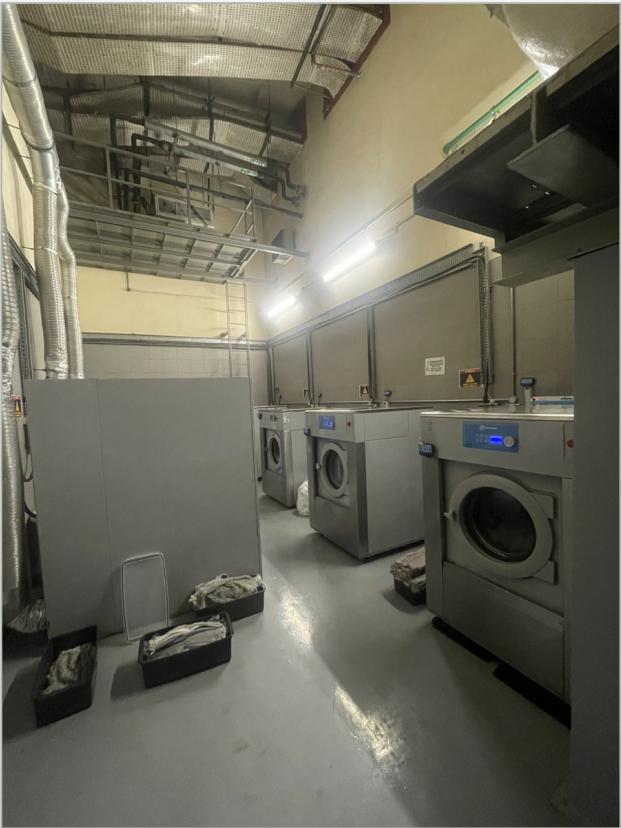
Opposite the machine line, from the site photographs

- A large grey panel and a wire frame stored upright against the wall, with open lint trays along the base.
- No marked bays, no staging zone, and no visible clean/soiled separation anywhere on this side.
- The wall carries services and a tiled dado but no signage system at all.

There is no staging zone here today. Render 3 is not an upgrade of this wall — it is the zone this wall does not yet have.

- Remove the stored panel and frame from the room — they are the largest single obstruction in it.
- This wall is where the linen staging zone goes: painted bays on the resin floor, one trolley per bay.
- SOILED / CLEAN / RETURN signage colour-coded above each bay, so segregation is visible rather than assumed.
- Replace trolley liners rather than frames, and retire anything torn.

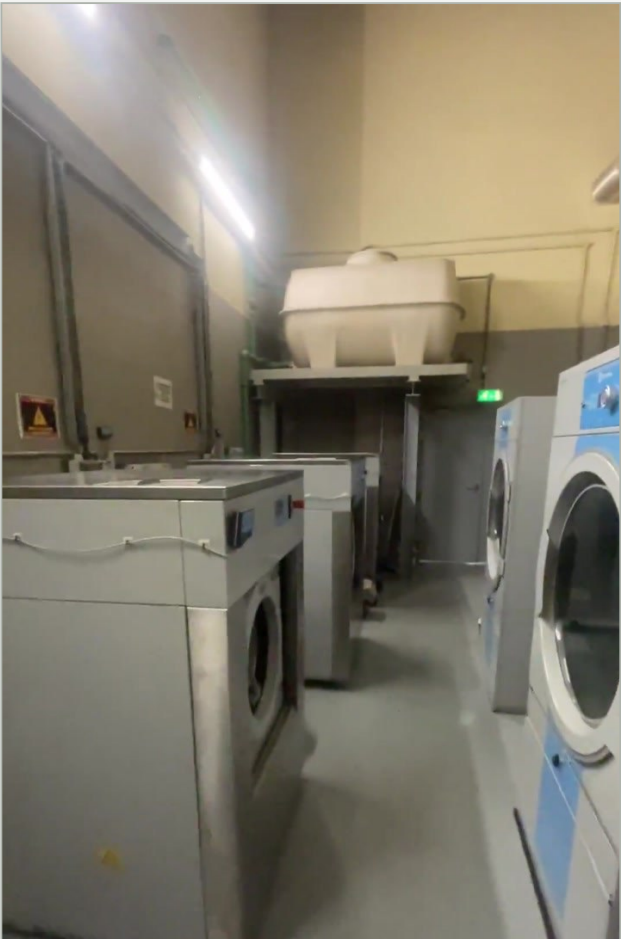
Far end of the run, 0:23

- A large white bulk tank on a raised steel frame, above head height, over the working area.
- A second green exit sign sits directly below and beside it — tank over an escape route.
- Contents, secondary containment, fixing and fill method all unverified from the footage.

Everything else in Tier 3 waits on this. Do not order the chemical shelf until the tank is identified.

- Establish what the tank holds before committing to anything in Tier 3.
- If chemical: it needs secondary containment and a check on what sits beneath it.
- If water: it needs a check on frame loading and fixing.
- Either outcome, keep the route beneath it clear and lit — the hero render shows the target condition.

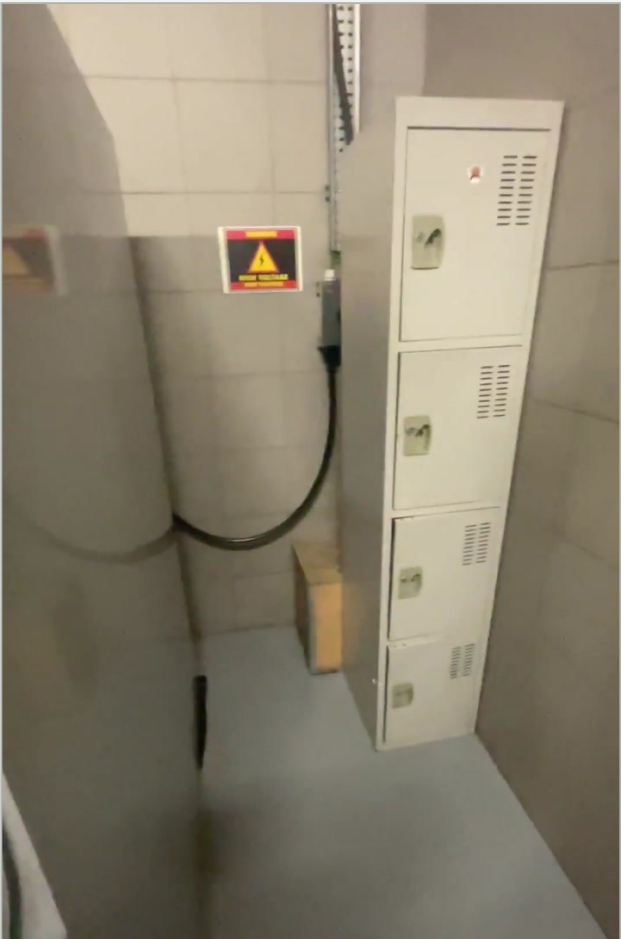
Rear area, 0:15–0:20

- Stacked washer/dryer columns against large-format grey tile — a different space at a different finish standard.
- A staff locker unit, a cardboard box on the floor, and a blue drum in the corner.
- Loose black cable draped down the wall and lying across the floor beneath an isolator.

- Not covered by this brief, which prices the main machine room only.
- Two items apply regardless: lift the draped cable onto P-clips, and get the box off the floor.
- Say the word and this area gets surveyed and priced separately.
