**Project Name: The Big Business District**

**Subject: Re: Design Review**

This report presents the structural design check for **Buildings B1 and B2** within The Big Business District project.

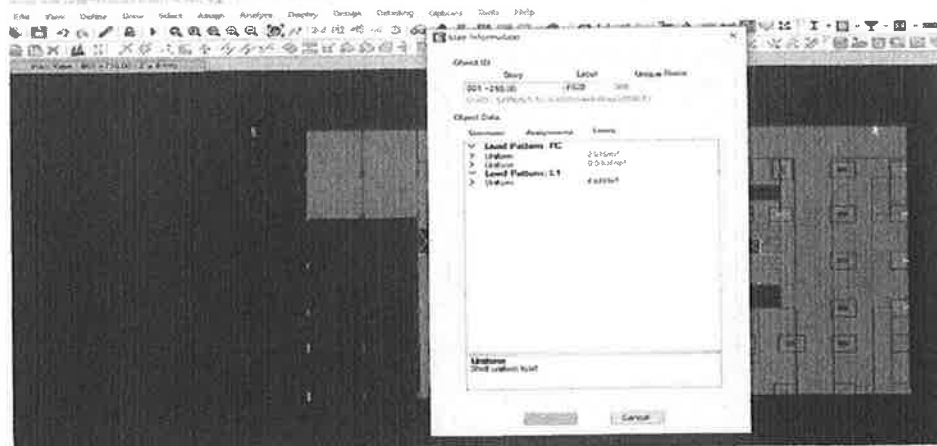
- The pavement loads need to increase.

**The pavement loads used in the structural model increased to be  $(2.50 \text{ kn/m}^2)$  instead of  $(2.00 \text{ kn/m}^2)$  as necessary to match the actual loads.**

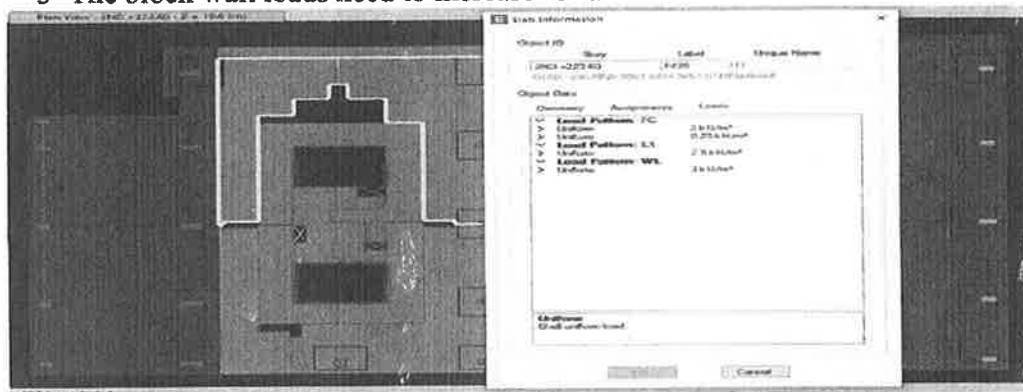
3- The block wall loads need to increase for all floors.

**The total wall load used in the structural model increased to be (17.90 kn/m) instead of (17 kn/m) and for internal open spaces increased to be (2.50 kn/m<sup>2</sup>) instead of (2.00 kn/m<sup>2</sup>) as necessary to match the actual wall and finish loads, ensuring realistic representation of self-weight and imposed loads in the design.**

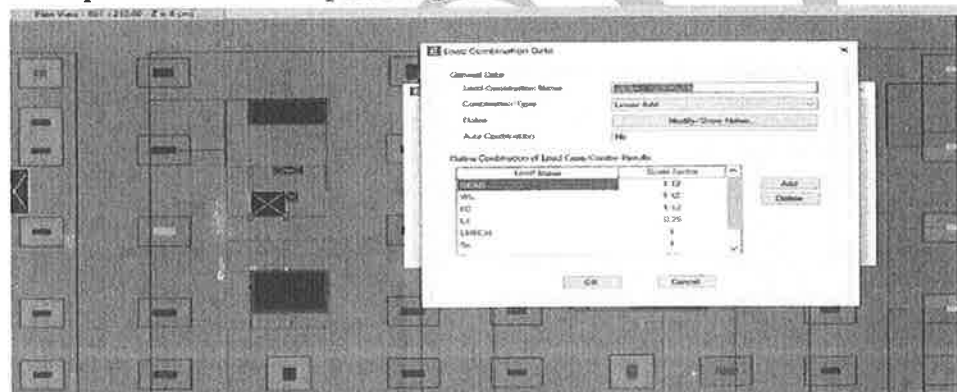
7- The equivalent Live load percentage = 50% instead of 25 %

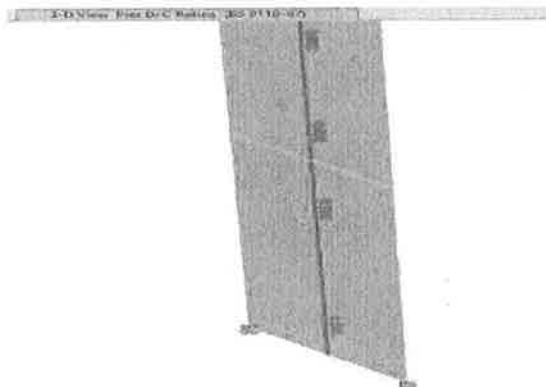
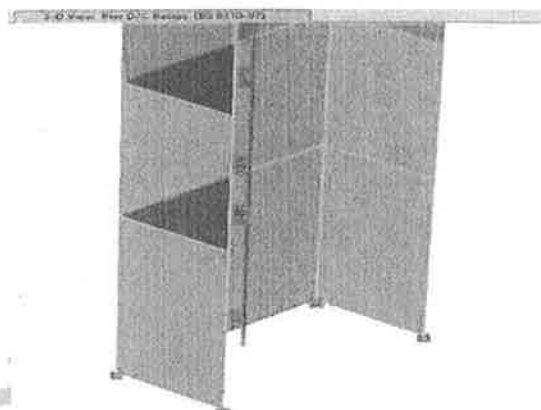
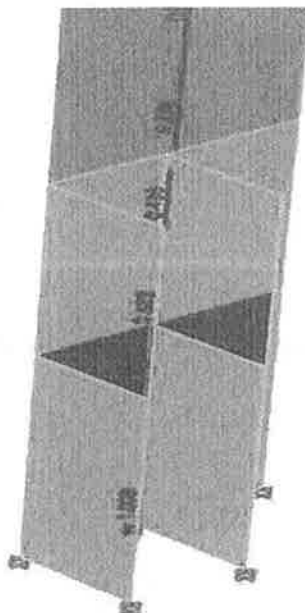
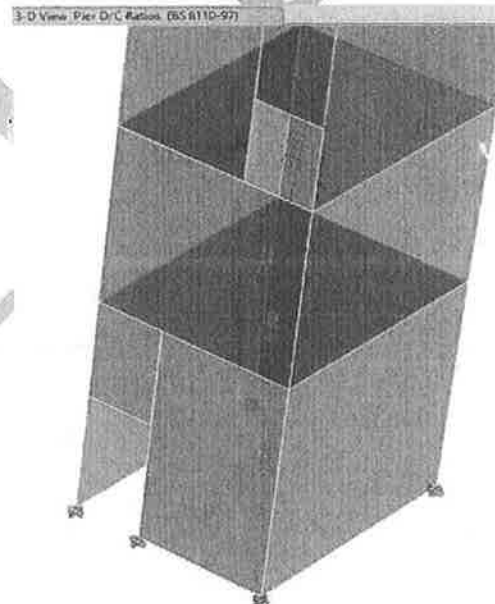
4 walls sections are consider unsafe.
