Project #201500075-01
May 7, 2016

Property Condition Assessment

**Atmore Shopping Center
1234 Spring Avenue
Atmore, Alabama 36502**

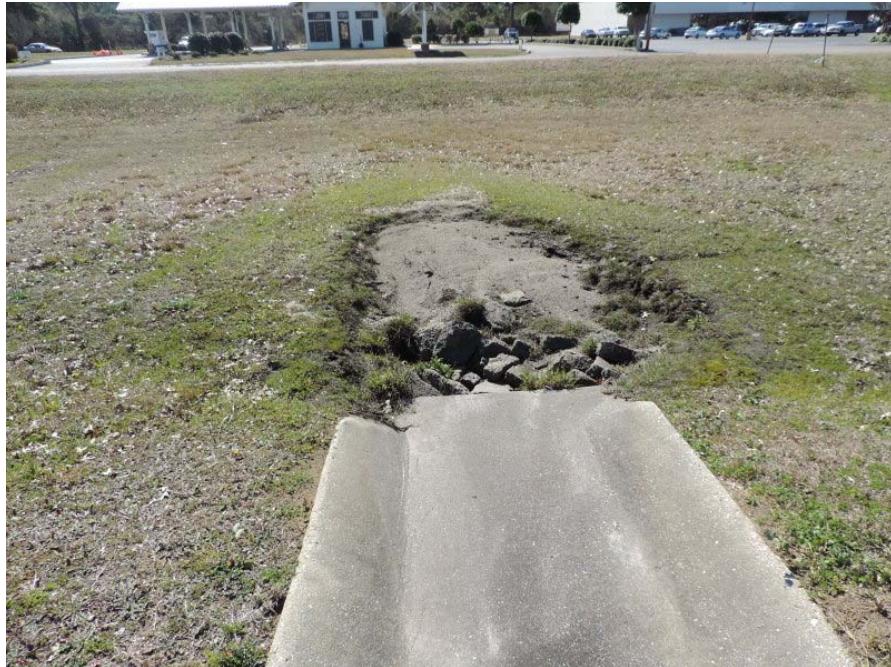
Area of soil erosion at concrete raceway to detention pond

Recommendations: No physical deficiencies/deferred maintenance or immediate/ short term needs were noted. The areas of minor erosion can be addressed as part of routine maintenance.

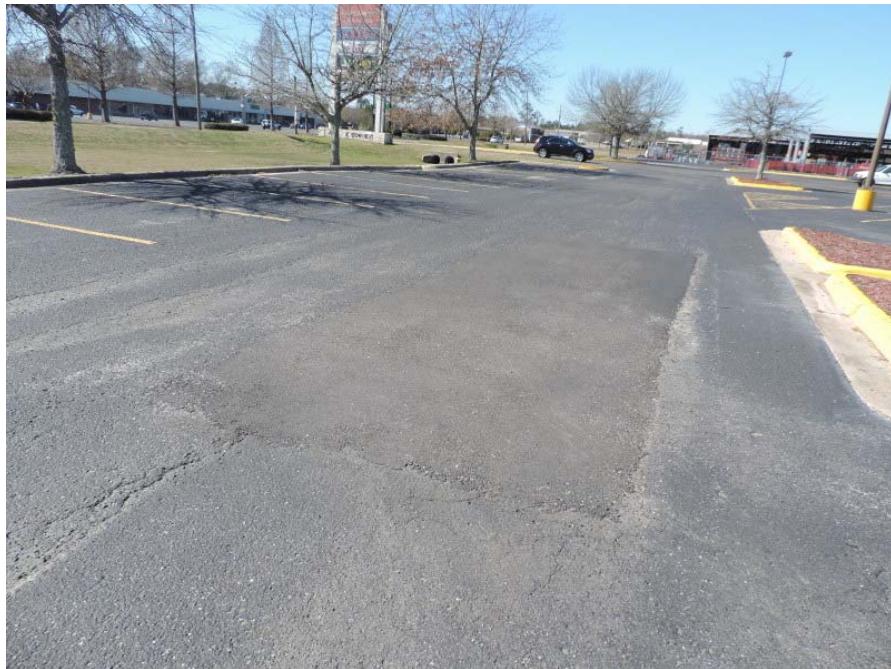
Recently patched pavement

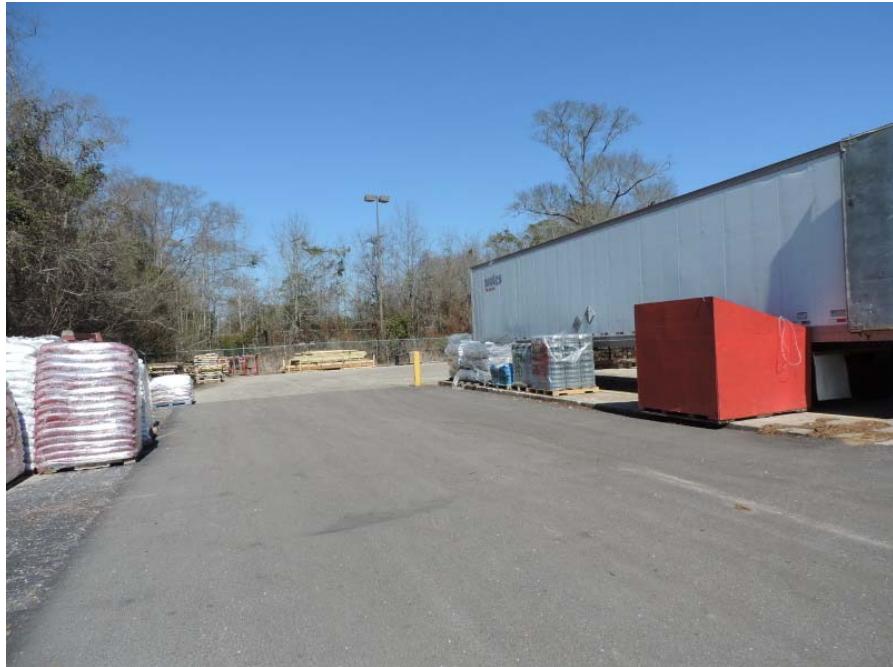
Recently overlain pavement

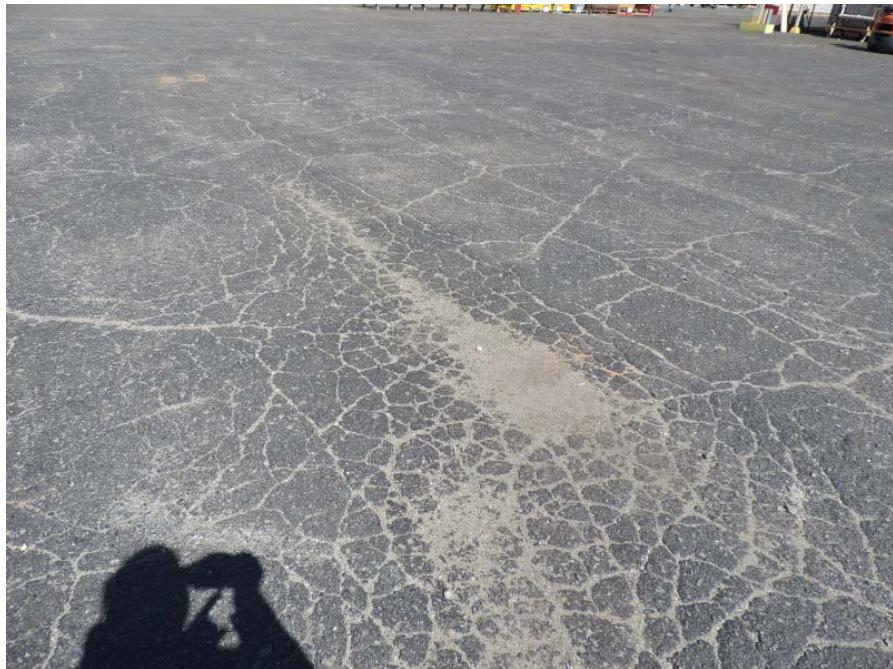
While the majority of the main parking lot and driveways have been sealed recently, it appears that many areas with pavement damage, such as alligator cracking, were sealed over, rather than repaired. Alligator cracking and raveling was observed in many locations. Additionally, the rear (north) service drive exhibits significant cracking and raveling. The damaged/deteriorated asphalt pavement should be repaired/replaced, in order to prevent further deterioration. Minor cracks can be crackfilled, some areas can be patched/ overlain and the more significantly deteriorated areas should be removed and repaved. An opinion of costs for this work has been included in the Short Term Costs Table.

Typical alligator cracking

| IMMEDIATE NEEDS /SHORT TERM COSTS | | |
|--|---|---|
| Repair/replace damaged/deteriorated asphalt pavement | ~32,000 SF @ \$4.00/ SF | \$128,000 |

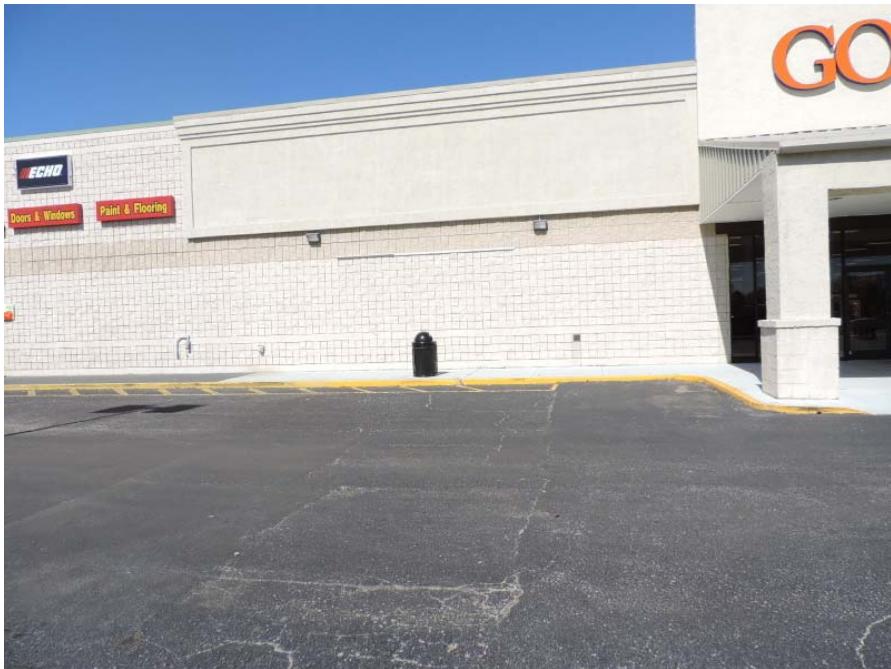
Typical pavement condition

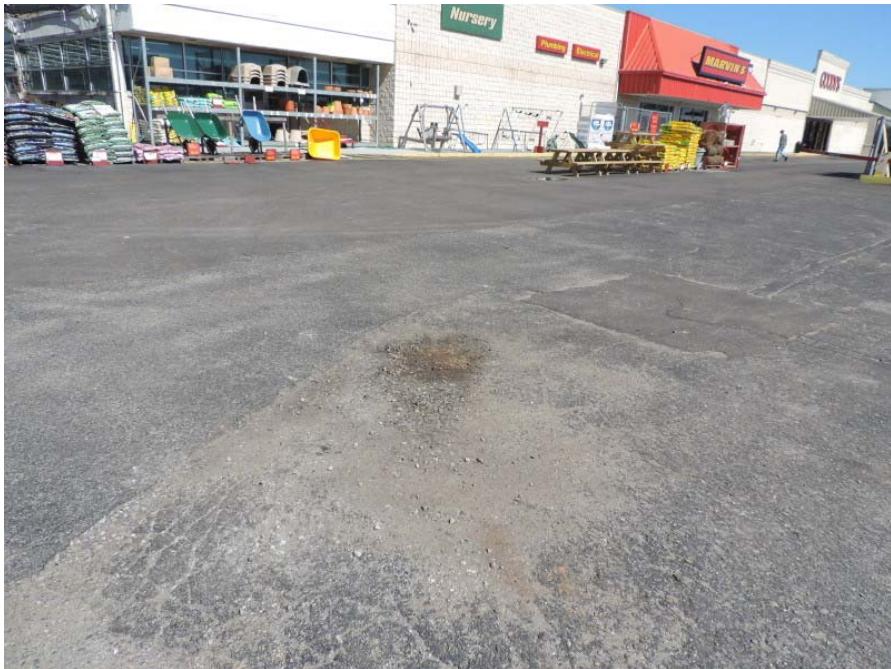
Typical alligator cracking and raveling

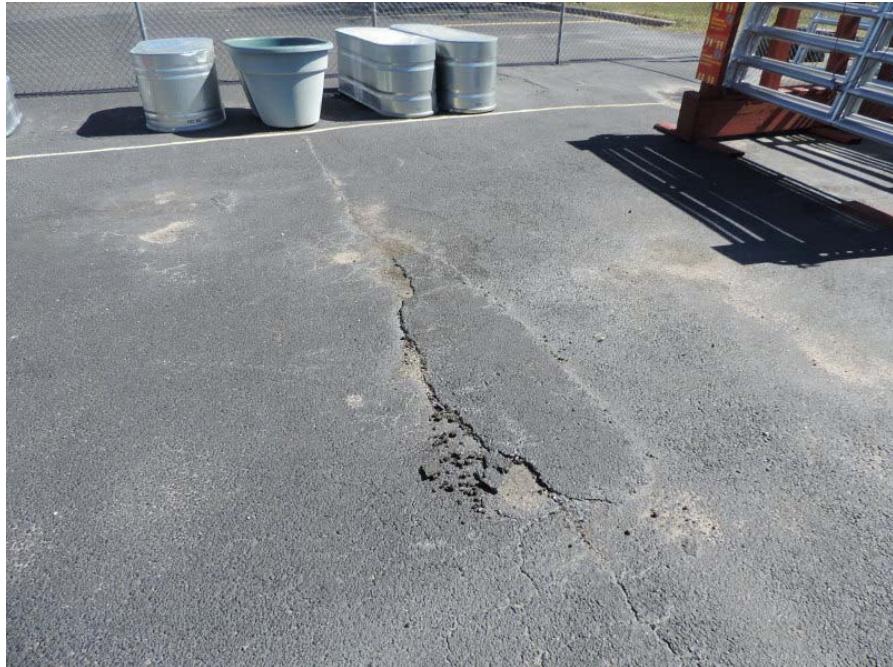
Typical pavement damage

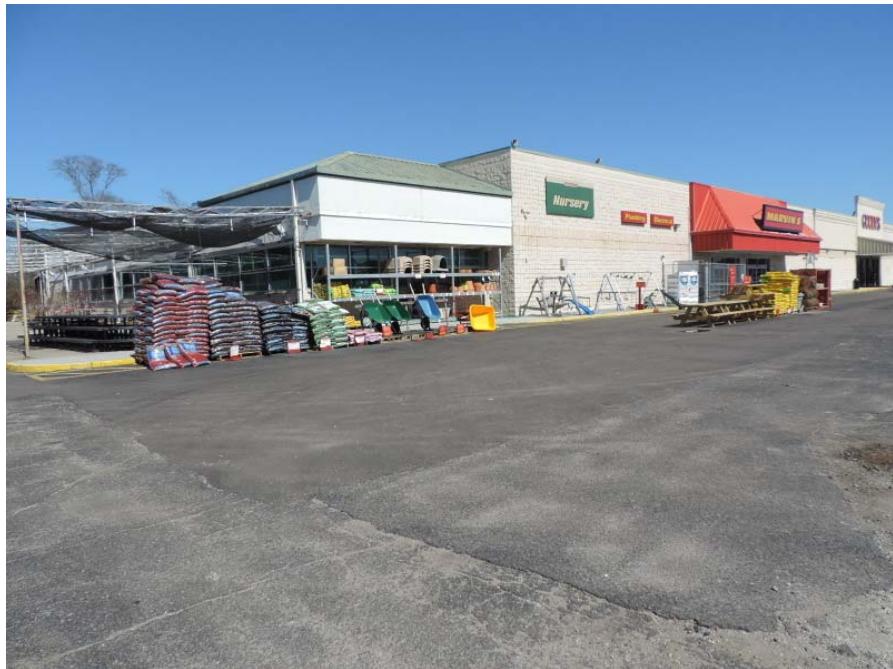
Recently overlaid pavement

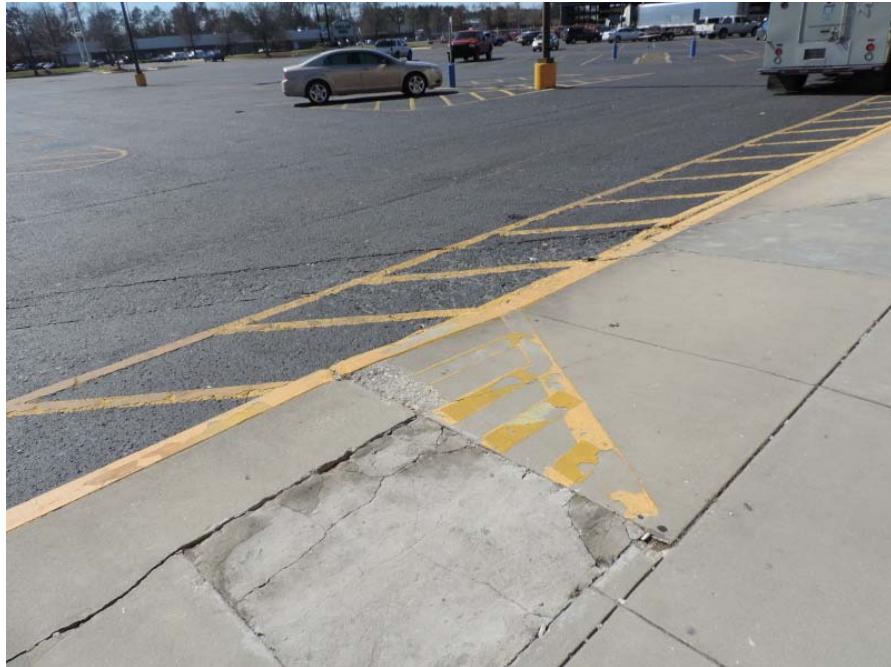
Typical cracking in sidewalk

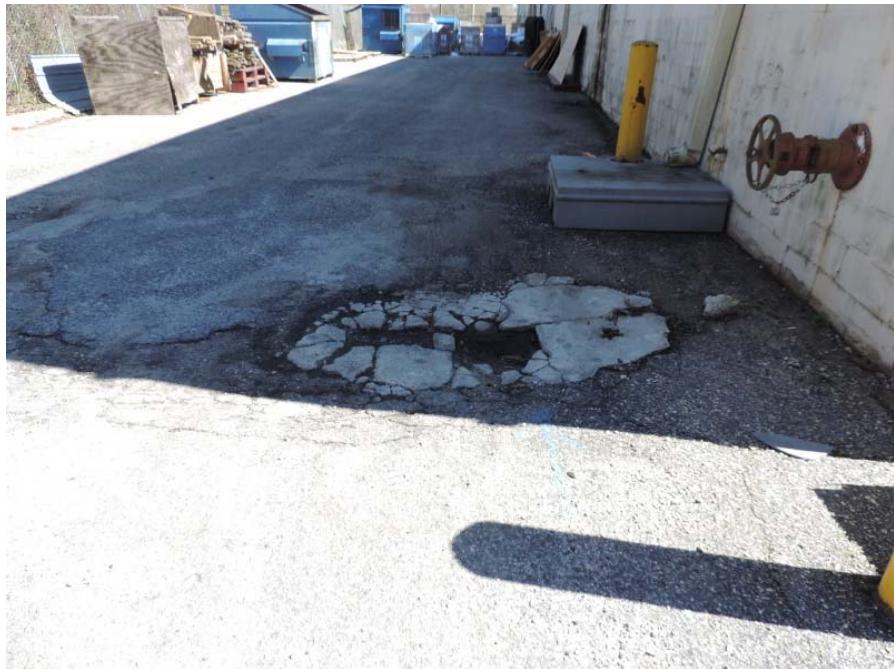
Damaged concrete at water meter surrounded by damaged asphalt

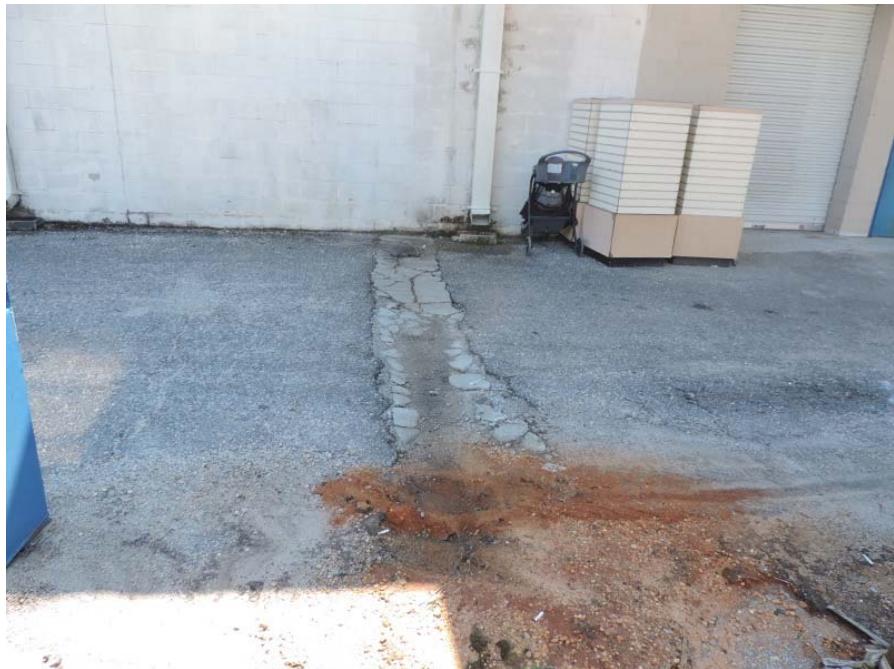
Damaged concrete at drainage line

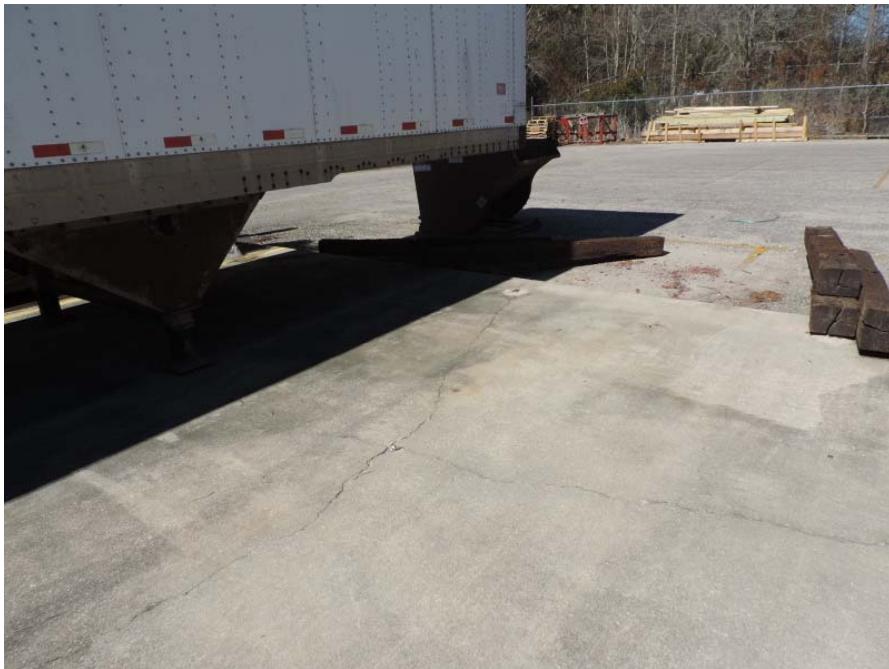
Typical cracking in concrete patio

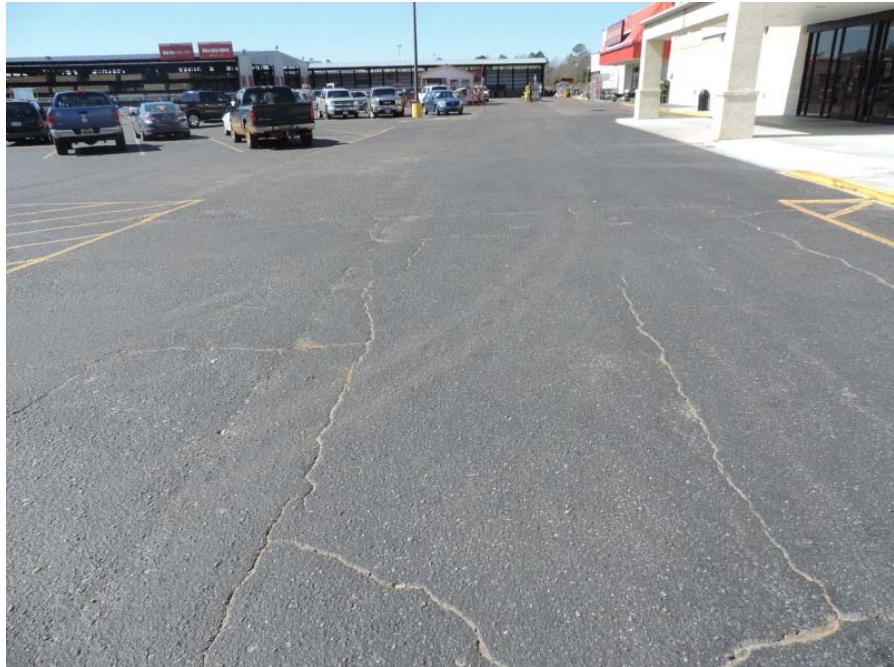
Driveway; note cracking

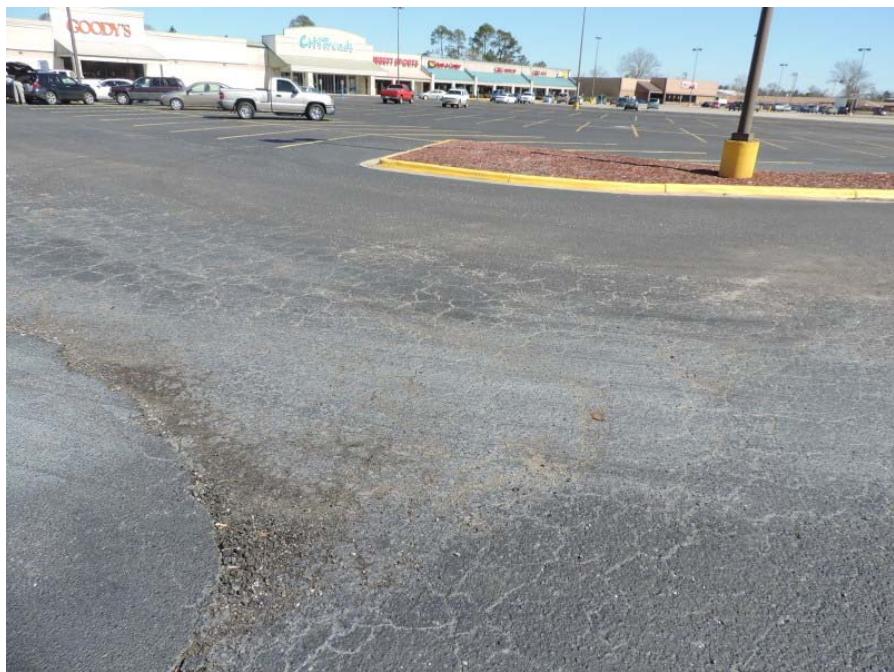
Typical alligator cracking and other pavement damage

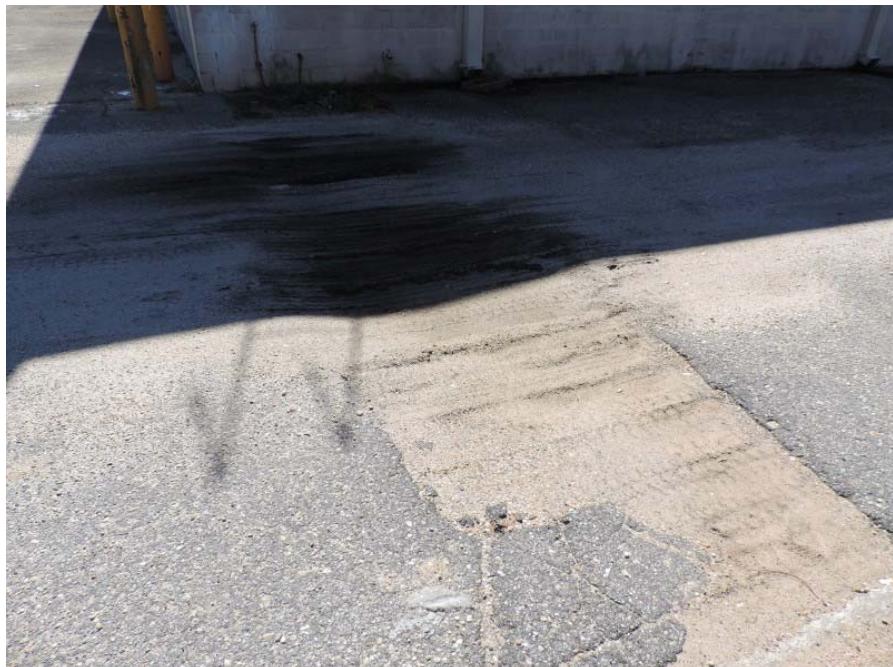
Pavement damage in northern service drive

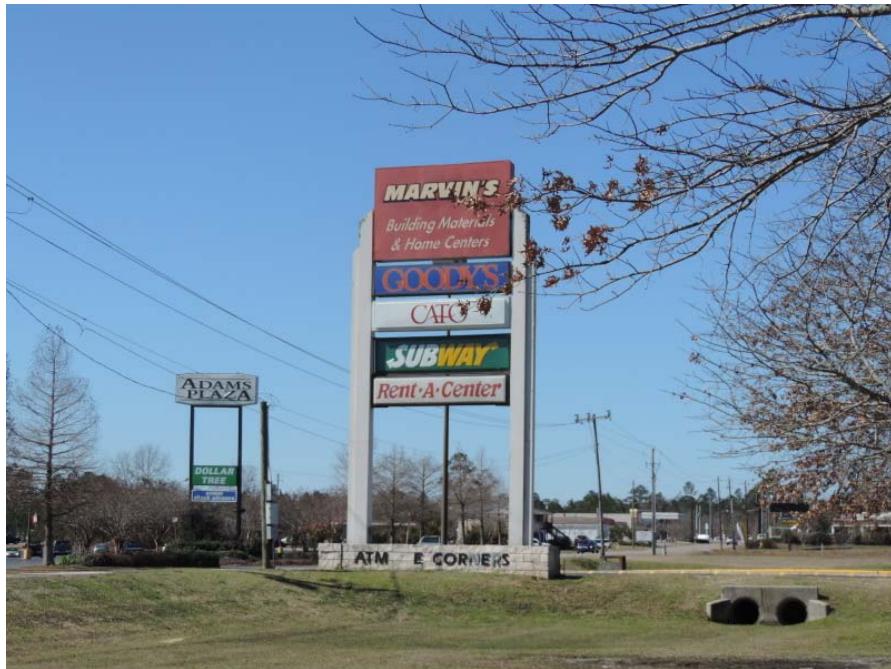
Note missing letters on main property sign

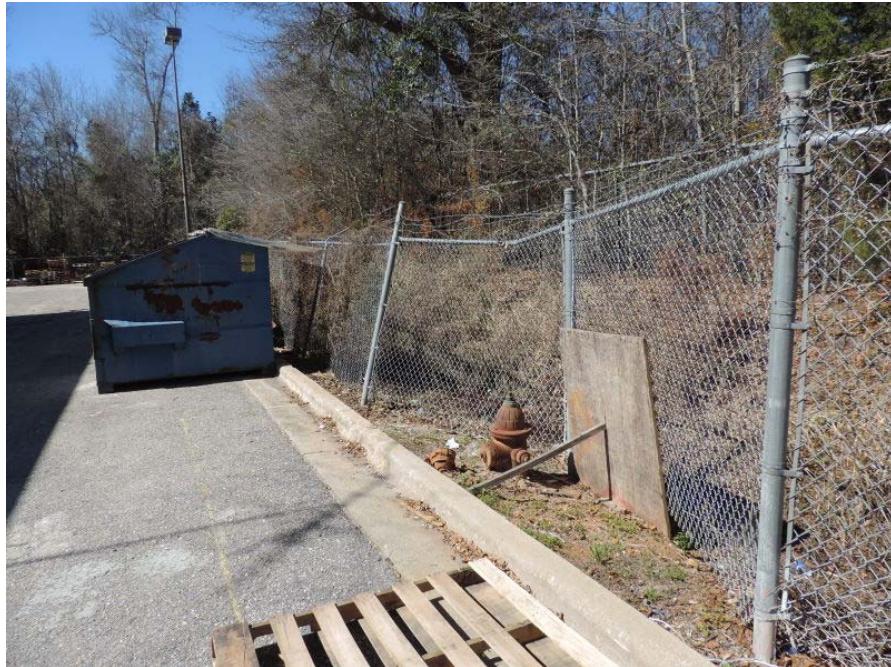
Area of damaged chain link fencing; note pole and board propping fence up

Recommendations: The ancillary structures/areas should be maintained as part of the ongoing exterior maintenance of the property as noted in Section 6.4, or as part of routine maintenance.

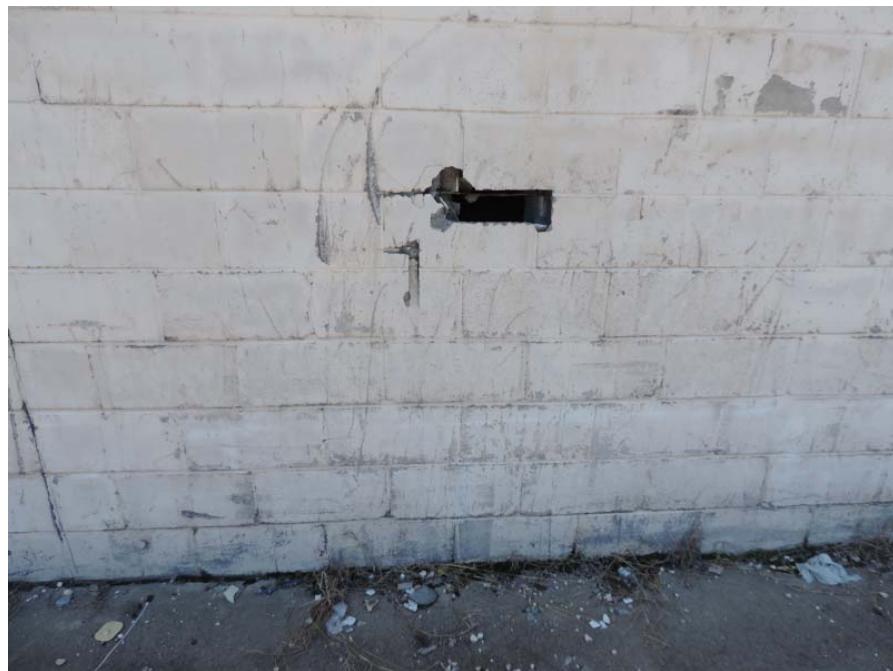
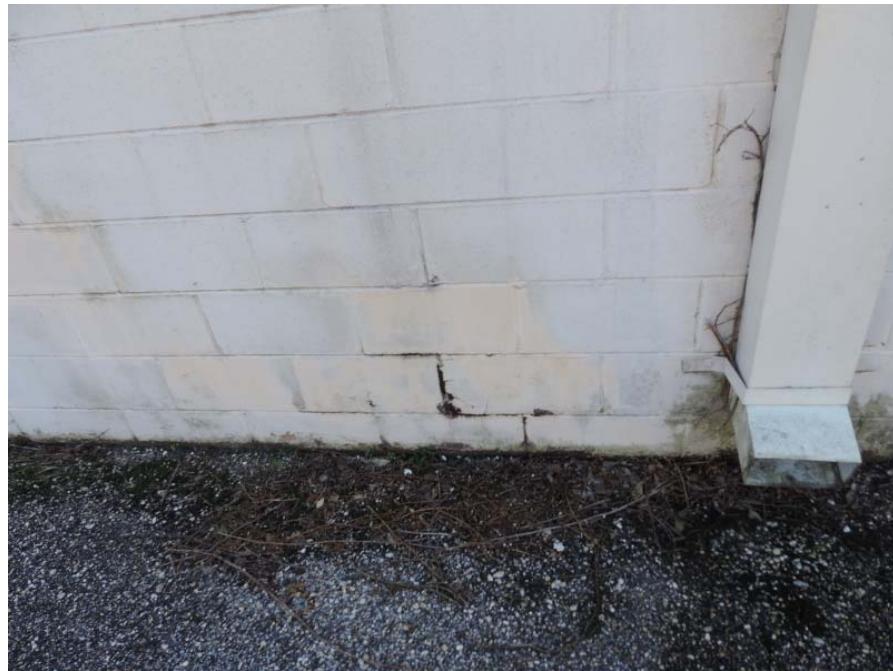
Cracking of the CMU walls throughout the rear building areas was observed, some of which is significant. Some of the cracking appears to have led to interior water intrusion issues. Additionally, a concrete block at the northeast corner of the building was damaged. The walls showing damage on both the interior and exterior should be repaired, cleaned and maintained, and testing should be completed to positively determine the reason for the observed water intrusion. An opinion of costs for this work has been included in the Short Term Costs Table.

Cracking of exterior wall

| IMMEDIATE NEEDS /SHORT TERM COSTS | | |
|--|---|---|
| Repair, clean and maintain CMU walls | ~13,000 SF @ \$3.00/ SF | \$39,000 |

Recommendations: CMU walls showing damage on both the interior and exterior should be repaired, cleaned and maintained, and testing should be completed to positively determine the reason for the observed water intrusion. An opinion of costs for this work has been included in the Short Term Costs Table.

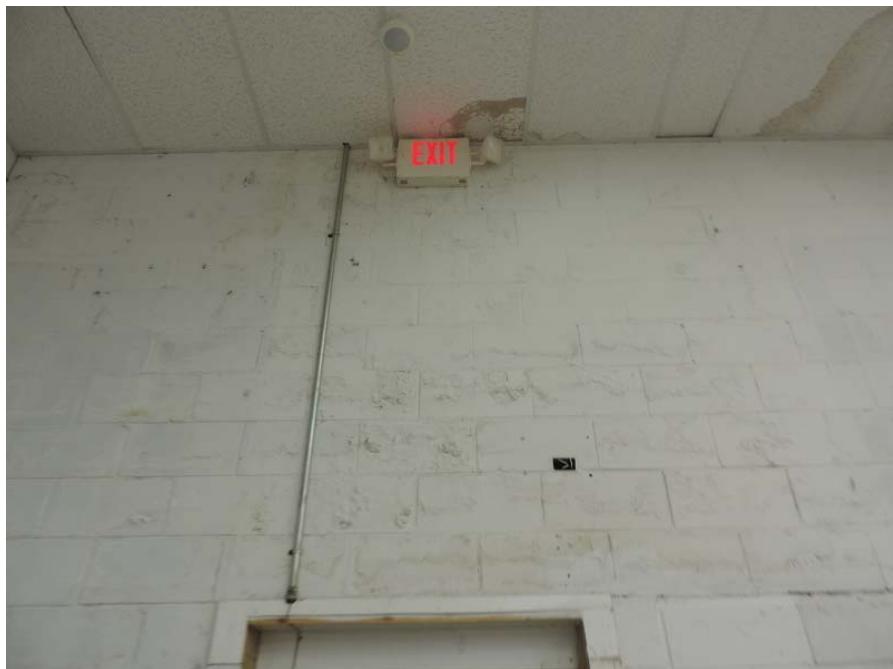
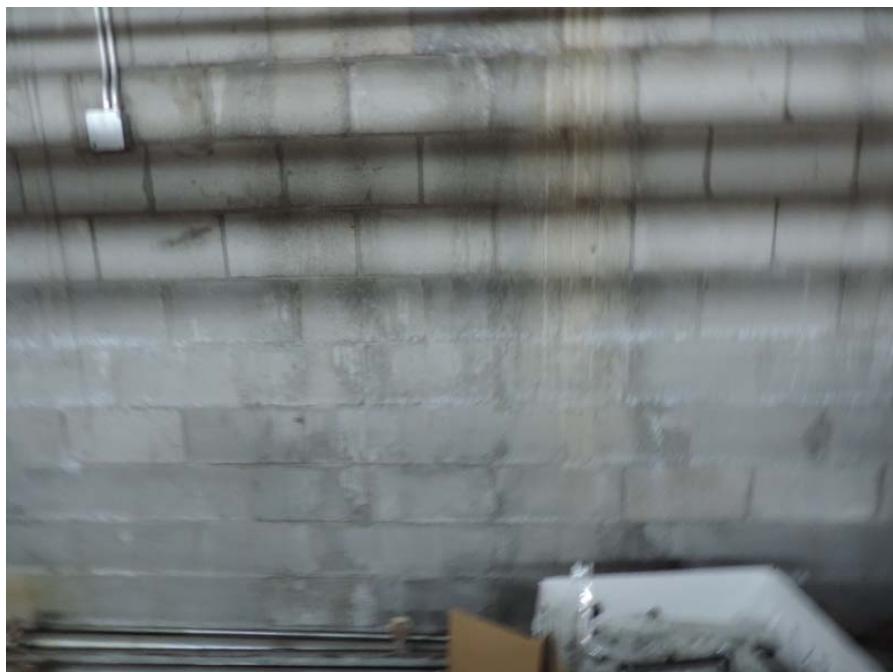
Evidence of water intrusion

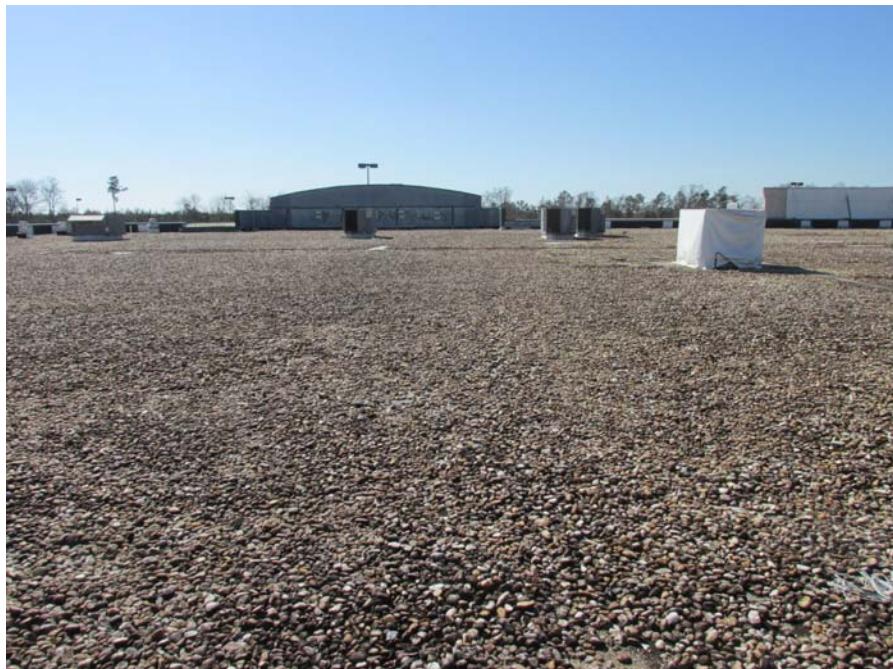
Recommendations: Based on the age of the roof, reported significant roof leaks, and an EUL of 20 years for flat roofs, replacement will likely be required at the beginning of the term. An opinion of costs for this work is included in the Short Term Costs Table. In addition, activities including, but not limited to, keeping drains clear and repairing leaks promptly, should be done as part of routine maintenance. Additionally, damaged or missing downspouts can be replaced as part of routine maintenance.

Roof

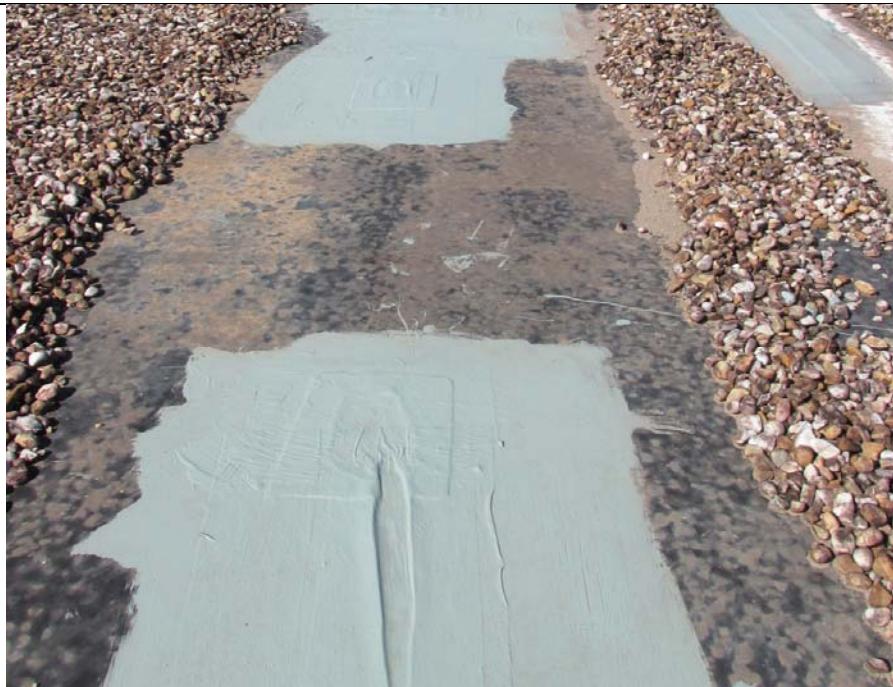
Reflective coating repair

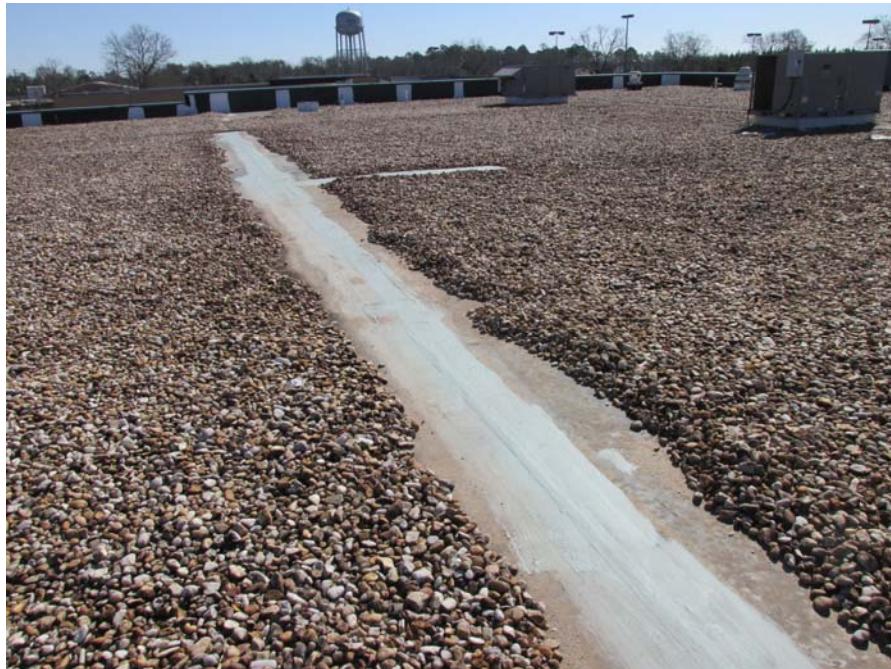
Roof surface, note reflective sealant

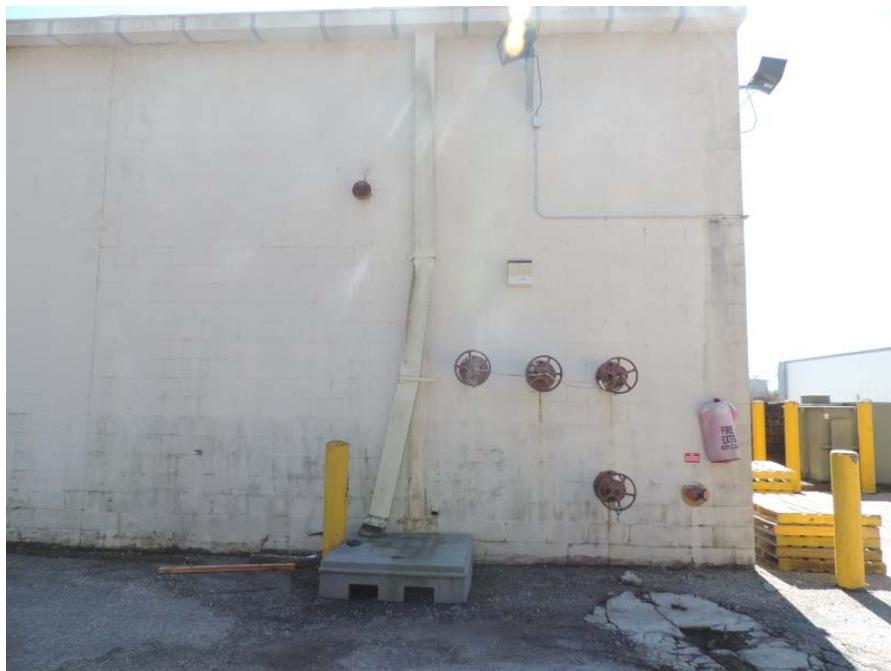
Damaged downspout

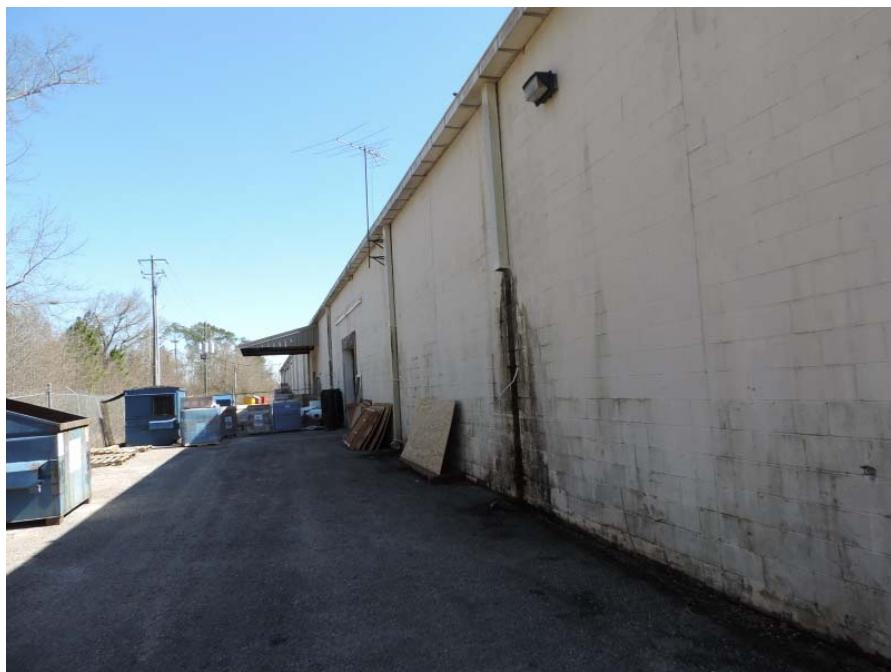
Missing downspout

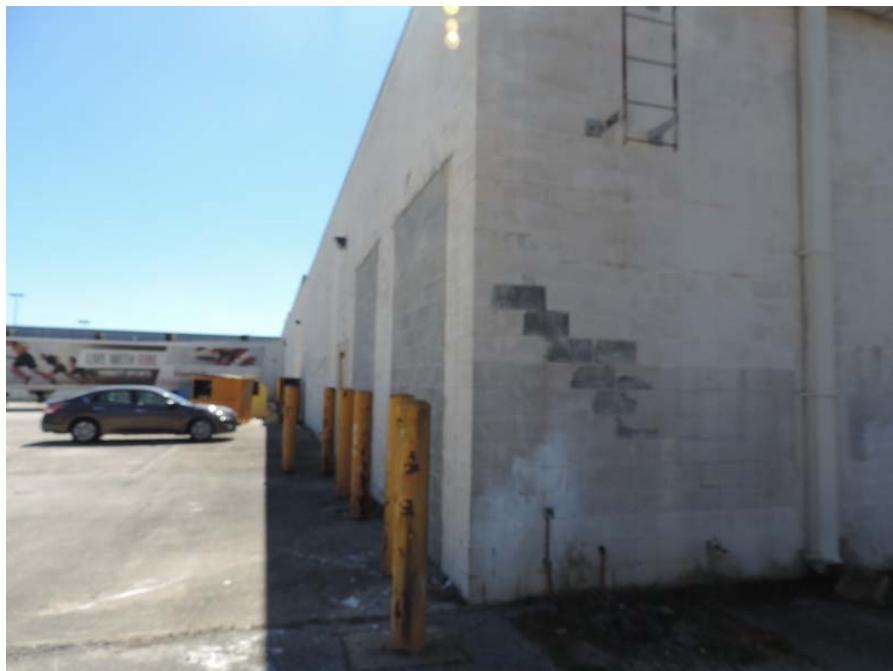
Deteriorated paint

painting, power washing, caulking, stucco patching, etc., is typically required every six to eight years depending on the quality of preparation of the surfaces, the quality of materials used and weather conditions. The building currently requires this exterior maintenance. An opinion of costs for the above work is included in the Short Term Costs Table.

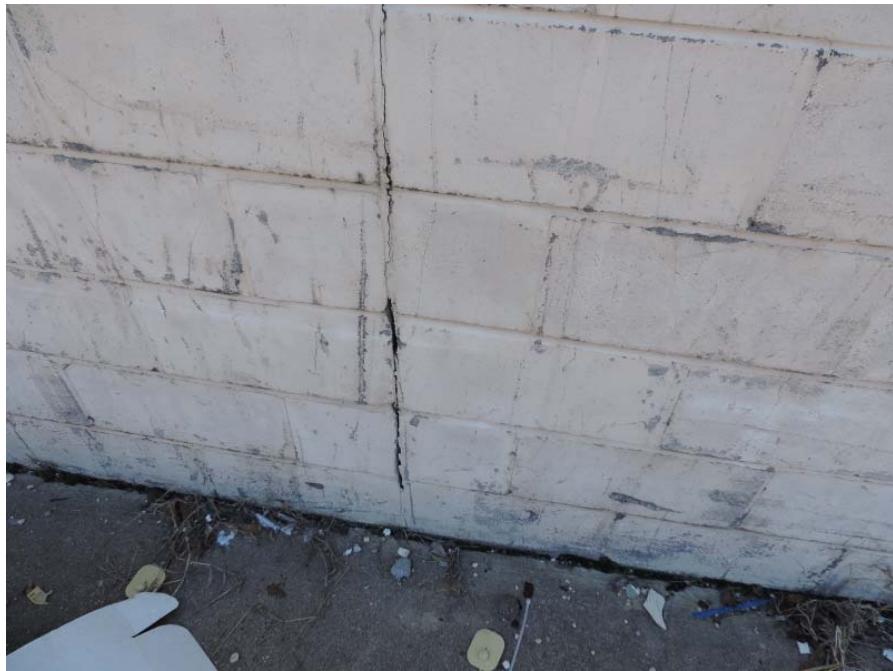
Deteriorated caulking/pointing

Any deteriorated caulking/pointing should be replaced. Exterior maintenance such as

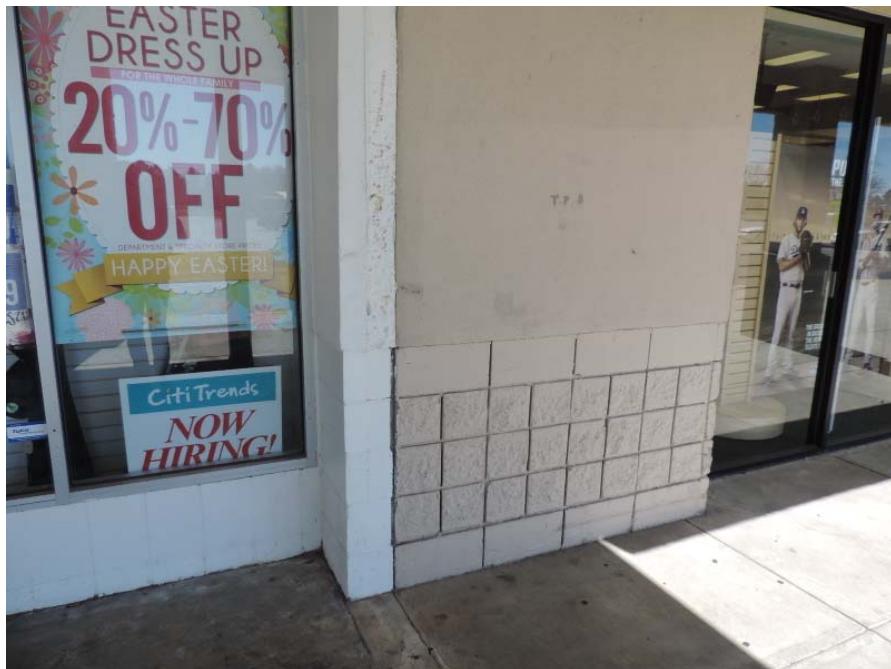
Damaged EIFS (minor)

Minor EIFS damaged can be patched as part of routine maintenance. The remaining portions of the facade should be monitored and addressed as part of the routine maintenance of the property.

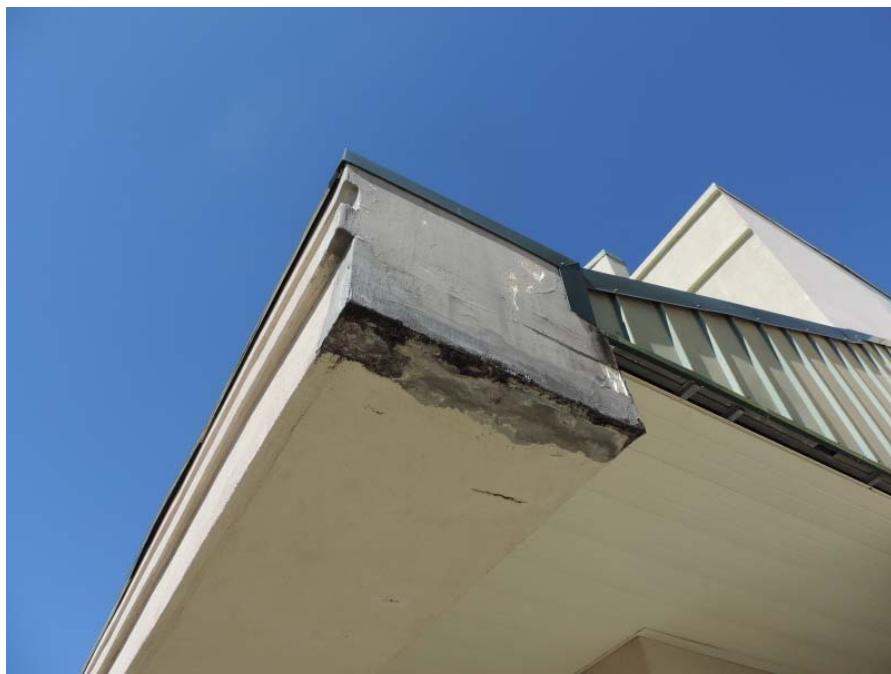
Recent EIFS repair

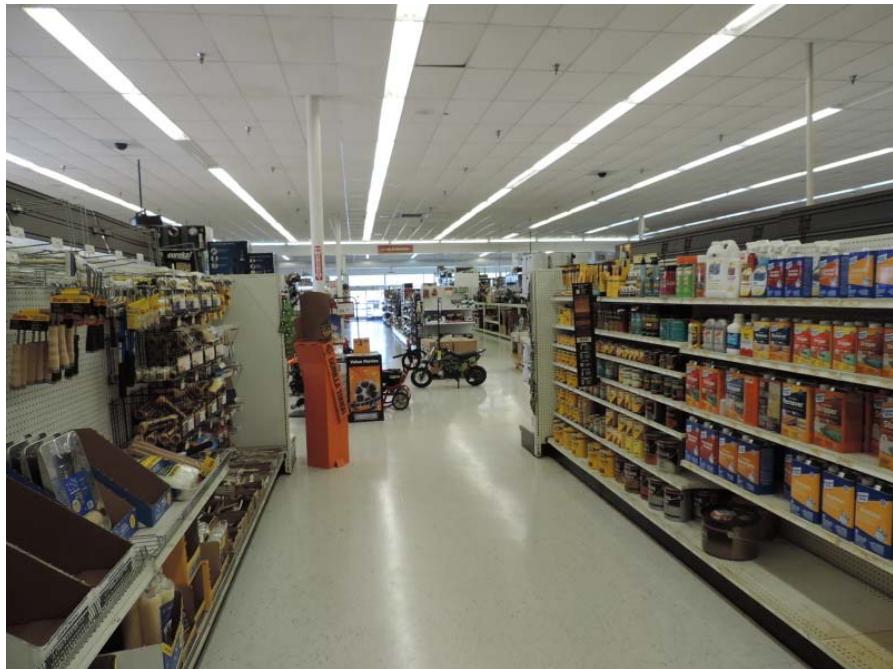
Typical occupied tenant space

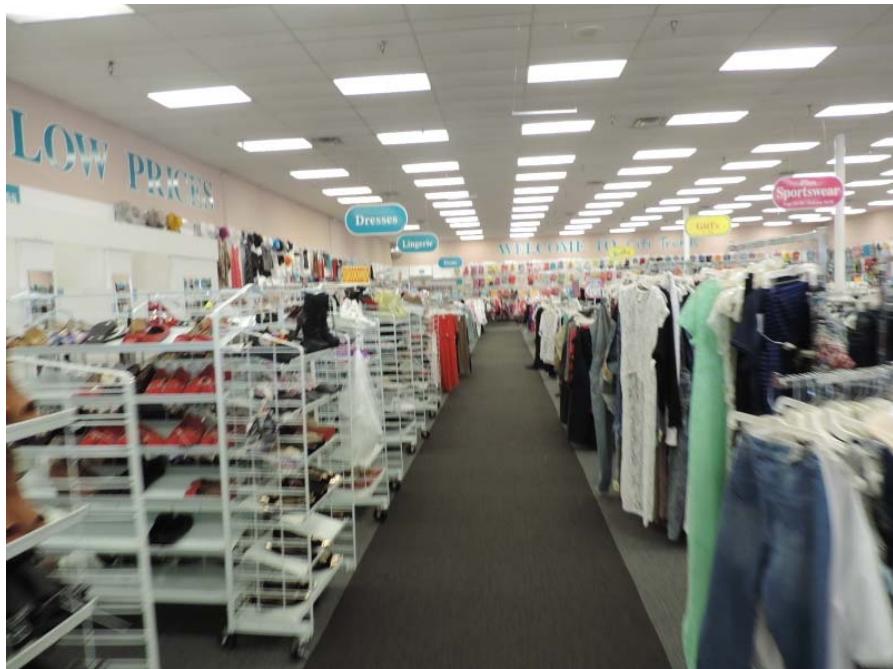
Typical occupied tenant space

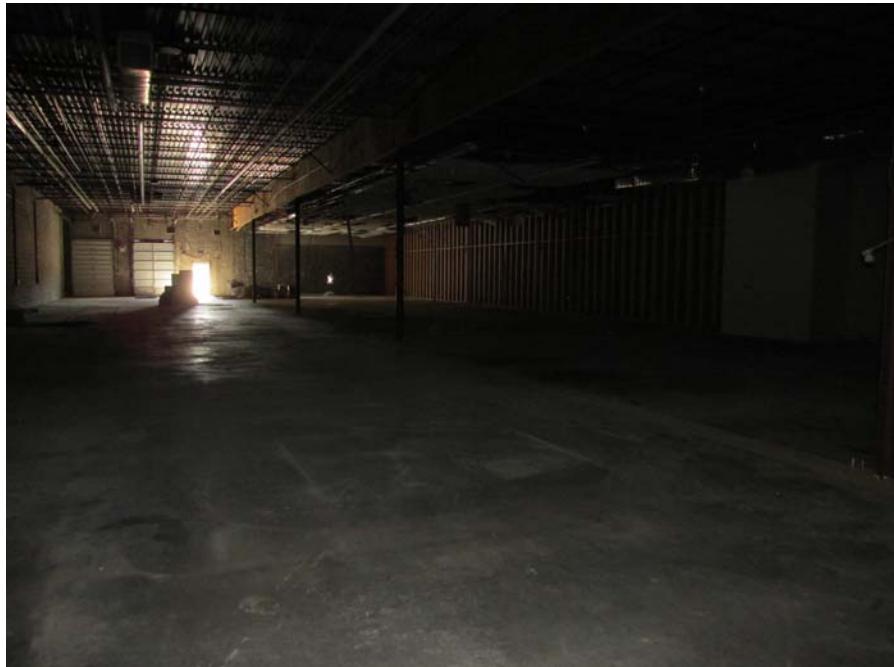
| Vacant tenant space |

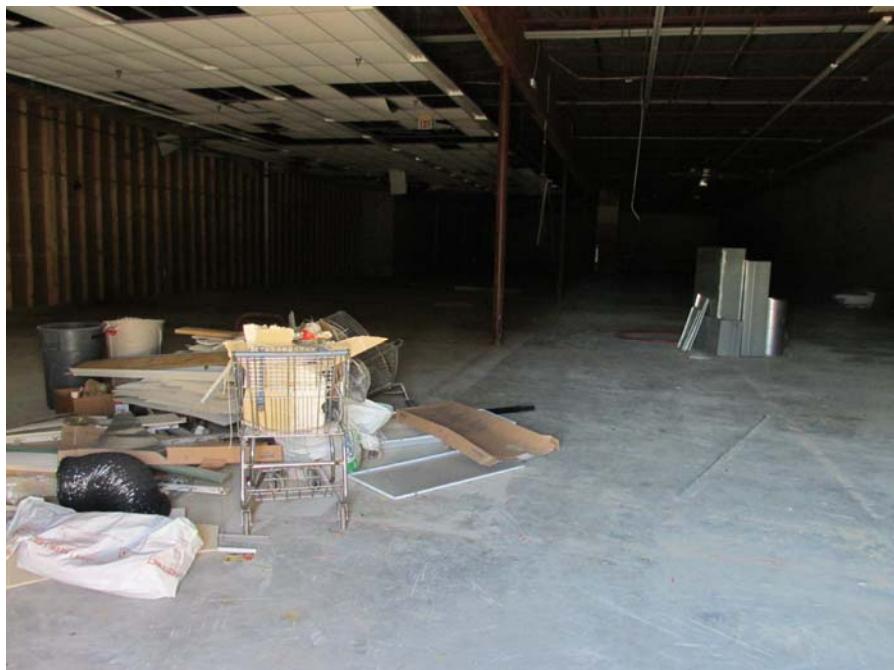
| Vacant tenant space |

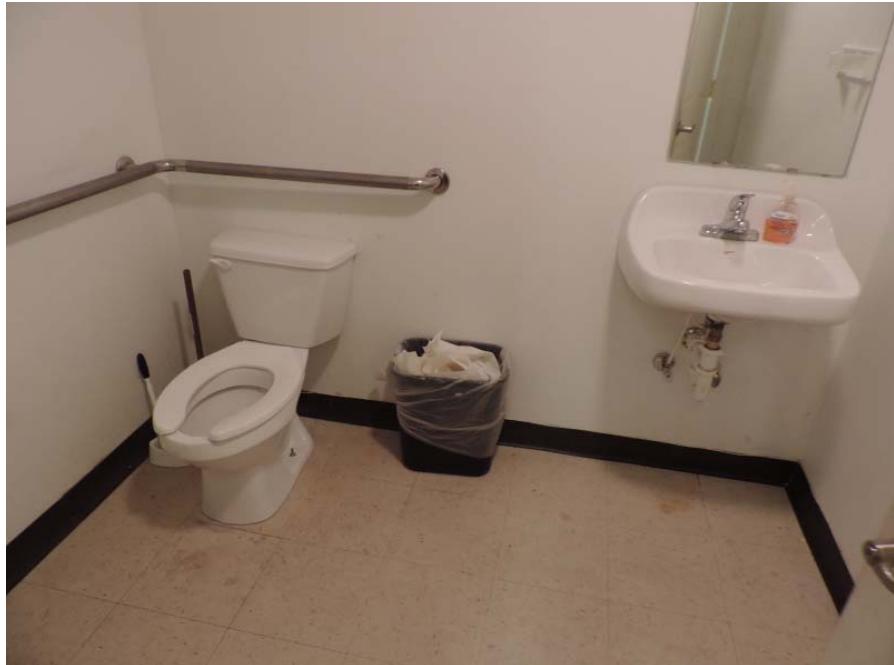
Typical tenant restroom

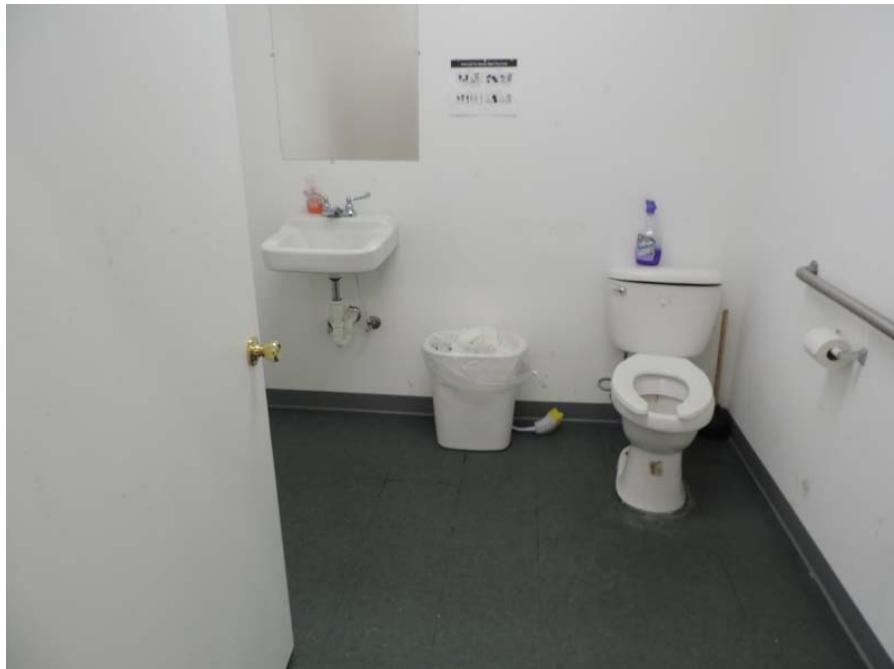
Typical tenant restroom
