Project #201500075-01
May 7, 2016

Property Condition Assessment

**Atmore Shopping Center
1234 Spring Avenue
Atmore, Alabama 36502**

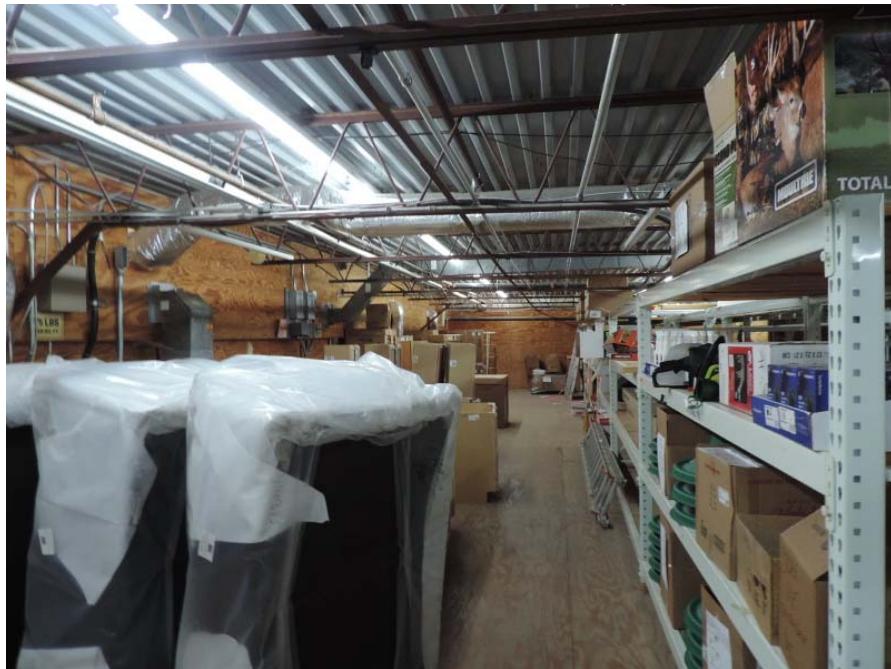
Marvin's mezzanine storage area

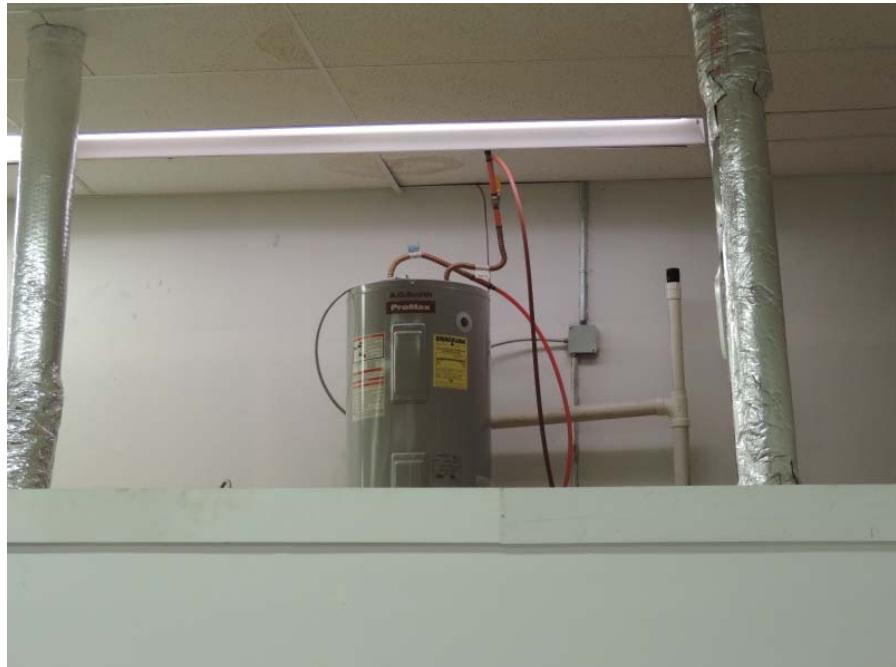
General Condition: Fair to Good - The plumbing systems are of various ages depending on tenant build-out and maintained as needed. Much of the piping is original. The water heaters are replaced as needed. The water heater observed in the Marvin's space appeared to be outdated.

Tenant space water heater

Recommendations: No physical deficiencies/deferred maintenance or immediate/ short term needs were noted. The water heaters are the responsibility of the tenants or replaced as part of TI allowances at the beginning of the lease; therefore, no costs for their replacement are included in the Replacement Reserve Schedule.

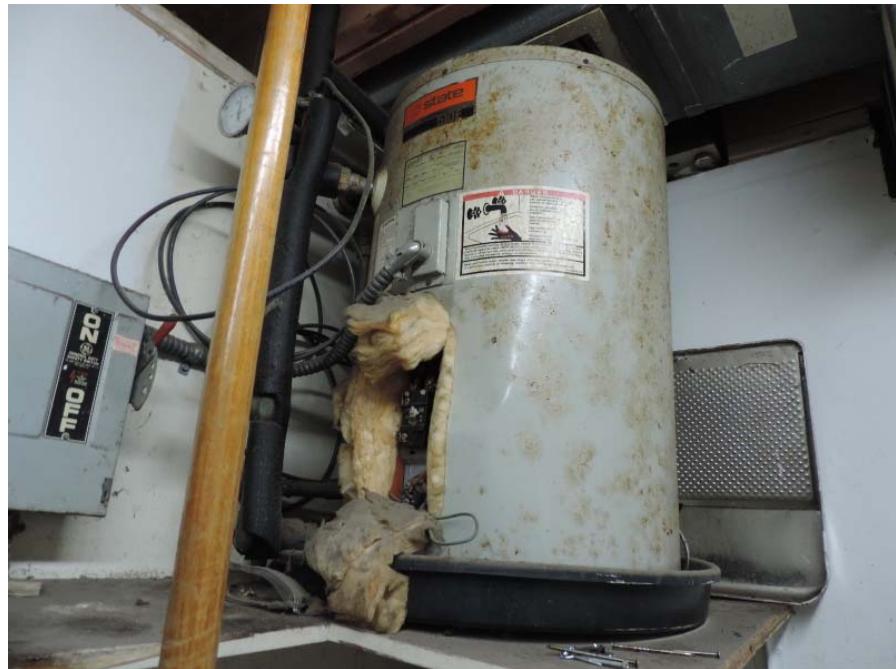
Tenant space water heater

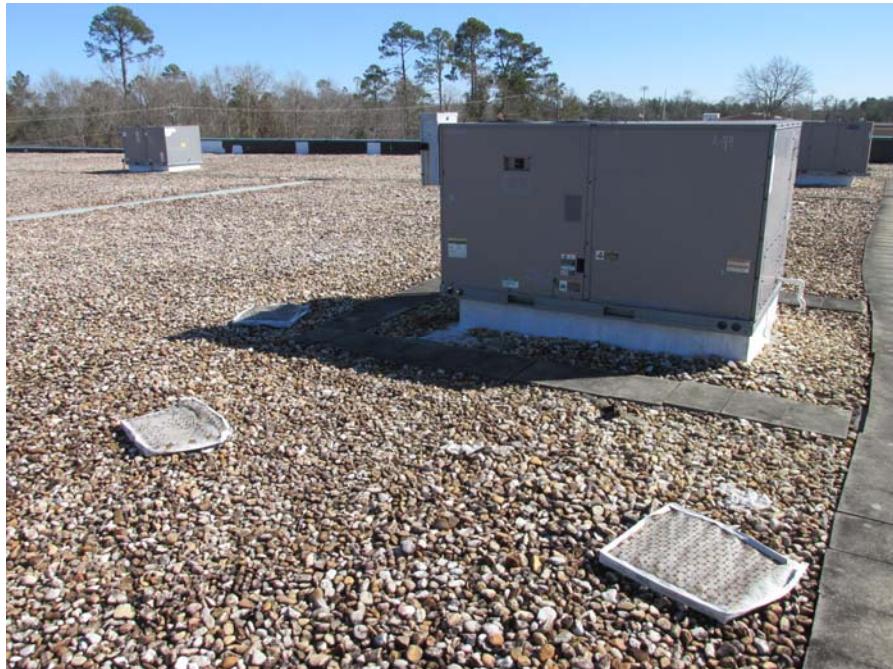
General Condition: Poor to Good – All currently functioning units (16) were installed from 2006 to 2014. However, five units are no longer functioning, and are covered with tarps. Additionally, at some point, two units were removed, and the curbs were covered. The maintenance and replacement of the equipment is the responsibility of property management.

Rooftop packaged HVAC units

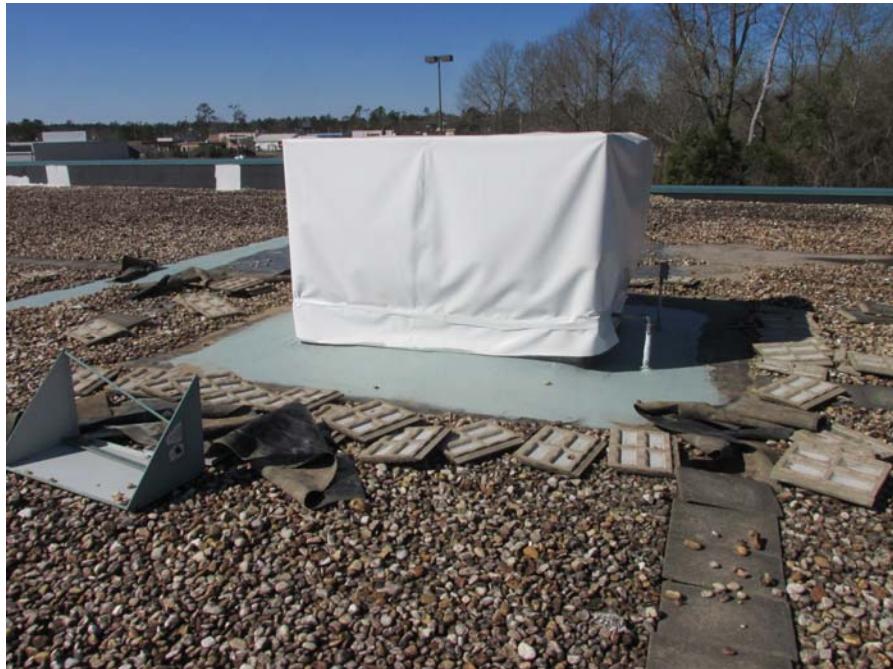
Inoperable unit

Recommendations: The five inoperable HVAC units should be removed from the roof to prevent any water intrusion issues. The curbs should then be covered. This can be handled as part of routine maintenance. As the property owner is responsible for providing a working system at tenant turnover, the replacement of the units at the vacant tenant space (approximately 30 tons) will likely be necessary. Costs for the replacements are included in the Short Term Needs Table. Otherwise, given an EUL of 20 years for the packaged units, it is not anticipated that any of the other HVAC equipment will require replacement during the term.

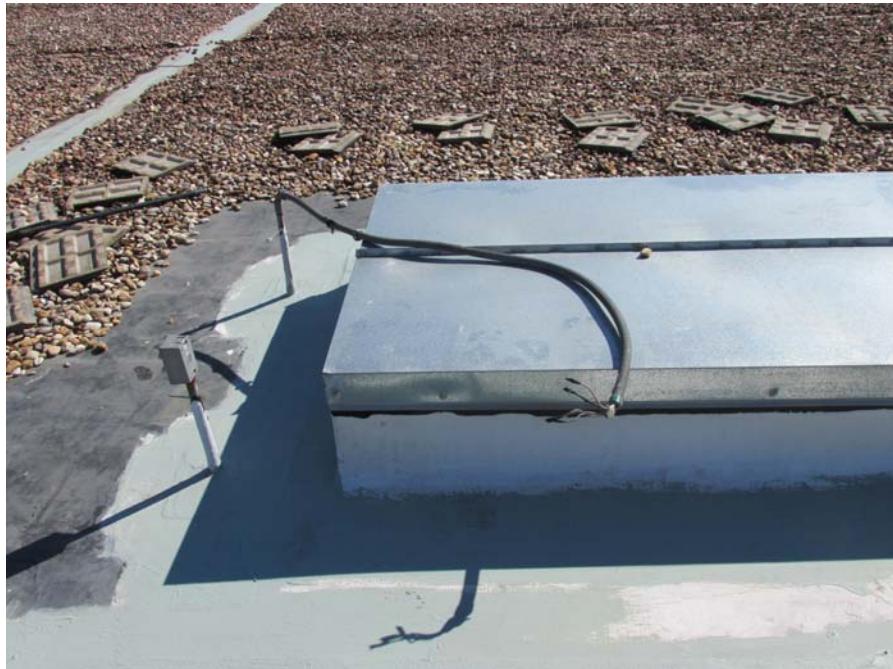
Covered curb- location of former unit

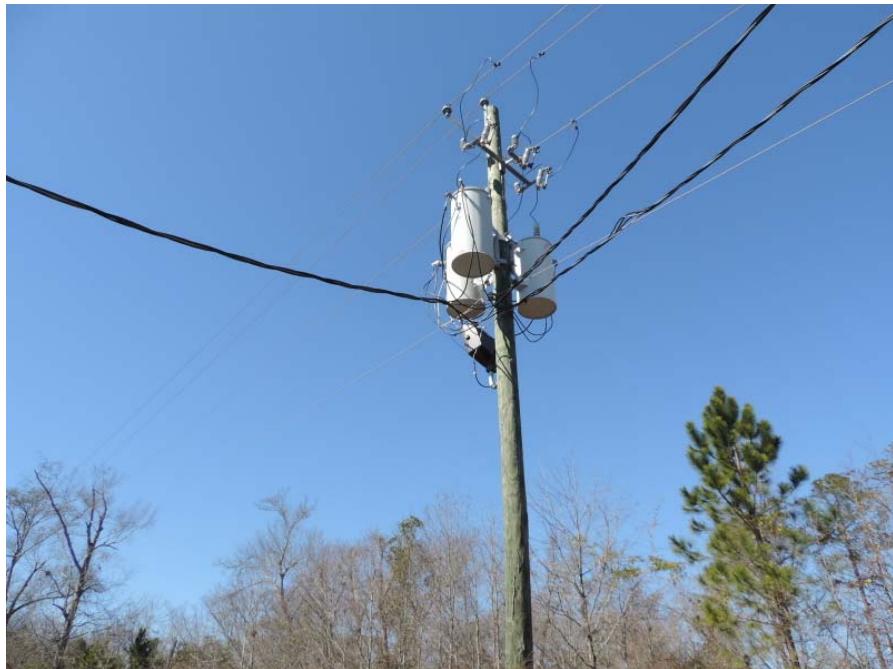
Utility electrical transformers

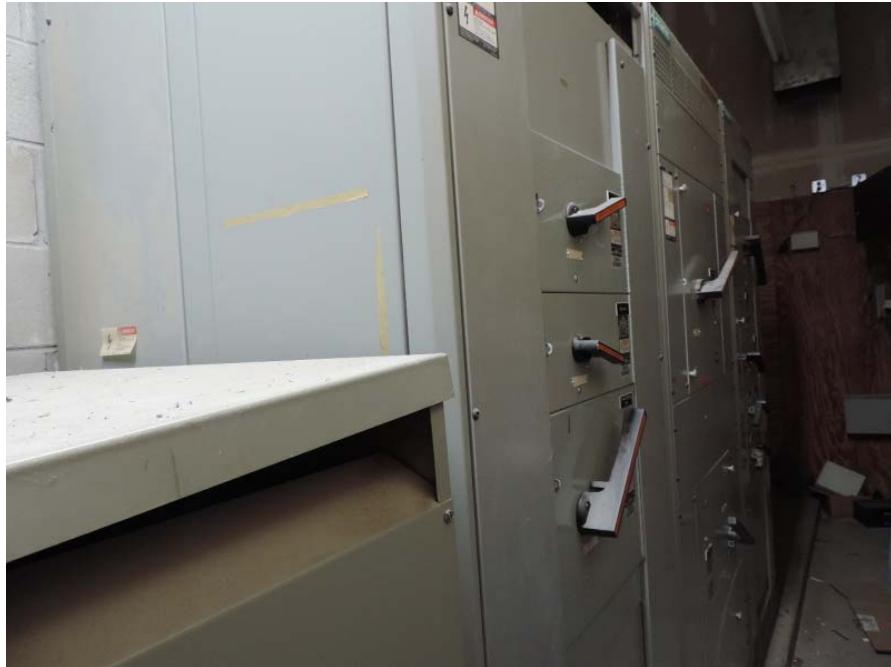
Electrical distribution panel and switchgear

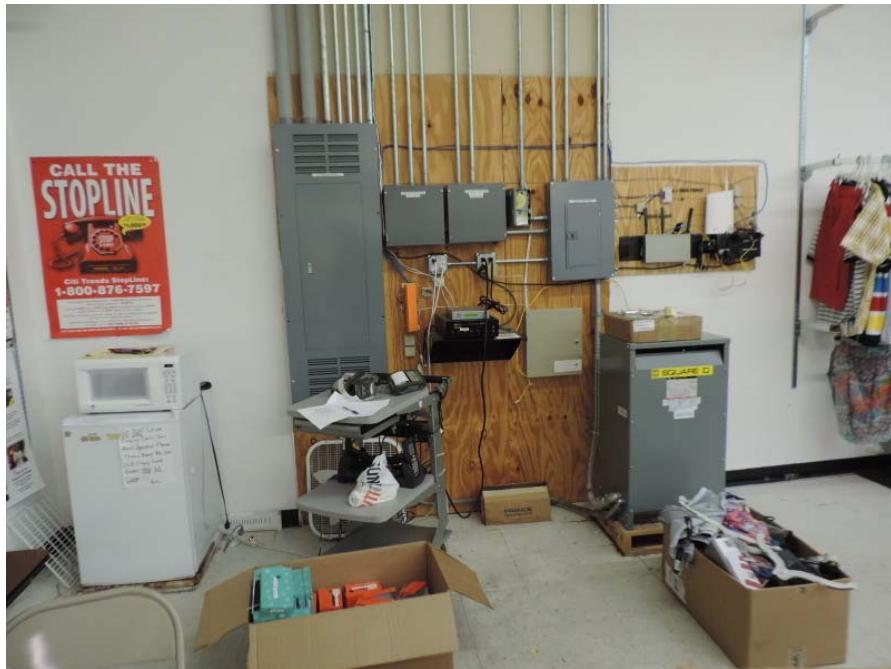
Typical electrical equipment in tenant space

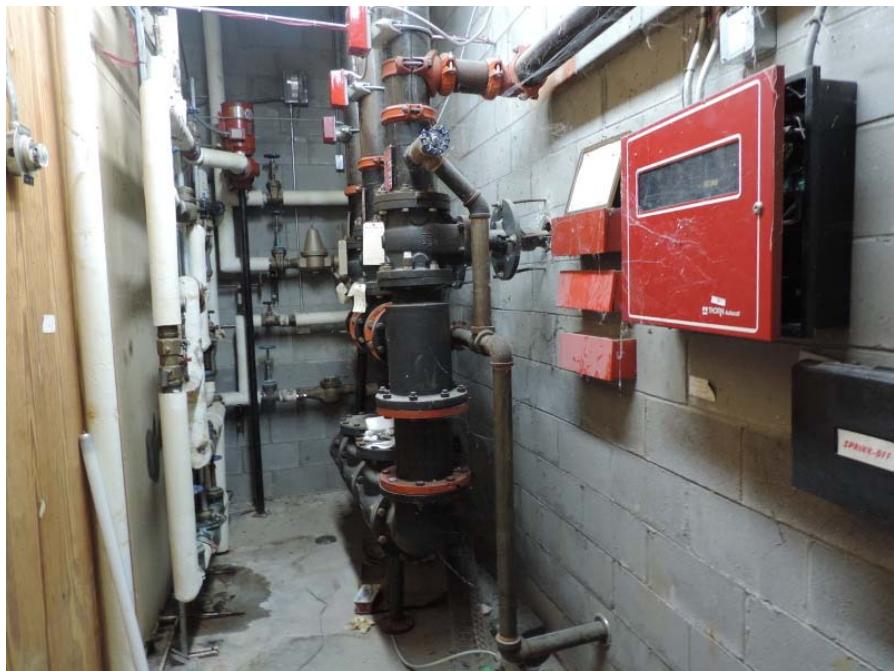
Sprinkler riser and alarm panel

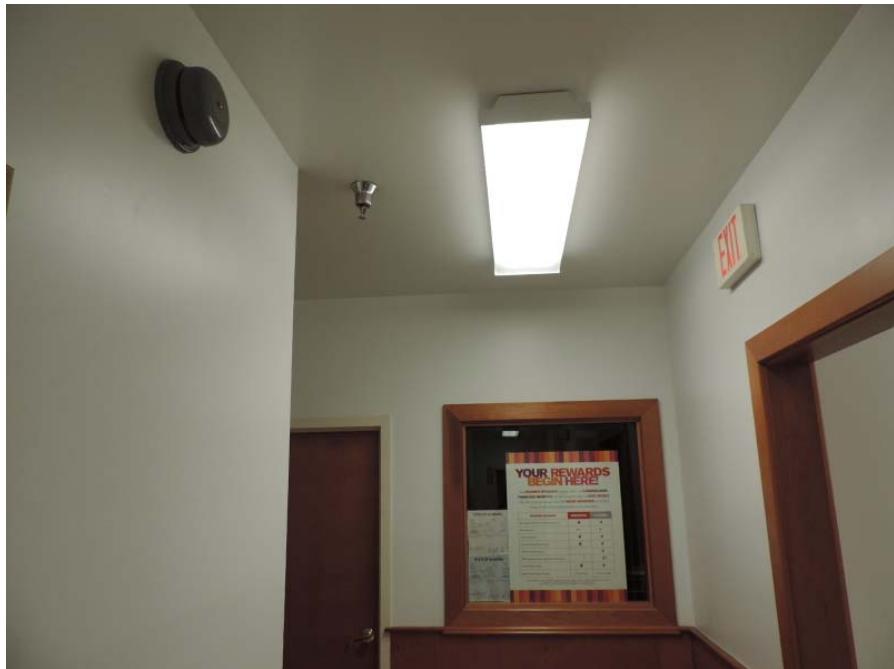
Interior alarm bell, sprinkler head and exit sign

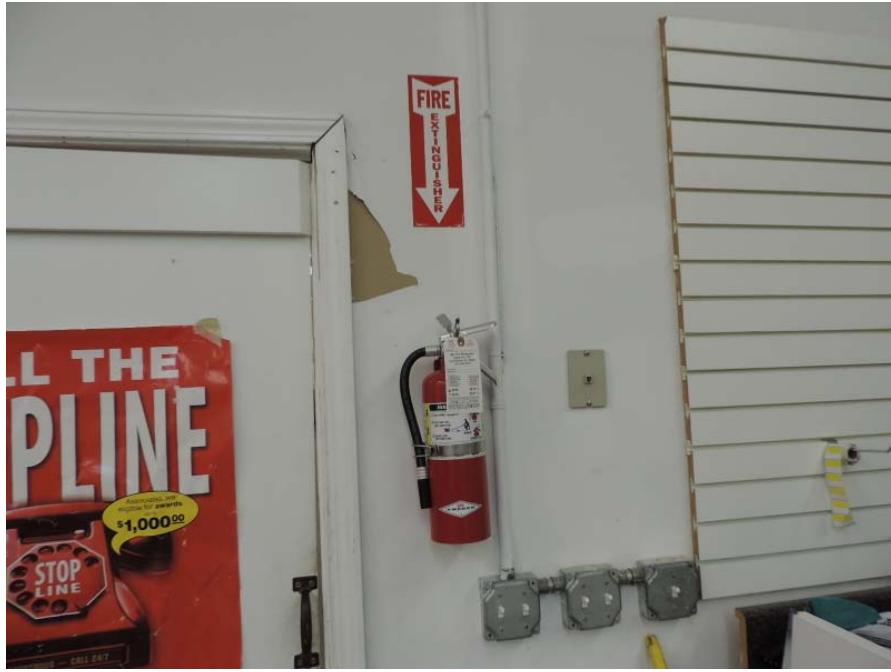
Fire extinguisher

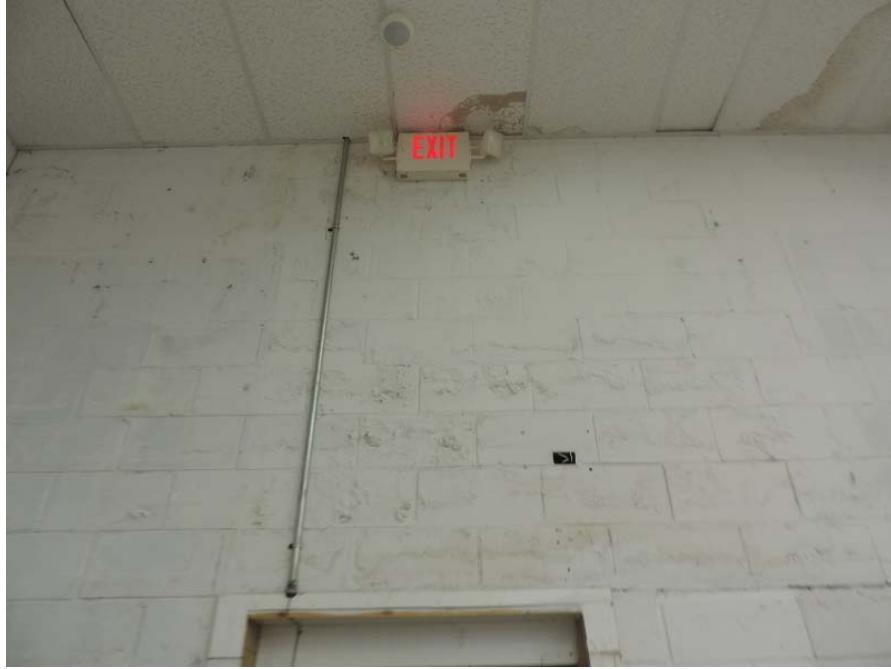
Emergency lighting and exit sign

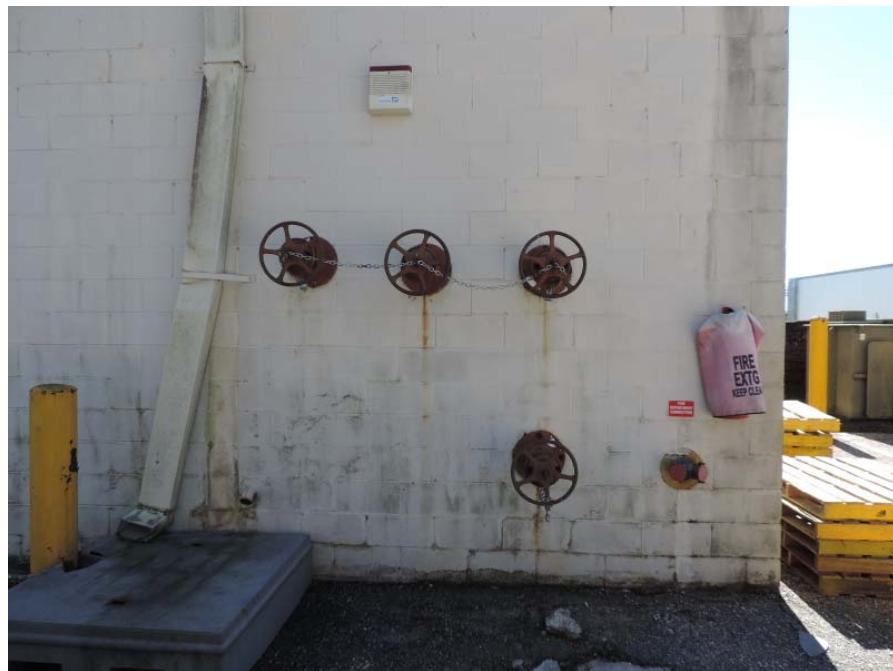
Fire department connection

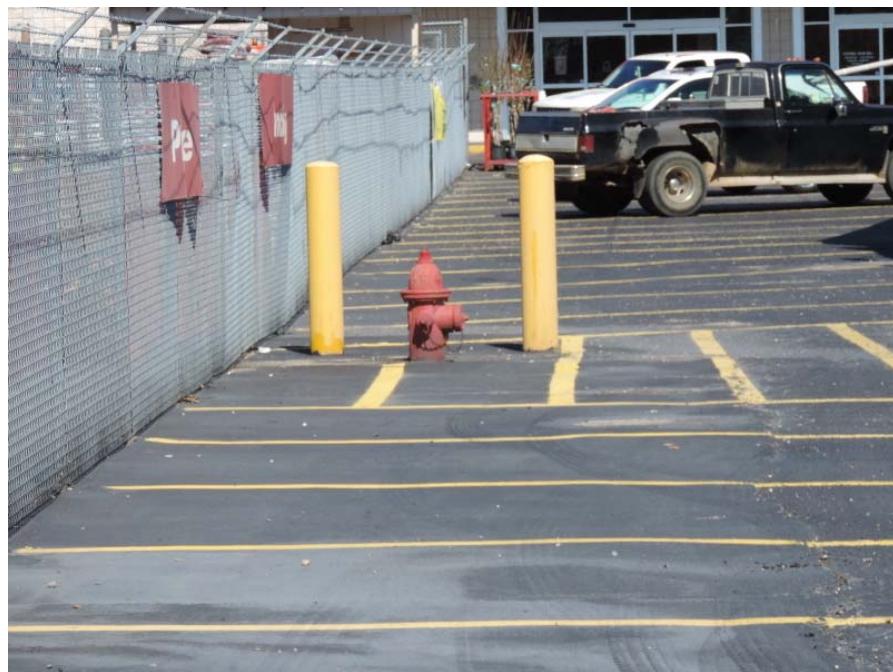
Fire hydrant

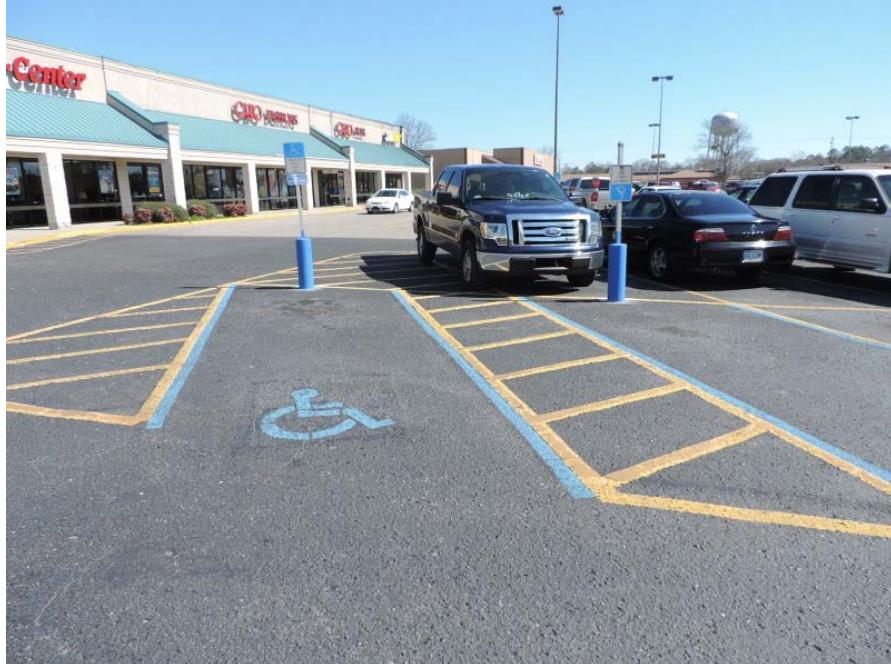
has twelve ADA spaces, at least one of which is van accessible. However, three of the parking spaces were observed to be lacking vertical signage.

ADA parking spaces

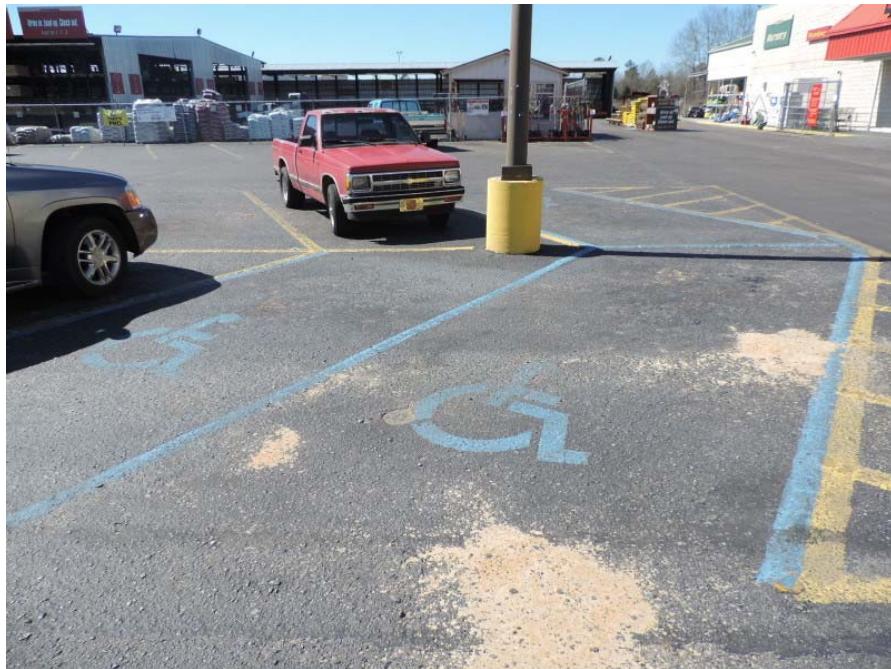
ADA parking spaces missing vertical signage

Three of the ADA parking spaces were observed to lack vertical signage. As such, vertical signage should be installed at these spaces. Costs for this work are included in the Short Term Costs table.

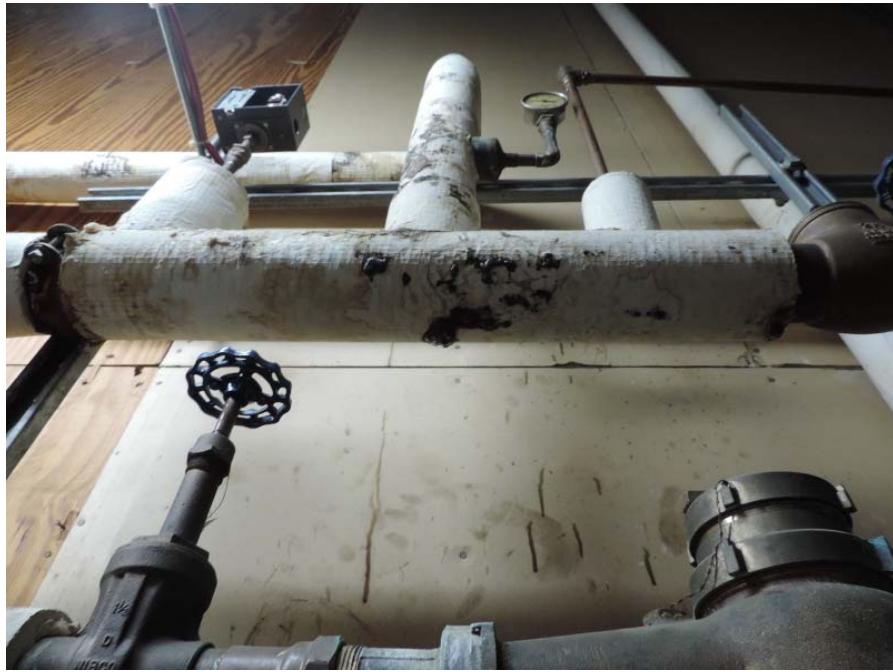
A comprehensive mold survey was beyond the scope of this assessment; however, during the assessment, visual evidence of active water and mold damage was observed throughout the interior areas inspected by Bock & Clark Environmental. In particular, mold growth appeared to be associated with water damage from multiple roof leaks. Mold growth was observed on water piping in the Marvin's space, and according to a Marvin's store employee, mold grows through the floor tiles and must be cleaned every once in a while.

Mold growth

Recommendations: It is recommended that mold-impacted building materials are removed and replaced in accordance with EPA guidelines. Additionally, due to the history and continued presence of water intrusion issues at the subject property, a Moisture Minimization Plan should be implemented at the subject property. The plan takes a proactive, preventative approach in order to minimize any moisture damage and/or mold impact by insuring the early identification and repair of potential problems. Bock & Clark Environmental has included costs for this work in the Short Term Costs Table. As previously mentioned, water damaged ceiling tiles can be removed and replaced as part of routine maintenance.

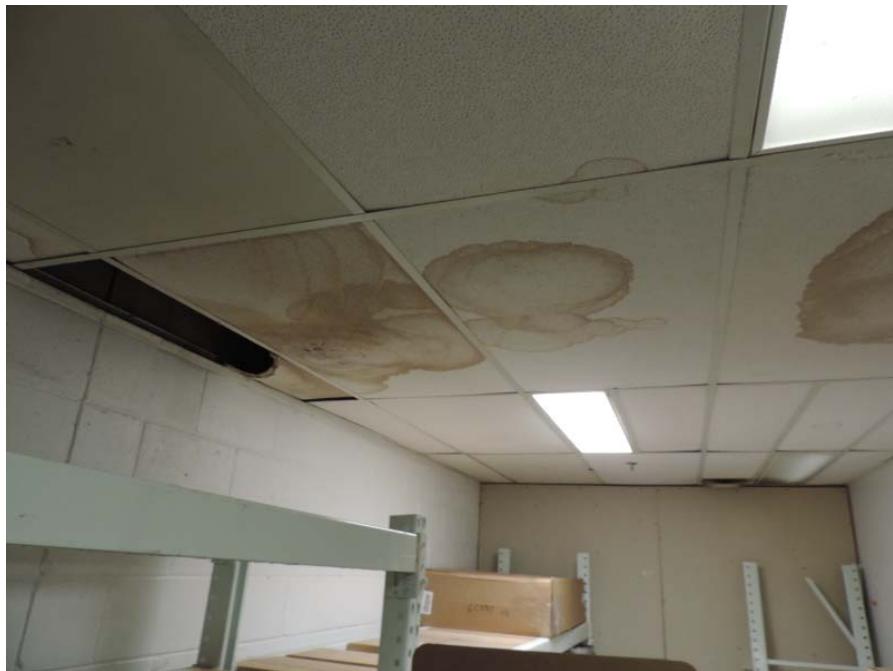
Water damaged ceiling tiles with mold growth

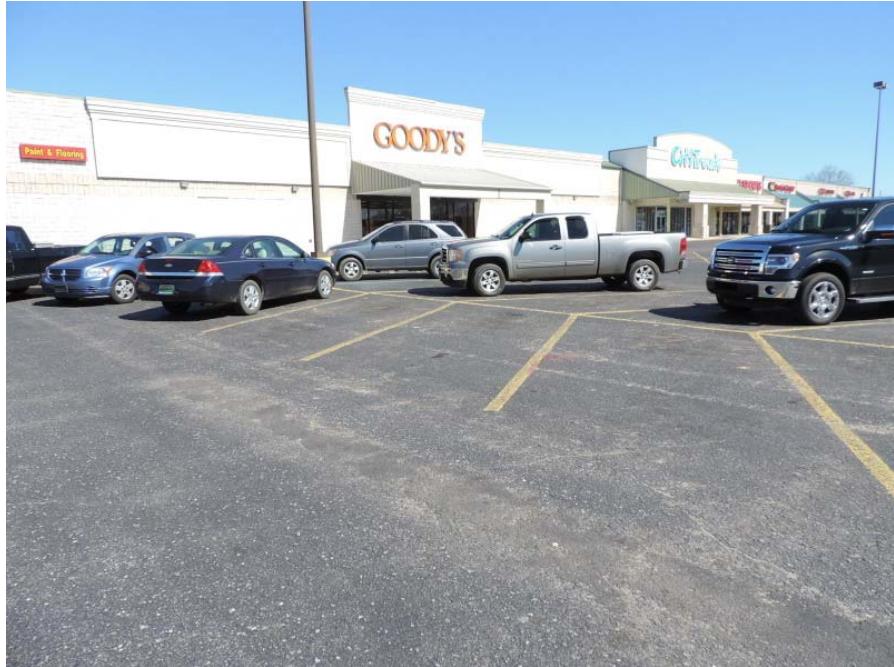
Property overview – Building and pavement

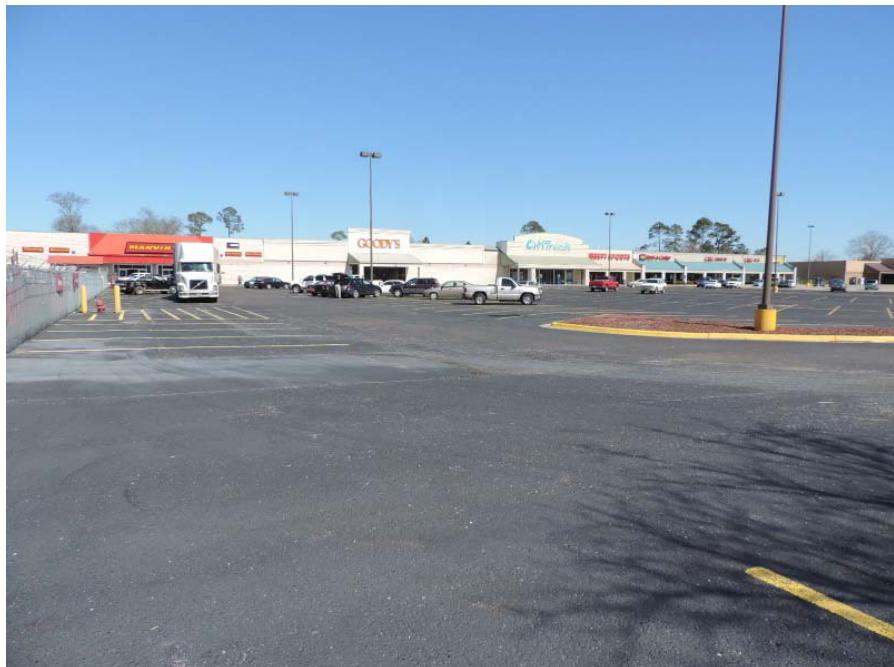
Property overview – Building and pavement

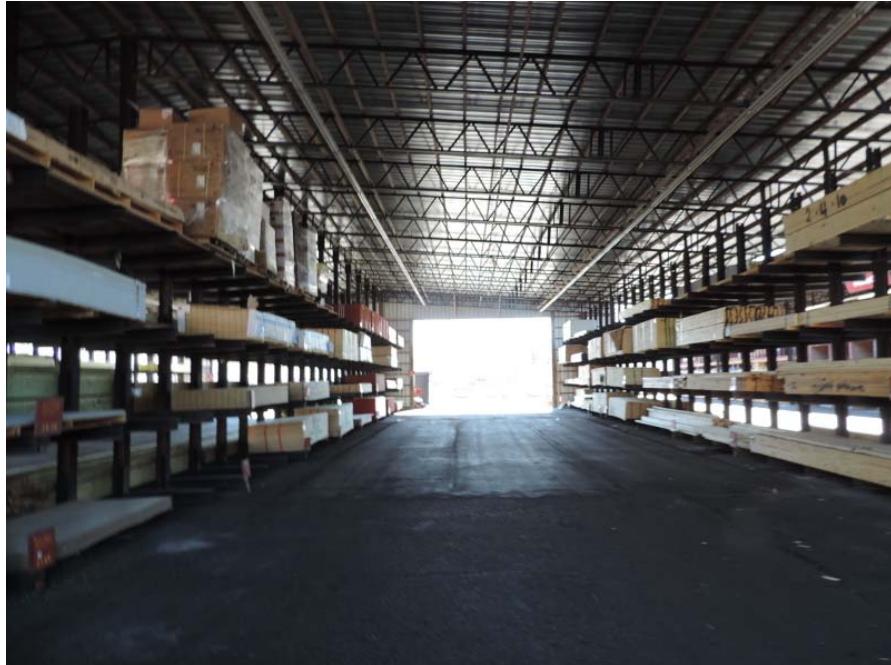
Property overview – Interior of lumber storage sheds

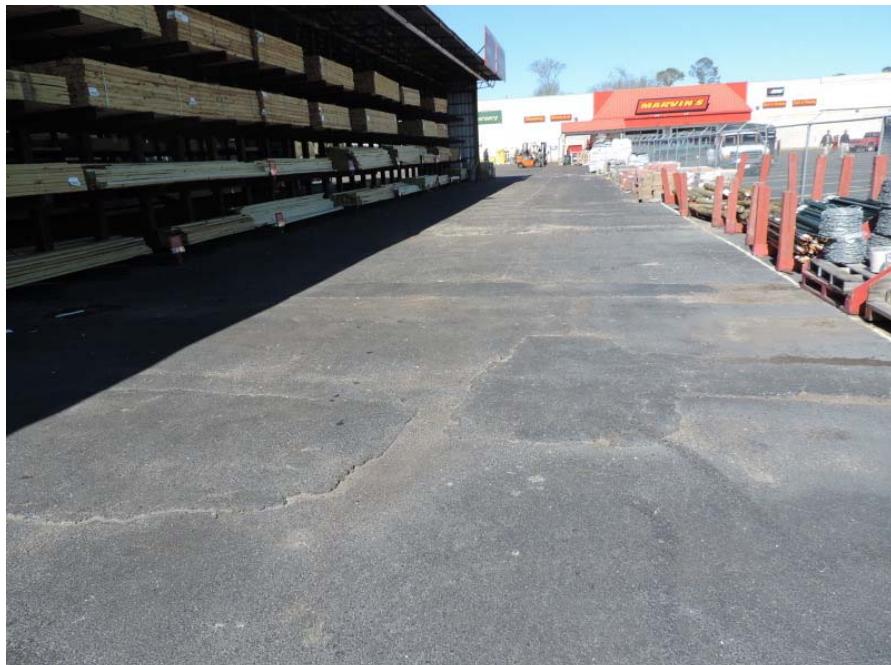
Property overview – Lumber storage area
