# RESULTS SUMMARY

Date 2023-10-23  
Assessor garyw@spectrumgroup.co.nz  
Farm Waybrooke Farms  
Irrigator Wiper Farm rd  
Irrigation Type Center Pivot

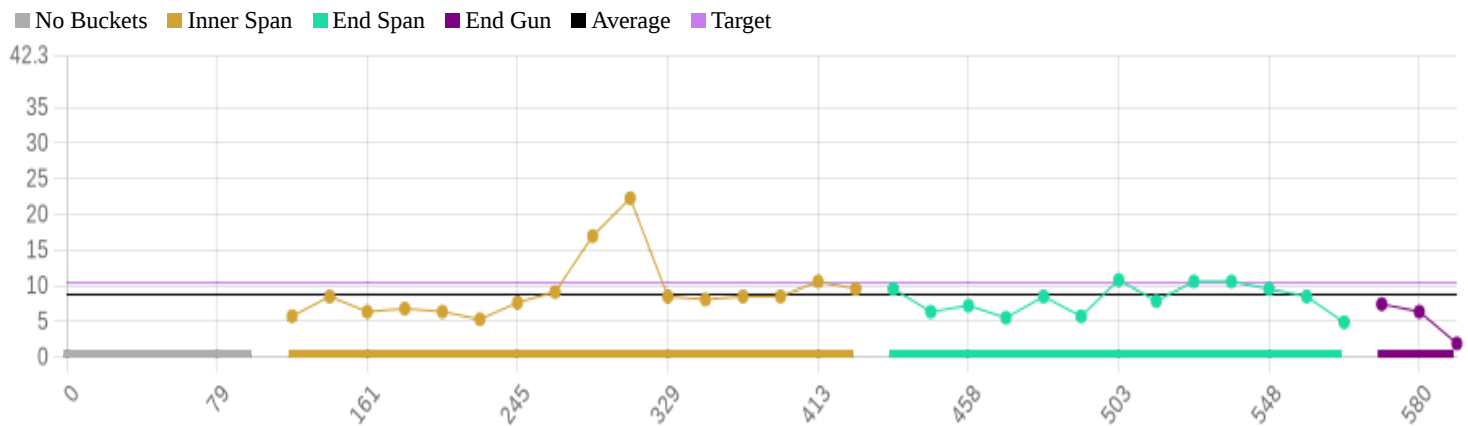
## DISTRIBUTION UNIFORMITY

| Sections | Distribution Uniformity (DU) | | Applied Depth Average (mm) | | Intensity (mm/hour) |
|---|---|---|---|---|---|
| Pivot | 0.63 | N | 8.76 | ! | |
| Pivot - Inner Span | 0.63 | N | 9.41 | Y | |
| Pivot - End Span | 0.68 | ! | 8.38 | ! | 40.37 |
| End Gun 1 | | | 5.23 | N | |
