ENVIRONMENTAL TESTS ZAURAC 4-30

VTT Expert Services Ltd

Requested by: Five Watts Oy

Environmental tests for ZAURAC 4-30

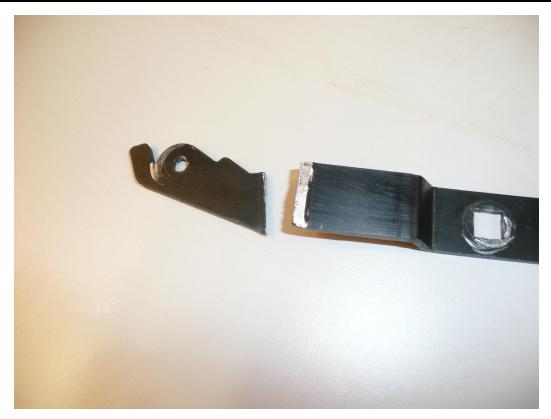
During the random vibration test the mounting brackets failed. Otherwise

The specimen operated during and after the test normally. The fixing brackets failed during the test in x-axis (see photo 4). The test in y- and z-axes were continued without the brackets.

Photograph 4. The fixing brackets after the tests in x-axis (P1100349.JPG).
