# *Greensmith's Classic & Custom*

## *Vehicle Report*

*Year: 1958*

*Model A35*

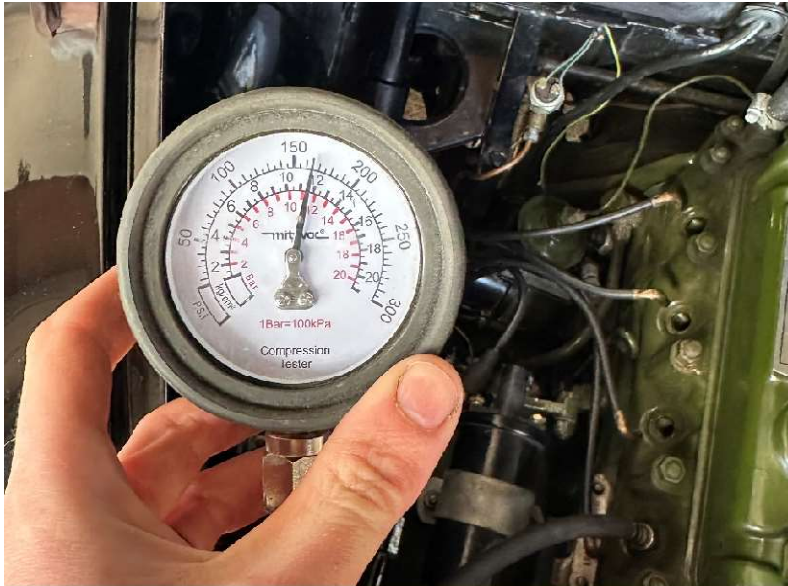
*Cylinder 1 Compression test result*

*The engine starts and runs very well with 165-170psi of compression across all cylinders which is perfect. The engine was warm when I arrived, so I was unable to see how the car started from stone cold. The owner said he briefly started it to make sure there was fuel in the carburettor. It did however start and run very well, the large battery along with the starter motor turn the engine over, what I would say is faster than normal. The owner also advised it benefits from an unleaded head conversion and a stainless steel exhaust. The oil was clean and up to the correct level with no obvious leaks. The oil filter seal did look to be slightly pinched but it wasn't leaking*

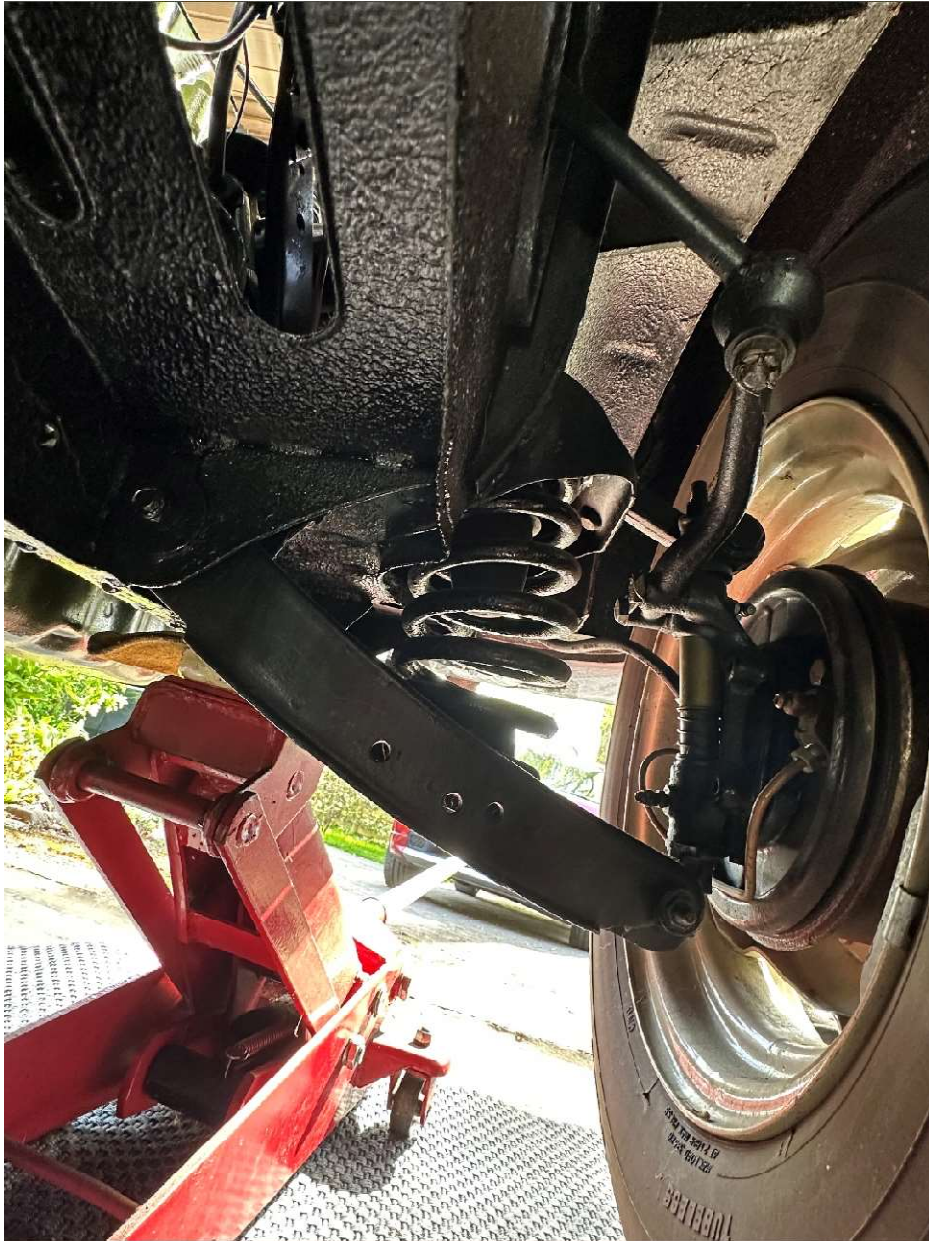
*The front suspension is in great order with no play, knocks or bangs while driving. The steering had a small amount of play which I believe is the steering box. This is fairly normal on a steering box set up. The steering box arm ball joint gaiter was ever so slightly perished and the steering box itself appeared to have a minor leak.*

- Speedo overreads, when travelling at 30mph the speedo reads 60mph. The owners says this is just a speedo cable and has a replacement he will include with the car. I would suggest the speedo may need an overhaul/calibration as the cable only drives the speedo and should only need replacing if it seizes or snaps. Overhauling a speedo is usually around £300
- Two small marks on the offside of the boot lid and a dent in the nearside rear wing - to fix and respray the rear quarter panel and boot lid would be around £1200 at the same time a body shop should be able to sort the orange peel effect on the front valance
- Slight play in steering box - this is fairly normal
- Slight play in rear prop shaft UJ - this just needs monitoring and doesn't justify replacement just yet - replacement would be around £100
- Drips of oil on offside chassis leg, looks to be coming from the steering box

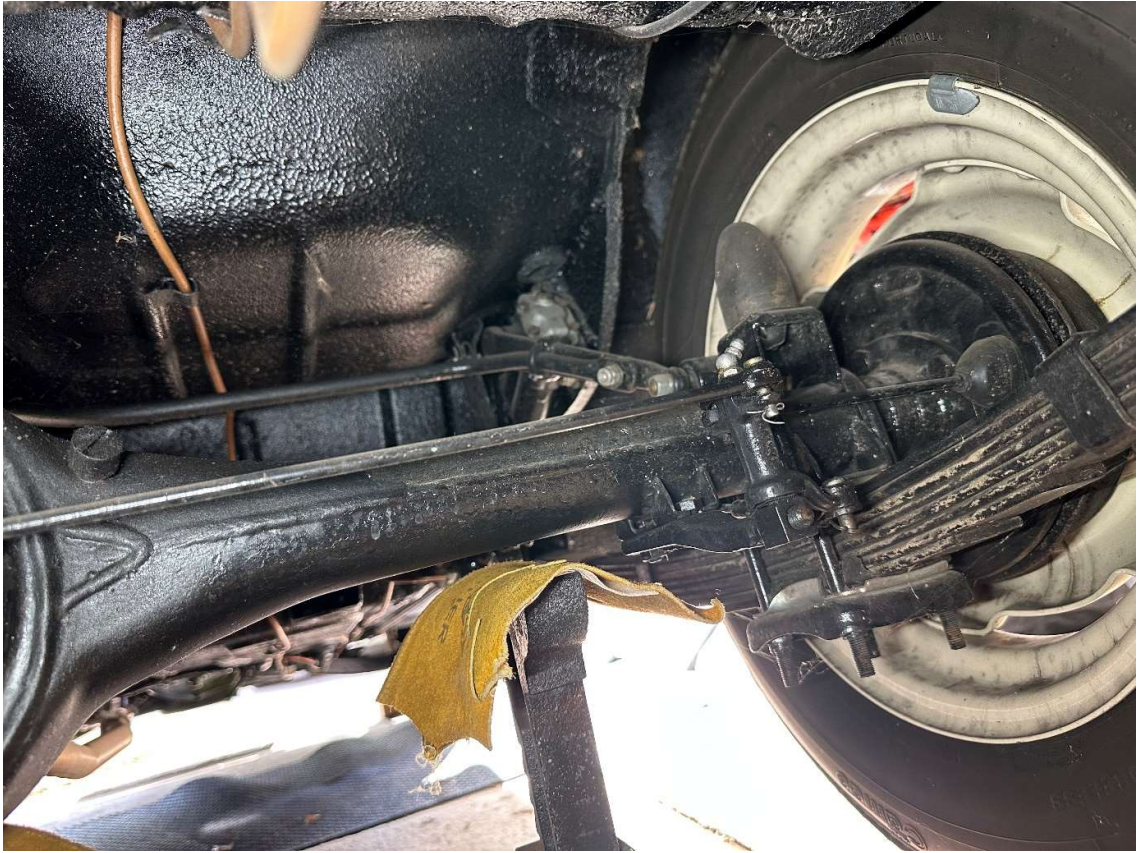
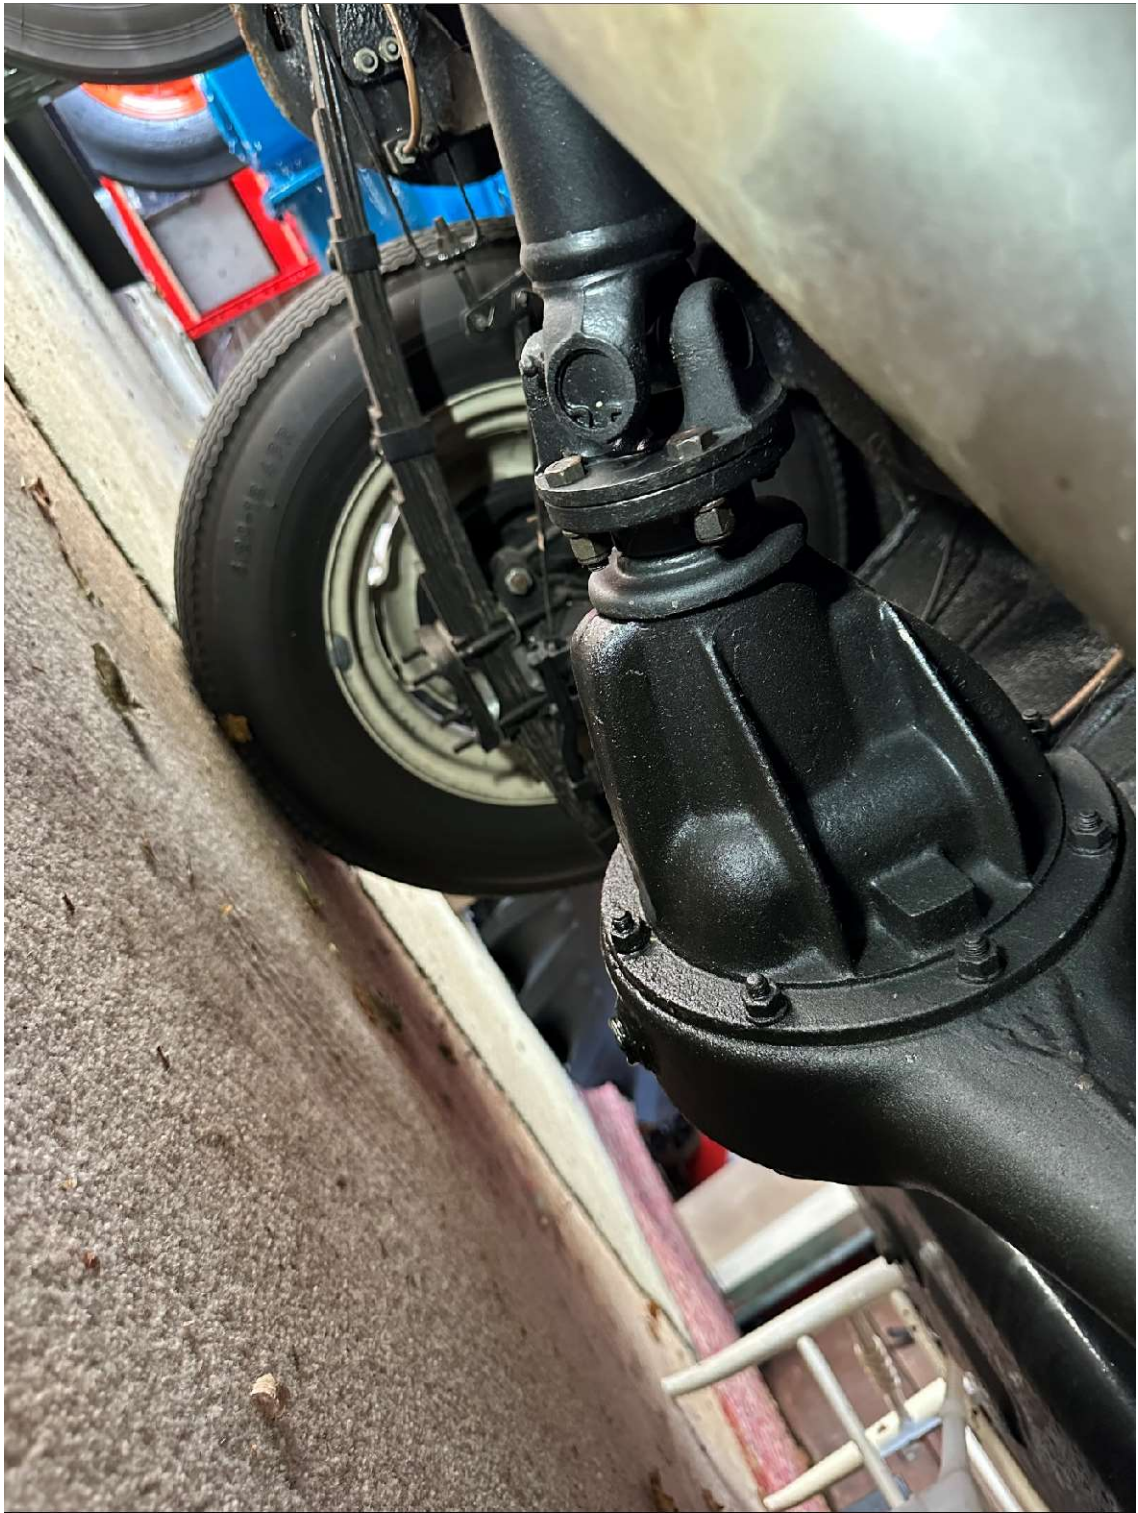
*The rear suspension and axle were also in great condition, with no leaks or corrosion. The differential had no excessive play and was quiet and smooth on a test drive. The only play I found was a small amount in the rear prop shaft universal joint. However this was minimal and shouldn't require immediate replacement.*

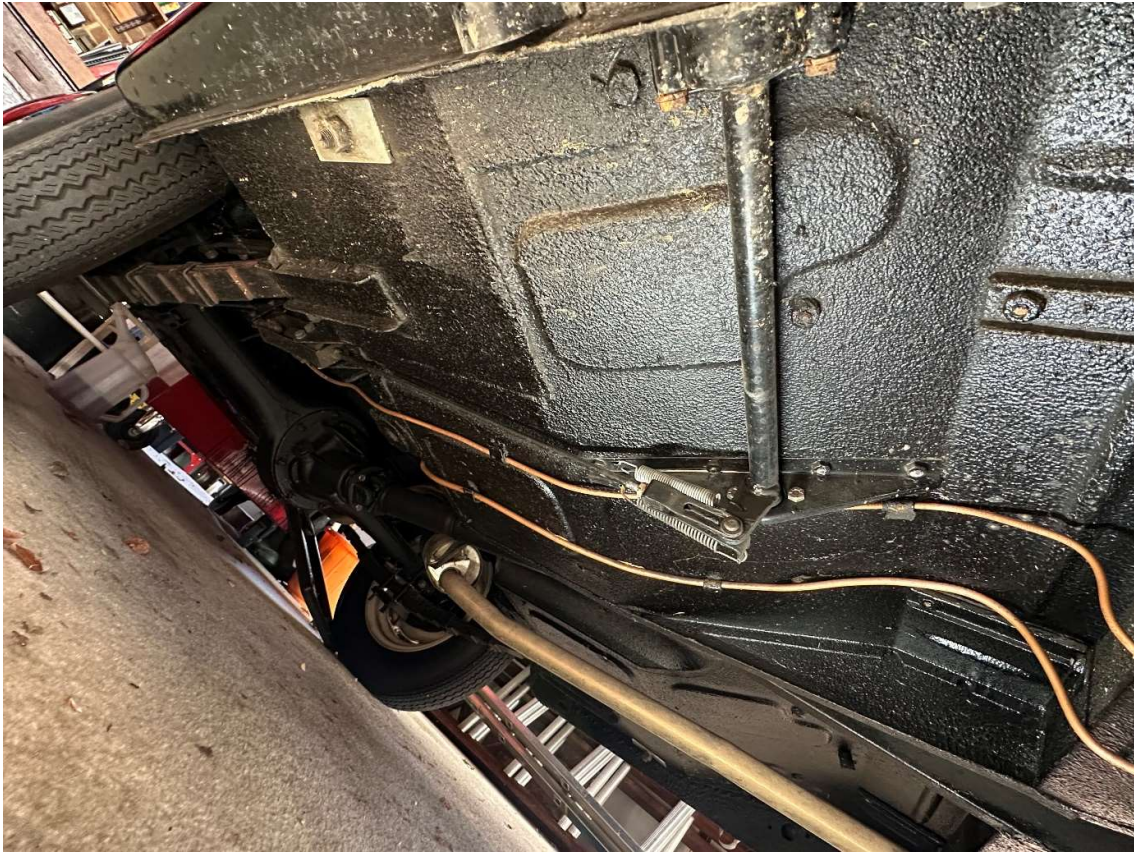
*There is no rust or corrosion on any part of the vehicle, all rust was repaired during the restoration and as per the invoice attached it was seam sealed and under sealed in 2012, then kept in a warm carpeted garage. There are only two bolts with any form of corrosion on them in the picture below, otherwise there is no corrosion anywhere!*

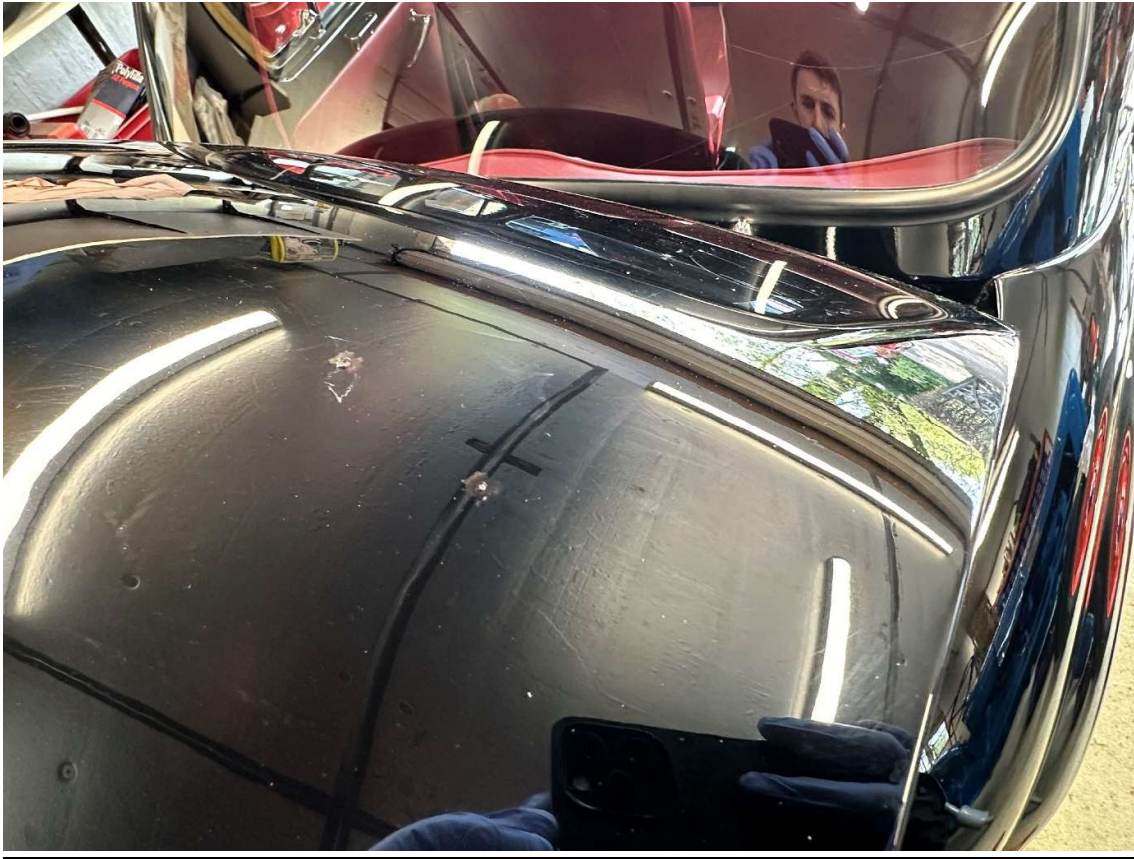
*Two marks on top of bootlid*

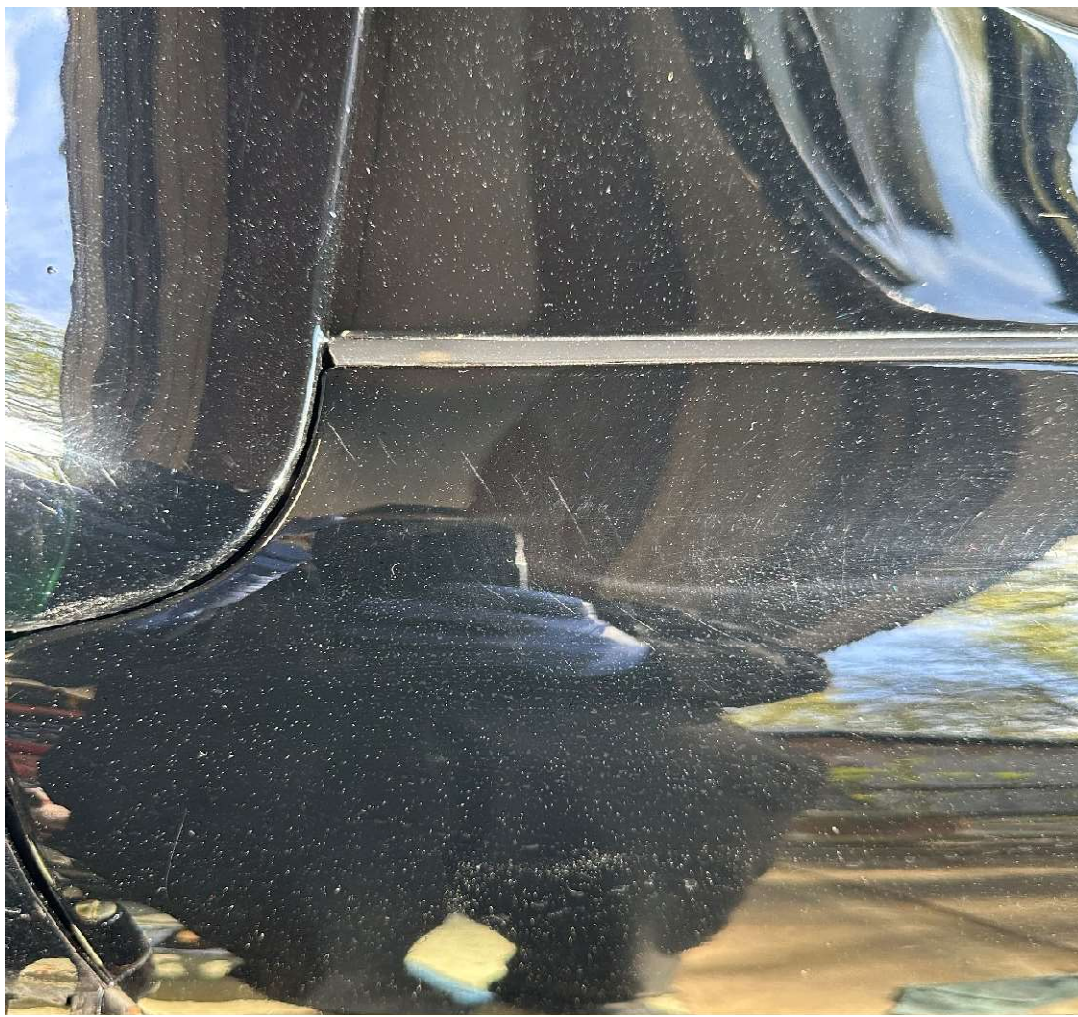
*Light scuff marks on top of offside front wing*

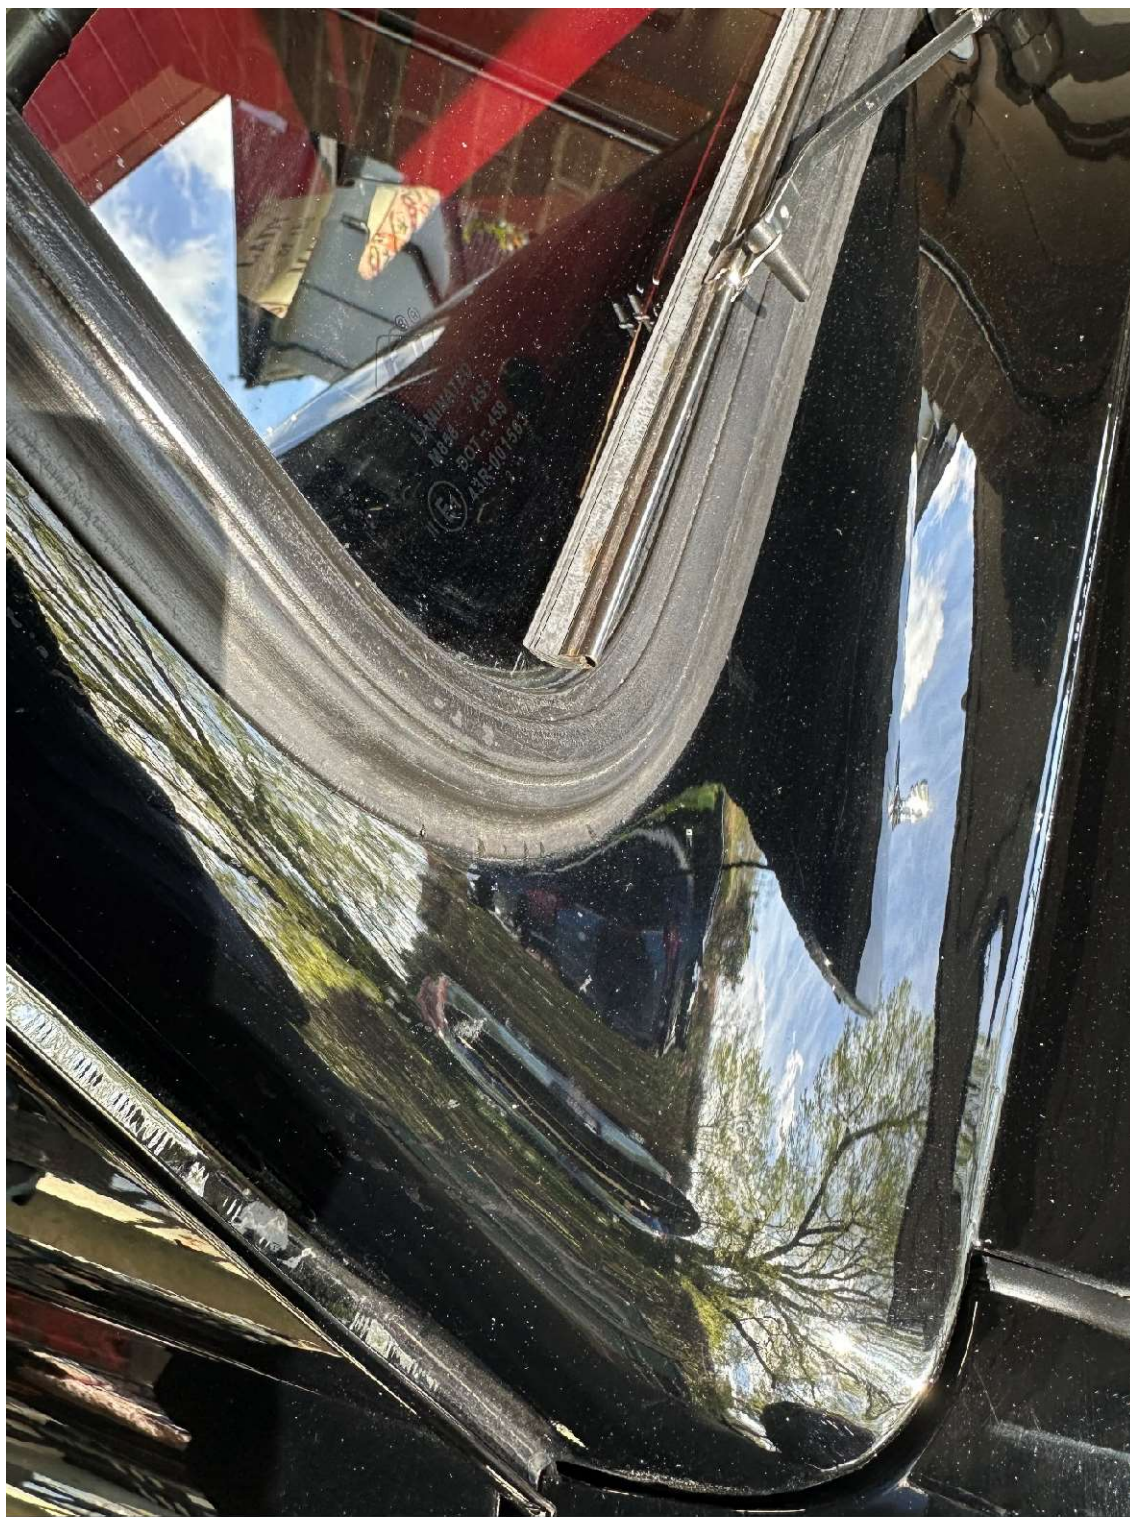
*Slight perishing to offside lower corner of windscreen seal*

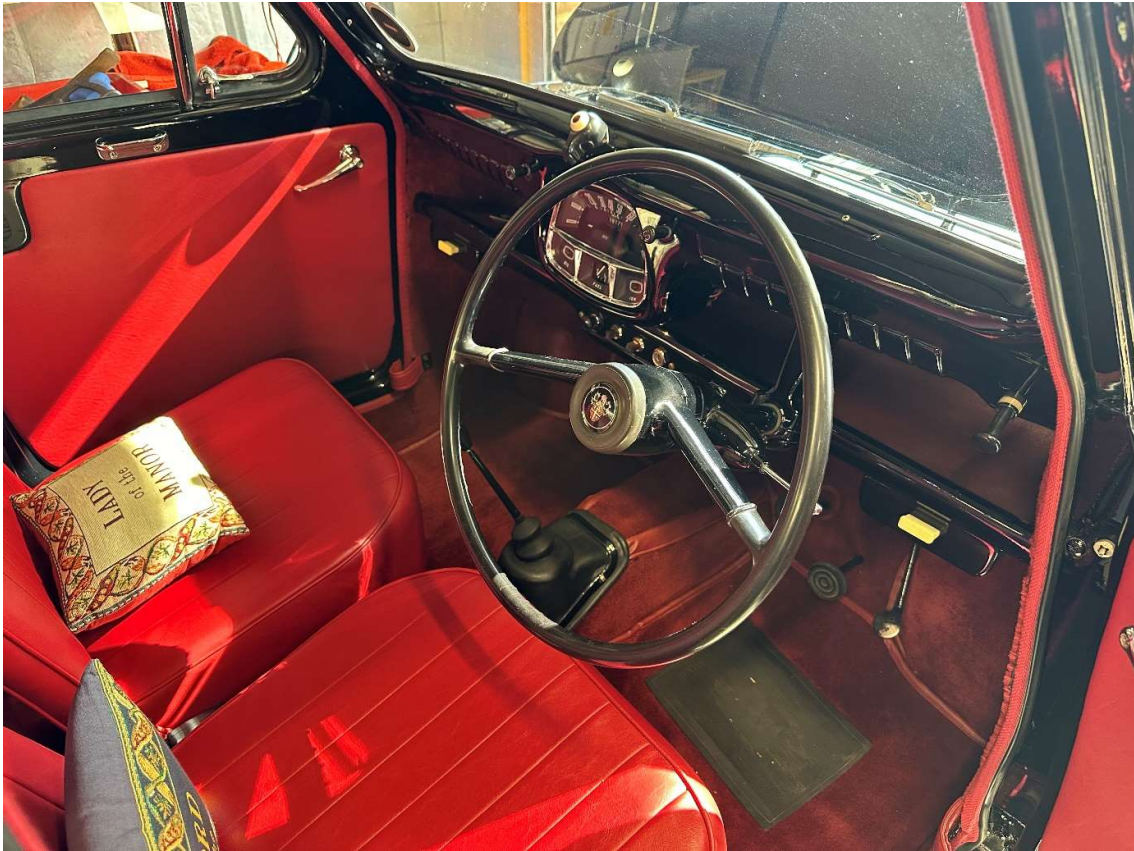
*The interior is in excellent condition with no rips, tears or damage and was restored in 2012. All the seats were firm with no sagging or foam disintegrating underneath.*
