**Subject: Residential Property Engineering Inspection - 946 River Landing Dr, Memphis, TN 38103**

05/26/2026 OZER DATA:  
RELATIVE SLAB ELEVATION

946 RIVER LANDING DR.

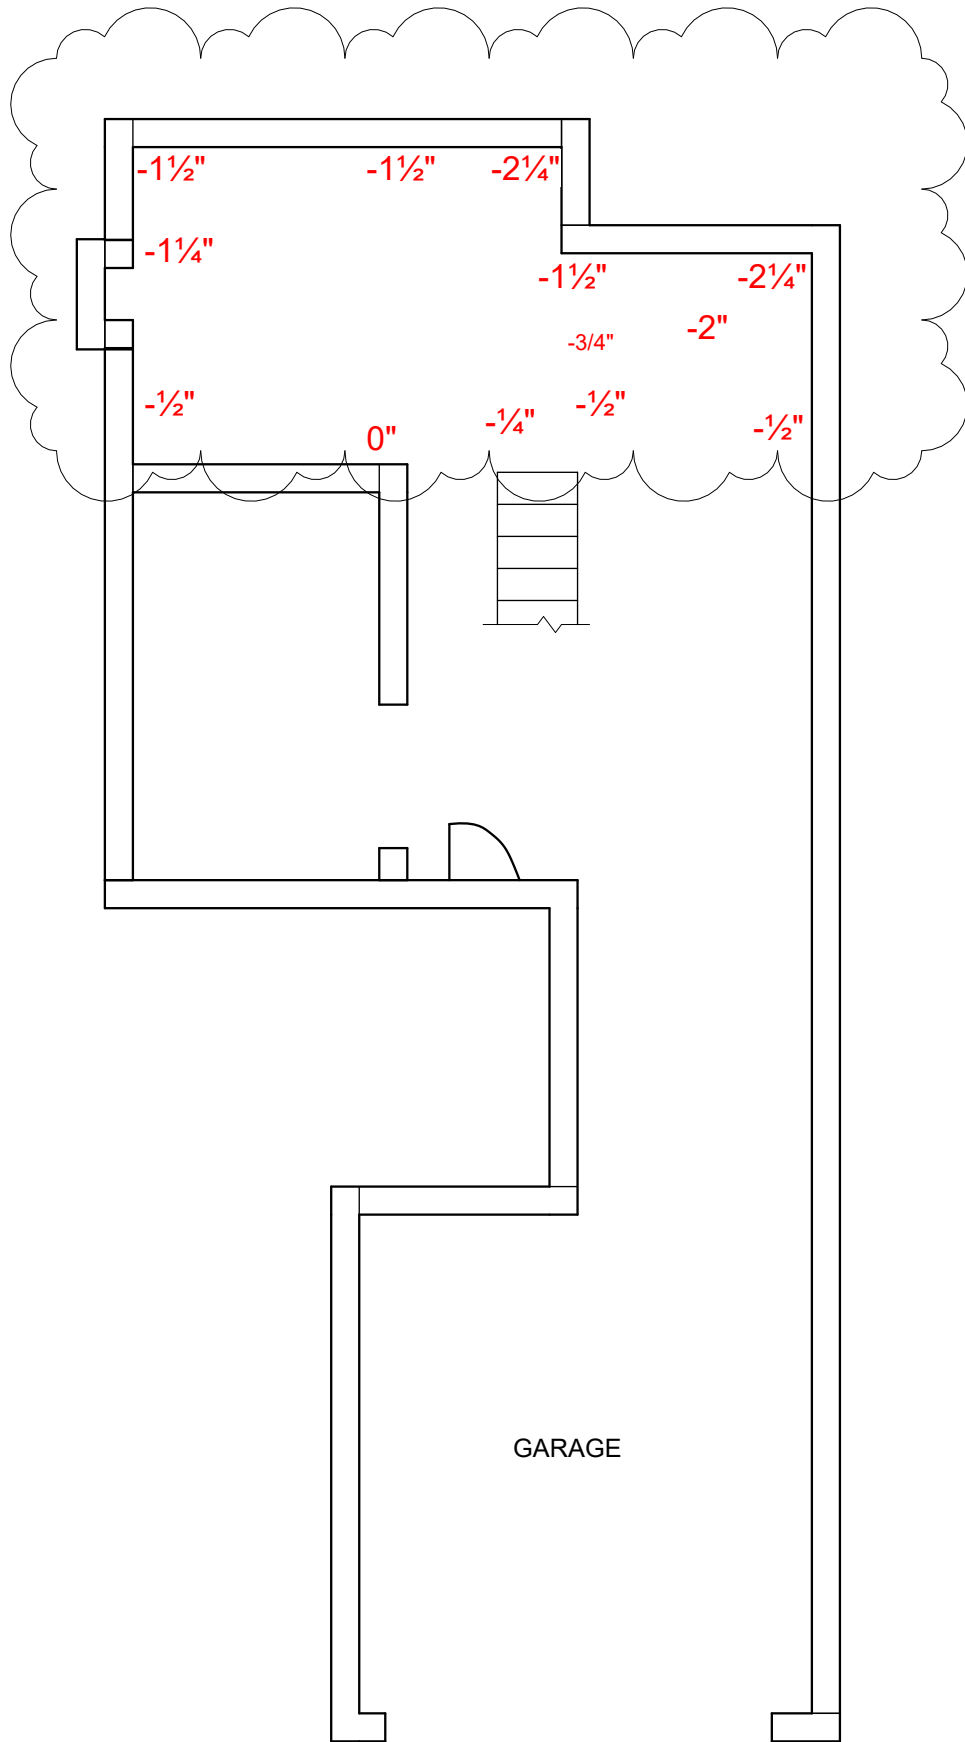
- **Structural Integrity:** The foundation does not exhibit signs of significant active movements.
- **Settlement Analysis:** By comparing slab elevation data provided by the owner with our current field measurements, we have determined that there is no indication of recent slab movement. Current data suggests that ground settlement in the rear portion of the structure has stabilized.
