June 30, 2026

**Subject: Residential Property Engineering Inspection - 946 River Landing Dr, Memphis, TN 38103**

05/26/2026 OZER DATA:  
RELATIVE SLAB ELEVATION

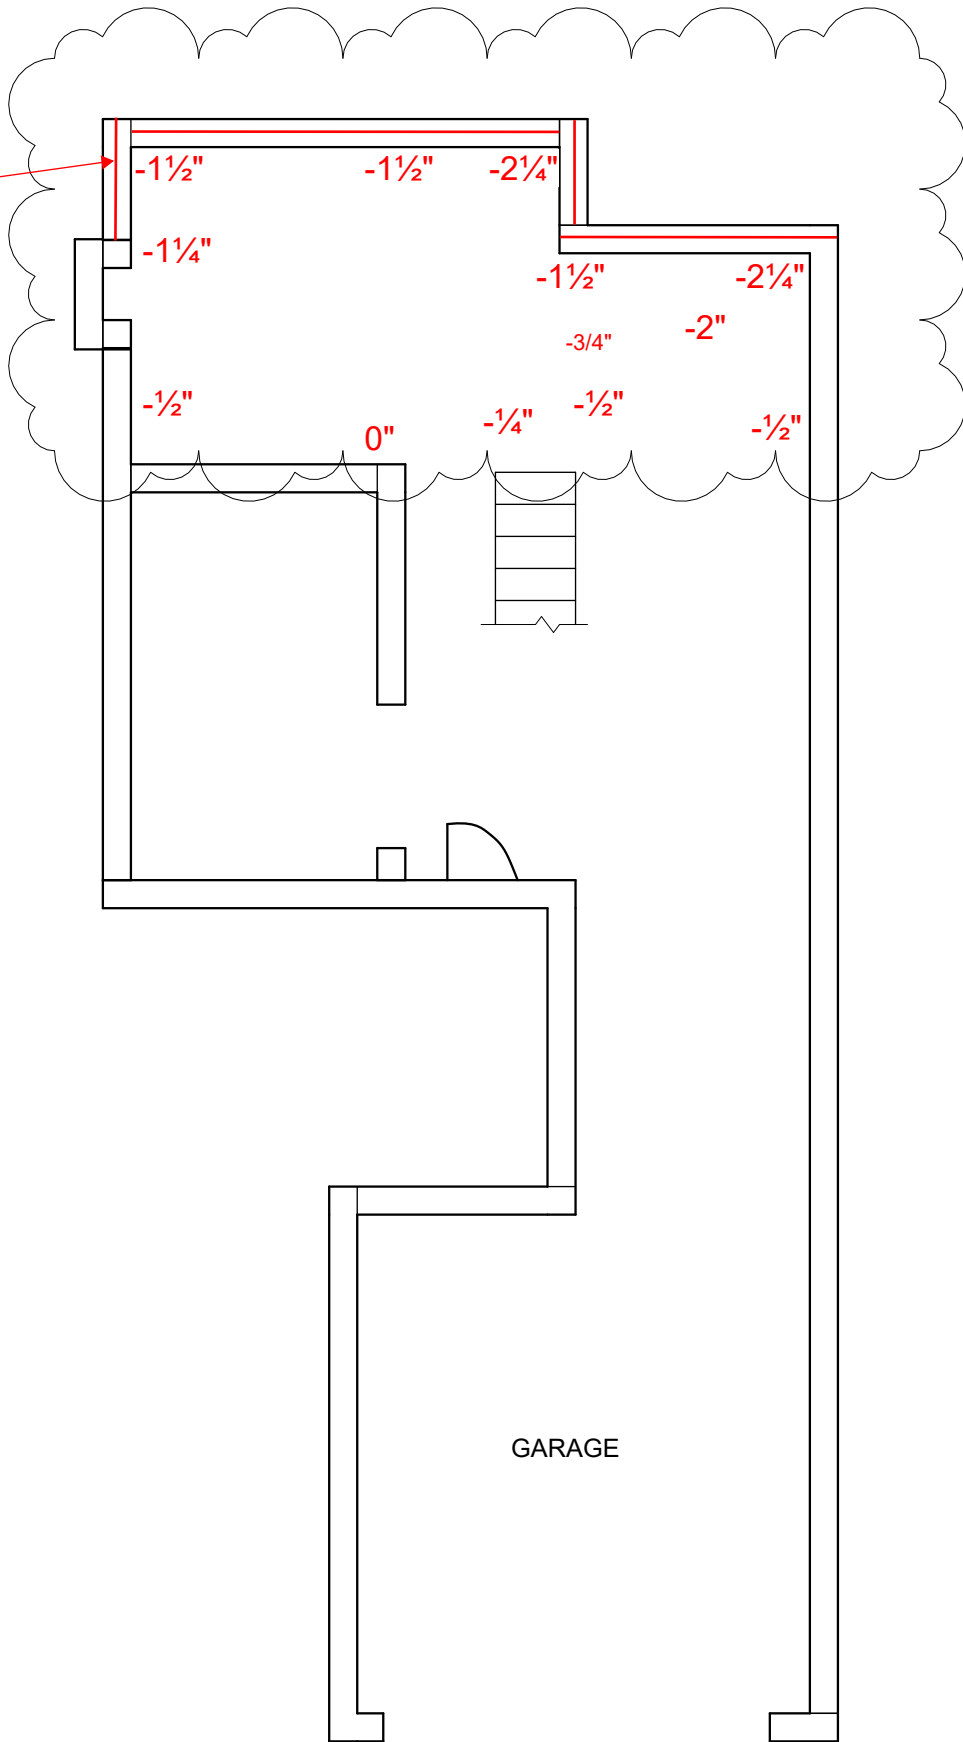
- **Structural Integrity:** The foundation does not exhibit signs of significant active movements.
- **Settlement Analysis:** By comparing slab elevation data provided by the owner with our current field measurements, we have determined that there is no indication of recent slab movement. Current data suggests that ground settlement in the rear portion of the structure has stabilized.

Slab and footing settlements in this area of the floor area, especially near the stairs, do not meet the residential standards for floor levelness (per NAHB Residential Construction Performance Guidelines criteria) which limit floor unevenness to not exceed 3/8" in 32 inches. Therefore, adjusting the slab elevations is recommended. Use the following approach.

Red line is where  
perimeter needs to  
be raised

Note that raising the slab will also require raising the rear perimeter footings that you have recently underpinned, about 1.5". However, there are some downsides: **Additional lift to improve floor levelness 2" or more can cause distress to interior finishes, slab cracks, and distress to partitions, doors, windows, cabinets, masonry veneer, and under-slab utilities. The risk increases where the interior slab or interior bearing elements do not lift uniformly with the perimeter. Lift should be gradual, monitored, and stopped if distress develops. Full cosmetic leveling should not be represented as**

- **Slab and Perimeter Lifting:**
- Raising the slab should be accompanied by perimeter pier adjustment to avoid significant dips at perimeter once slab is leveled.
  - **Raise Perimeter Piers:** The homeowner should contact the foundation repair company who installed the piers, s and instruct them to raise their perimeter piers 1½ inches. The piers should be raised uniformly in increments to minimize damage to the house.
  - **Polyurethane Injection:** Once the perimeter piers are raised, injecting high-density polyurethane beneath the affected slab area is an economical and viable method to achieve interior slab lift and support, provided the subgrade remains stable.
