## M22B INY1

## 19/10/22 MAÑANA

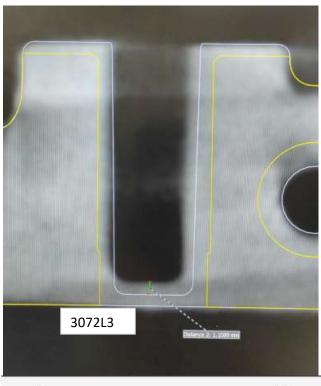
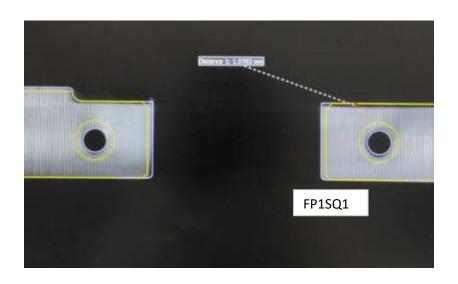
-Tol D	esviación +/-	
1,0000	1,0000	-0,6000	1,4430 🜑 📖	0,4430
	1,0000	1,0000 1,0000	1,0000 1,0000 -0,6000	1,0000 1,0000 -0,6000 1,4430 🛑 🖂 🔠

## NO SE PUEDE CAMBIAR EN MÁQUINA

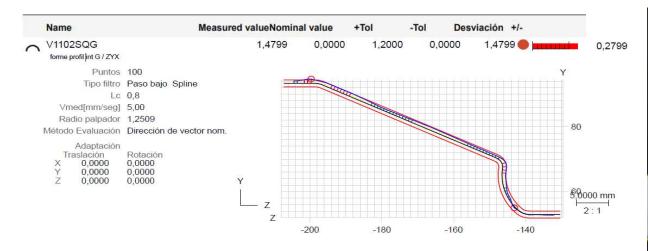
Name	Measured valueNomin	al value	+Tol	-Tol De	esviación +/-	
Δ	FP1SQ1	2,1756	0,0000	1,5000	0,0000	2,1756	0,6756
	forme flanc de palier 1 / ZYX

SOLO SE PUEDE LIMPIAR ALUMINIO

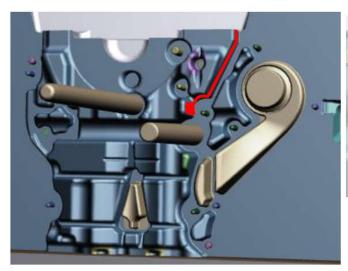
## V1102SQG

Faltas material pieza:

Quitar material con piedra fina
