NO CONFORMIDADES MOLDE 13B

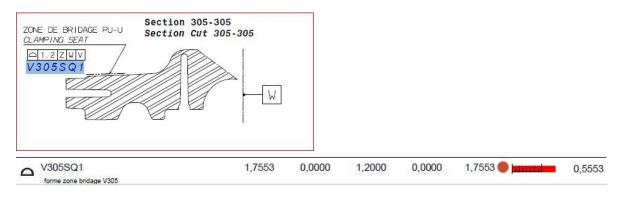
V305SQ1 LIMPIAR ZONA

LIMPIAR ZONA

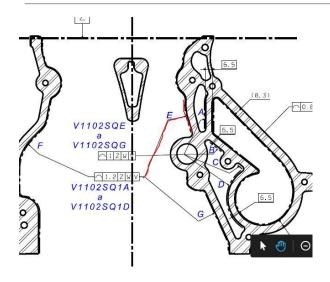
Faltas material pieza:

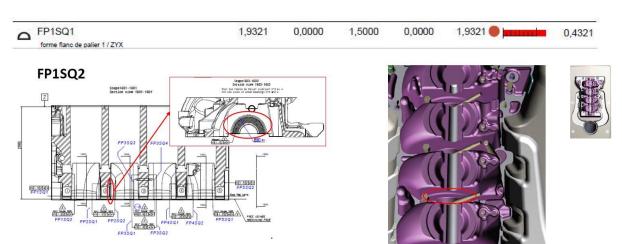
Exceso material pieza:
