# WOOD KILN PROJECT - 2024

## Building the kiln

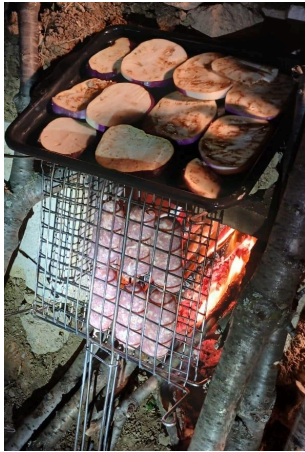
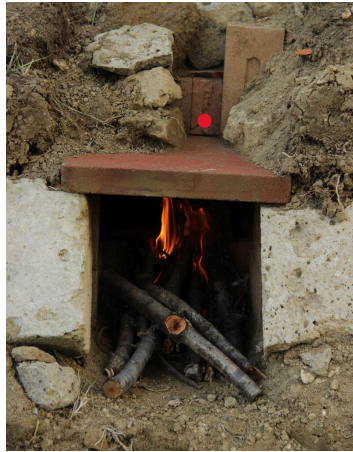
It was regularly necessary to remove ash and embers from the firebox to make more space for the wood and allow more oxygen in (didn't think about that when I - uh, we - were building this thing). This was probably one of the factors that prevented the kiln from reaching the desired temperature (obviously).

Every hour the temperature was measured using a laser thermometer by removing a brick placed on top of the kiln (dumb decision) (red dot in the picture, if you can find it). This was DEFINITELY another factor that affected the temperature.

Divide the firebox into two levels with a grate to make removing ash and charcoal easier and faster.

Improve the thermal insulation, and for the love of God, change the position of the brick used to check the temperature. Not on top of the kiln - the heat rises.

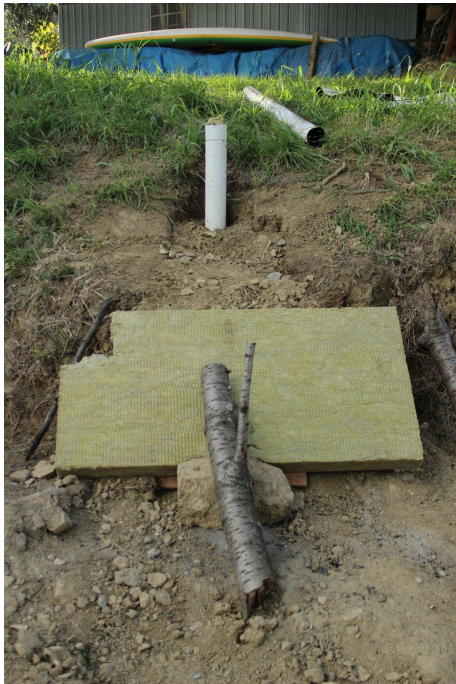
After 12 hours of firing (a nice barbeque and a cup of tea or ten) the kiln entrance was sealed with another refractory slab, on top of which a rock wood panel was then placed to

provide additional insulation. The top of the kiln was also covered with an additional layer of earth. (It looks fucking ugly, I know).

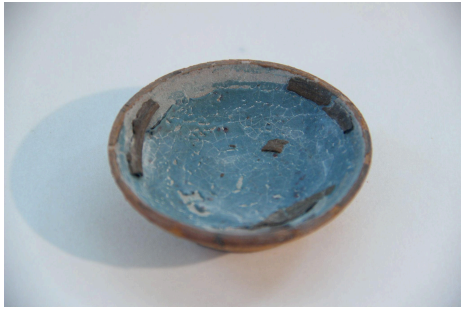
The bronze glaze has the most severe defects: it detached from the ceramic surface and did not vitrify.

The turquoise glaze appears to be the most homogeneous. If the temperature had risen by another 80°C (approximately) it would probably have vitrified and produced a more conventional result.

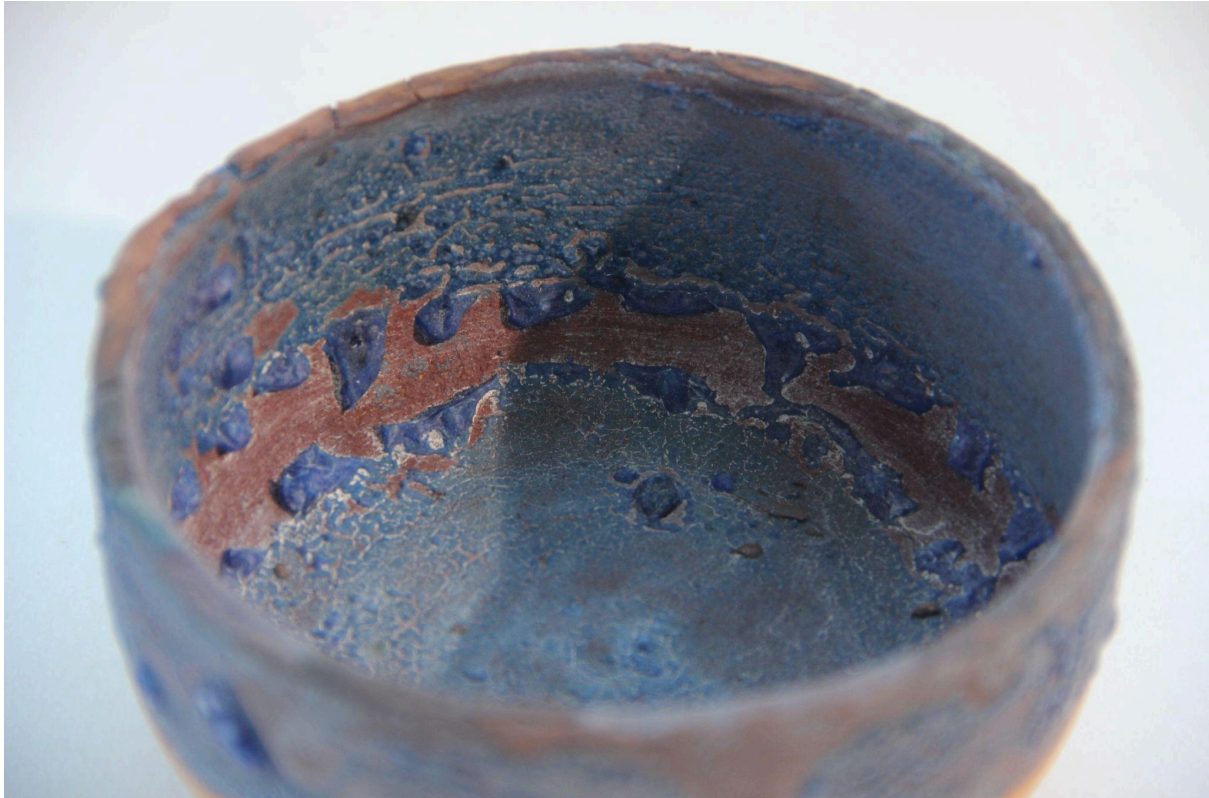
The persian blue transparent glaze (above) formed lumps. In some areas, it also appears to have shrunk and cracked (it's called crawling, as you know, but I was a bit ignorant about this kind of thing at the time), creating a particularly interesting effect.

The clay collected from the river (top right) appears to be pinkish in color. It is excellent for throwing (on a banding wheel for now, I'll try it on a real throwing wheel when I have the opportunity), and fairly plastic (duh). It remains to be seen how it behaves with glazes and at high temperatures. (It melts at 1240°C).
