## WDFW Fish Passage and Diversion Screening Inventory Database

## Level A Culvert Assessment Report

Site ID: **342433**  
Latitude: **46.9528618** Stream: **Spurgeon Cr** WRIA: **13,0037**  
Longitude: **-122.7807236** Tributary To: **Deschutes R** Fish Use Potential: **Yes**

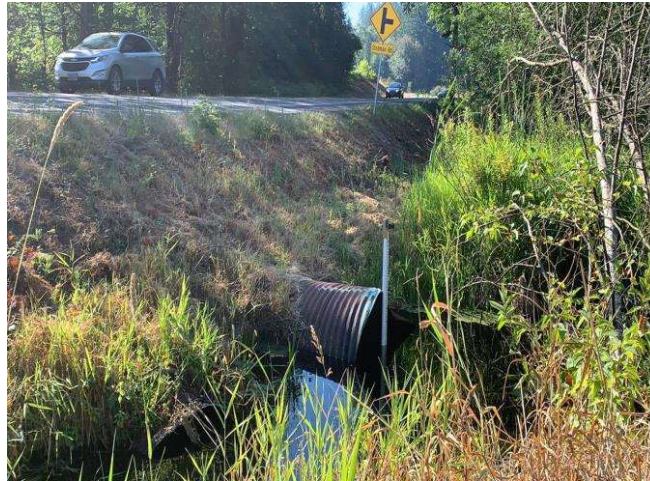
Channelized wetland on both ends of pipe. Unknown juvenile salmonid species observed on DS.
