# Washington Department of Fish and Wildlife

### Site Description Report

Site ID 342433

## Level A Culvert Assessment Report

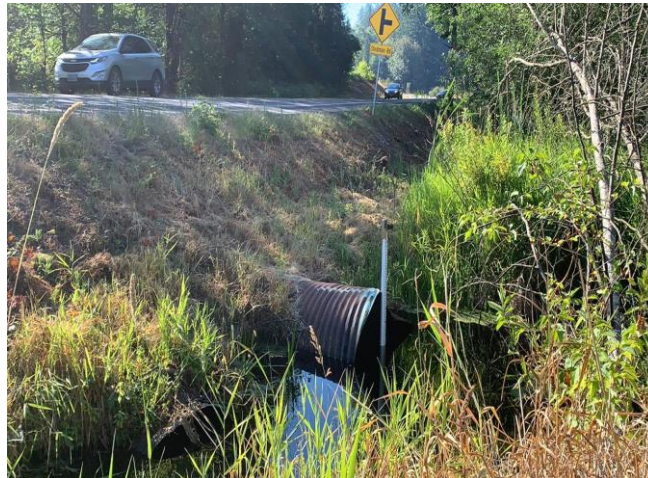
Channelized wetland on both ends of pipe. Unknown juvenile salmonid species observed on DS.
