# MAX3010x Sensor Module Failure Analysis Report

**May 31, 2026**

**Prepared from ESP32/PlatformIO diagnostic testing**

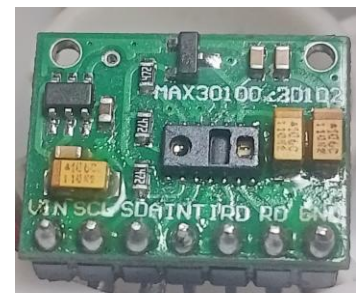
**Figure 1 : Oximeter Sensor Board**

Conclusion: Module is incapable of producing valid pulse-oximetry data.

Sensor Board Marking: MAX30100/MAX30102 compatible module shown aside.

- Red LED not visible.
- IR LED not visible through a smartphone camera.
- Indicates LED driver subsystem never activated.

The module cannot be considered a functional MAX30102/MAX30105 sensor. Although it responds on I2C and exposes a partially working register map, the measurement subsystem fails all functional tests.

1. Counterfeit or clone device with incomplete functionality.
2. Factory-defective module.

Replacement of the module is recommended. Continued debugging is unlikely to yield a working pulse-oximeter because the fundamental optical acquisition hardware is non-operational.
