# Technical Bulletin 2025

| Model : Omoda E5 | Nomor : CSTB-25-005 |
| Perihal : Pemeriksaan Kondisi Selang dan Pipa Minyak Rem Omoda E5 | Informasi : <ul style="list-style-type: none"><li>- Rahasia [v]</li><li>- Informasi Umum [ ]</li><li>- Edukasi Pelanggan [ ]</li></ul> |

| <b>About</b> : Brake Hose and Brake Pipeline Inspection on Omoda E5 | <b>Information</b> : <ul style="list-style-type: none"><li>- Classified [v]</li><li>- General Information [ ]</li><li>- Customer Education [ ]</li></ul> |

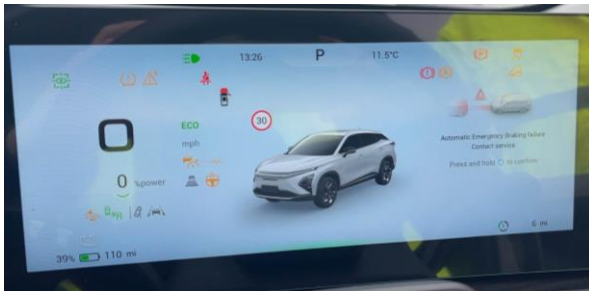
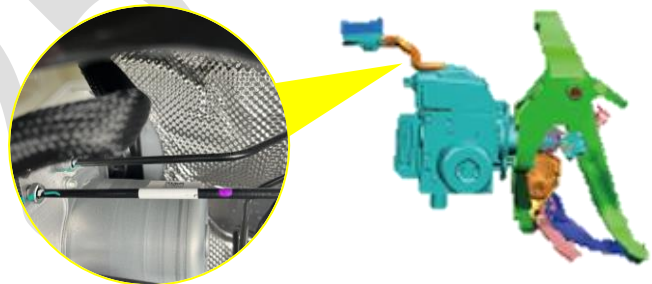
Telah ditemukan beberapa kendaraan Omoda E5 dengan keluhan indikator sistem rem menyala dan daya pengereman berkurang. Berdasarkan pemeriksaan ditemukan pemasangan selang minyak rem yang menghubungkan tangki cadangan dan IPB yang kurang baik, mengakibatkan kekurangan suplai minyak rem ke sistem rem.

Untuk langkah pencegahan dan keselamatan, dealer wajib melakukan pemeriksaan terhadap potensi problem yang sama terjadi pada kendaraan pelanggan dan stok di dealer masing-masing.

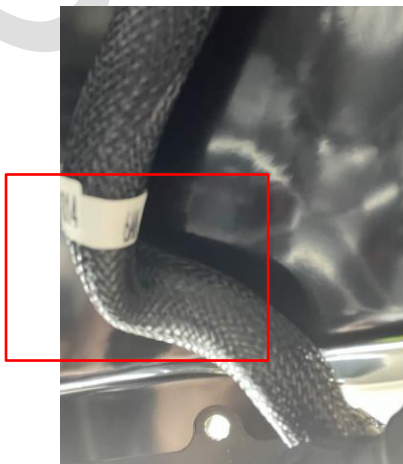
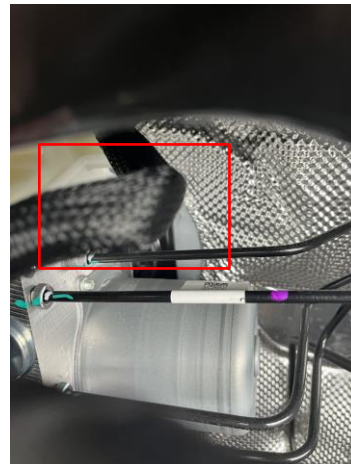
Lakukan pemeriksaan secara visual dengan seksama terhadap jalur selang minyak rem dan pipa-pipa minyak rem. Pastikan semua part terpasang sempurna dan tidak ada yang tertekuk, terpuntir atau terlipat. Bila ditemukan part dengan kondisi kesalahan pemasangan seperti disebutkan di atas, lakukan penggantian part selang minyak rem atau pipa minyak rem yang terkait.

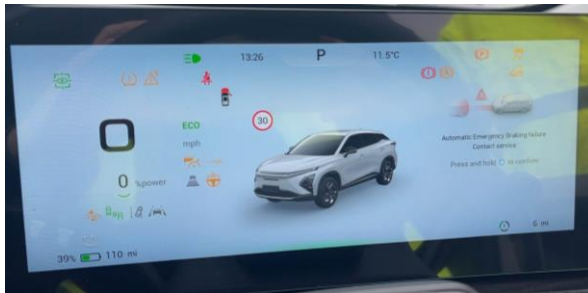
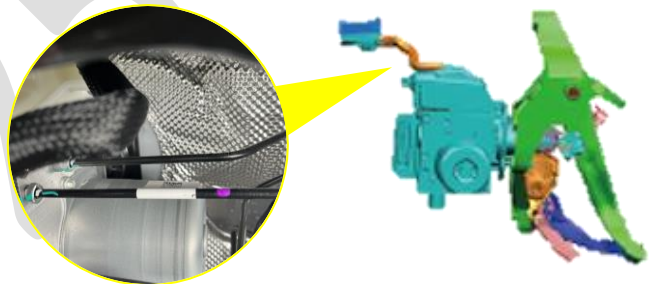
Found already some on some Omoda E5 models complained braking malfunction indicator was lit and decreased braking power. Based on investigation, found the brake fluid hose connecting the reservoir tank and IPB actuator improperly installed, led to lack of brake fluid supply to the brake system.

For further preventive and safety action, the dealers instructed to perform inspection due to persists problem potency in customer's cars and dealer's stock cars.

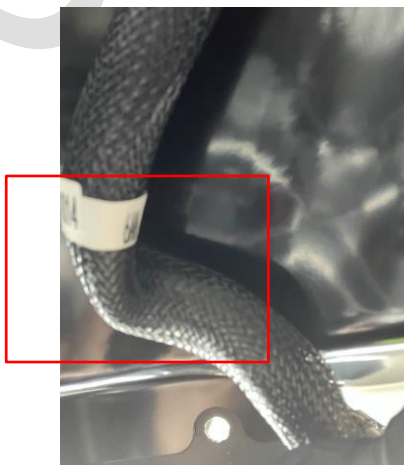
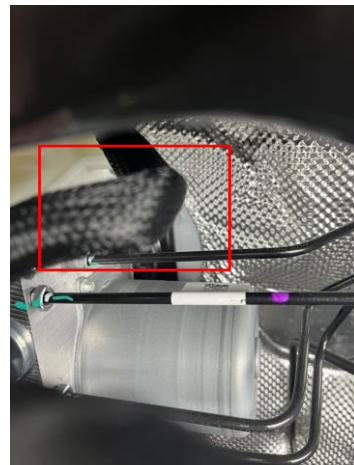
Perform visual inspection to brake fluid hose and brake fluid pipe lines. Make sure all related parts are installed properly and there's no kinked, twisted or folded. If there is failure installation conditions as described before, please replace related brake fluid hose or brake pipeline.
