- CBCT/CT 503 QA Test -

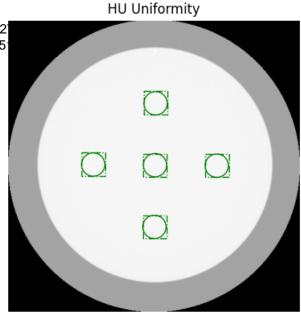
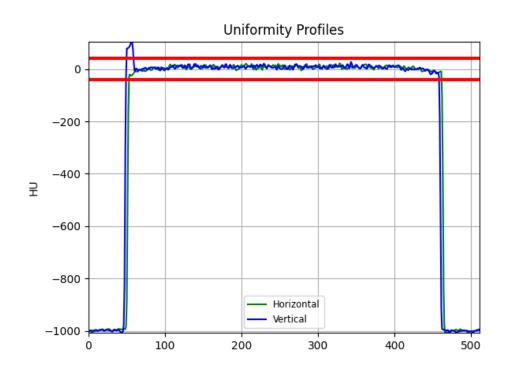
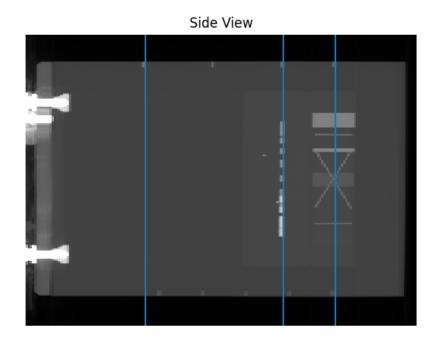
- CTP486 Results -Uniformity tolerance: 40

Uniformity ROIs: Top: 9.0, Right: 8.0, Bottom: 8.0, Left: 9.0, Center: 10.0

Uniformity index: -0.198 Integral non-uniformity: 0.0010 Uniformity Passed?: True

Max Noise Power frequency: 0.1034482 Average Noise Power: 0.200900453785
