# SOLAR UNDER STORM

SELECT BEST PRACTICES FOR RESILIENT GROUND-MOUNT  
PV SYSTEMS WITH HURRICANE EXPOSURE

BY CHRISTOPHER BURGESS AND JOSEPH GOODMAN

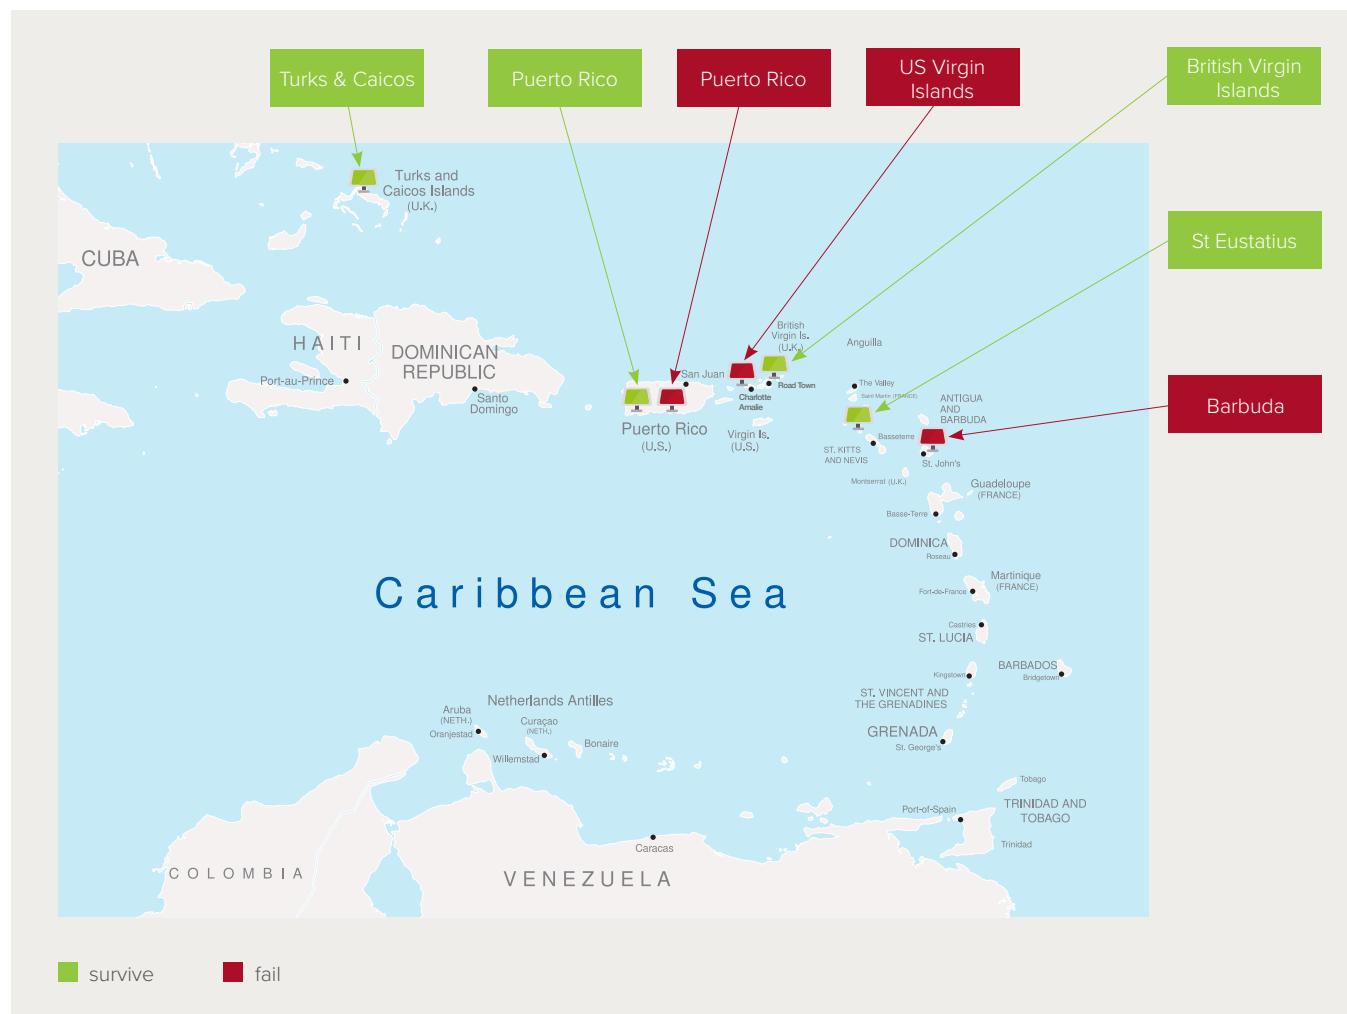
**FIGURE 1**

Despite the record sustained wind speeds of over 180 miles per hour, many solar PV systems in the Caribbean survived. Some solar installations in the British Virgin Islands, Turks and Caicos, Puerto Rico, and St. Eustatius faced tremendous wind yet continued producing power the following day.

In contrast, some PV systems in Puerto Rico, the US Virgin Islands, and Barbuda suffered major damage or complete failure with airborne solar modules, broken equipment, and twisted metal racking.<sup>3</sup>

SURVIVORSHIP AND FAILURE OF GROUND-MOUNT SOLAR PV DURING HURRICANE SEASON 2017

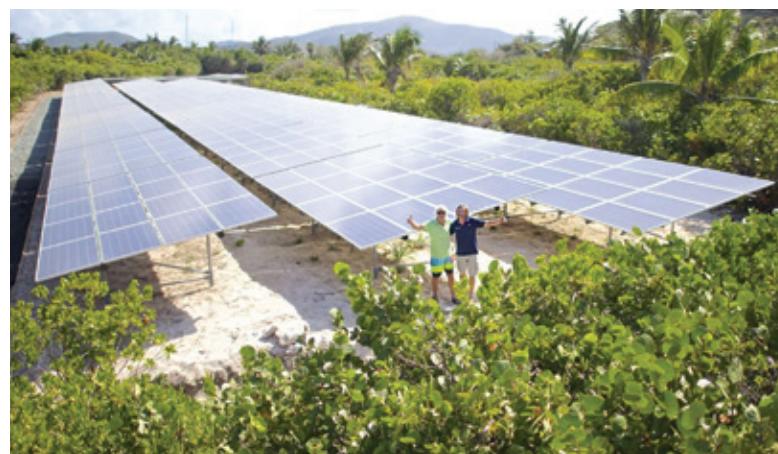
Necker Island, British Virgin Islands, took a direct hit from Hurricane Irma on September 7, 2017. This 800 kW ground-mount solar PV system survived and powered on the next morning.

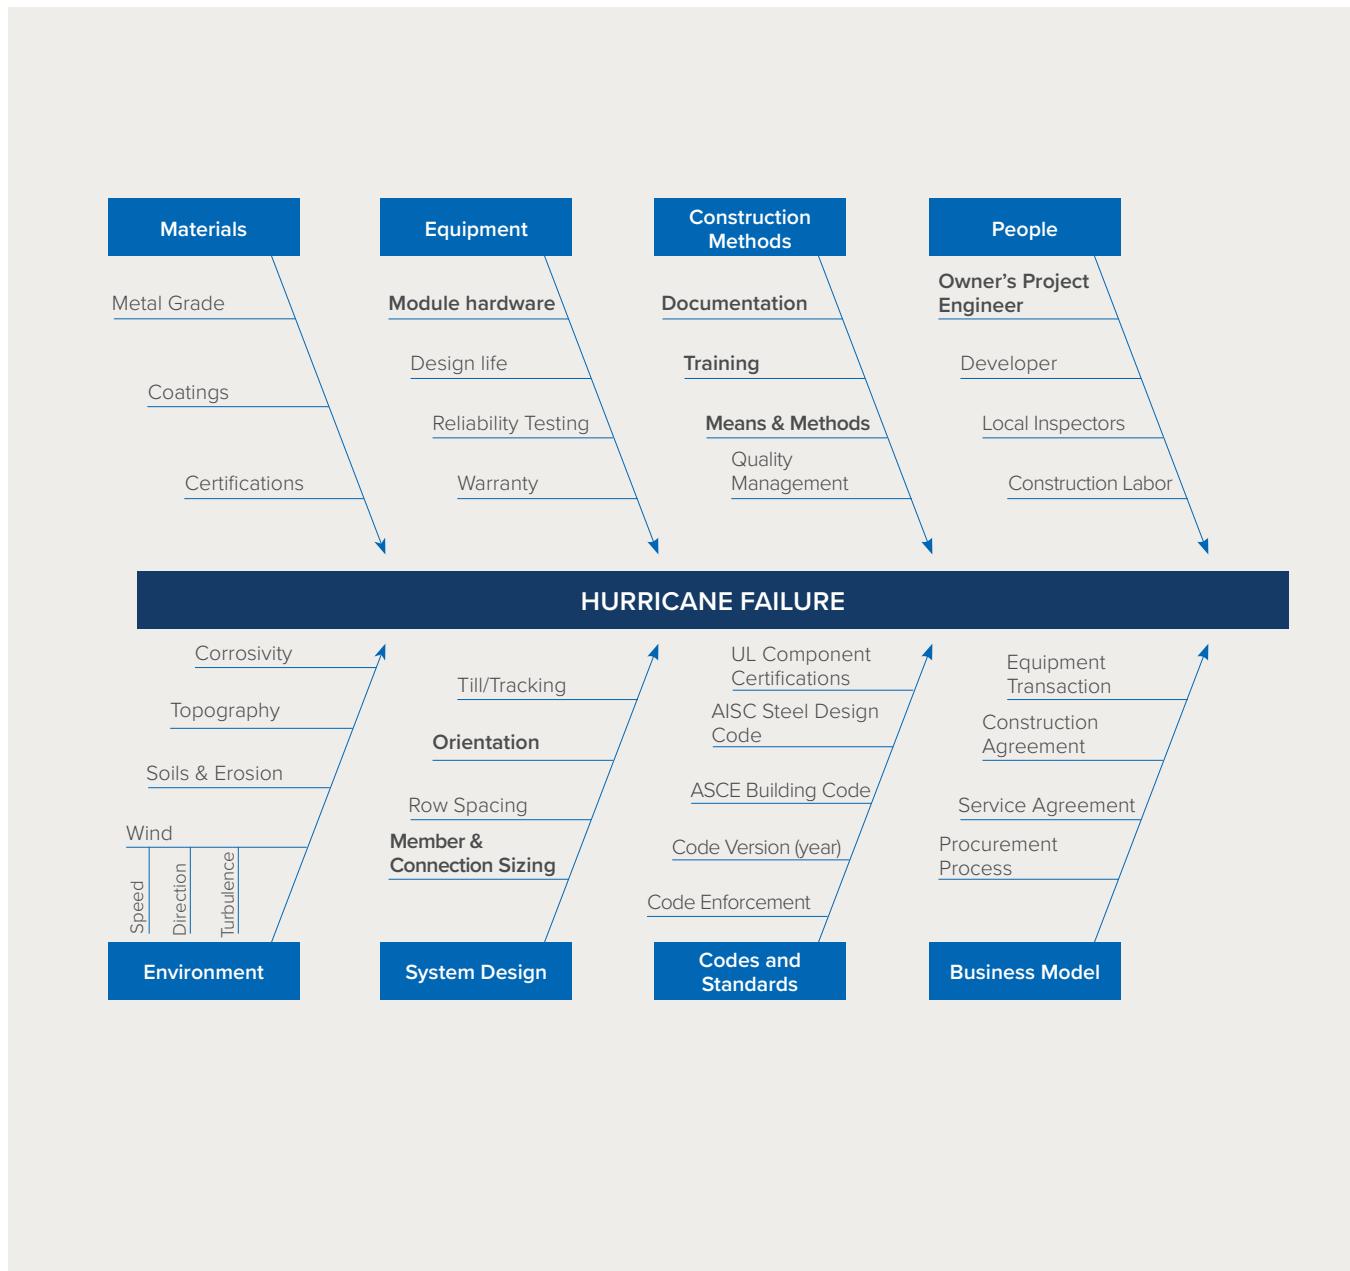
**FIGURE 2**

Figure 2 illustrates a common reliability tool for systematic cause and effect identification called a fishbone diagram. The diagram shows the supply chain responsible for design, manufacturing, procurement, delivery, installation, and operations of a solar power plant, along with the operational use case. The most urgent causes of failure are in bold text.

FISHBONE DIAGRAM FOR ROOT CAUSE ANALYSIS IDENTIFICATION

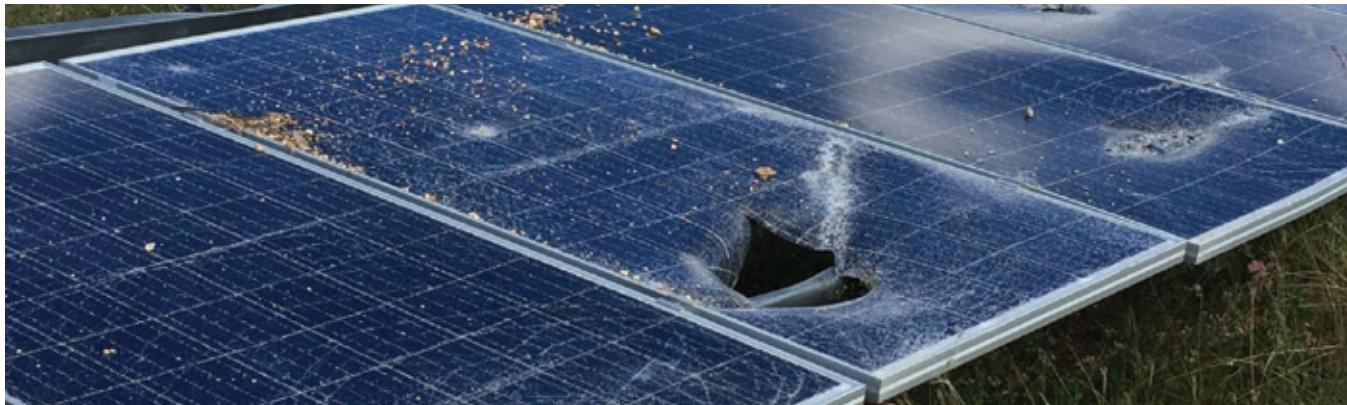
**TABLE 1**

PV MODULE FRAME AND LAMINATE

#	FAILURE MODE(S)	CURRENT MITIGATION	LIMITATIONS	POTENTIAL MITIGATION ACTION	COST/IMPACT
1a	Laminate tear-out (module glass dislodged from frame)	UL 1703 static load (global PV module testing standard)	Local pressure may exceed module rated pressure	Review racking system/full structural system wind tunnel test report for local wind pressure and compare against module front and back rated pressure. Refer to example in Appendix A. Racking suppliers furnish these wind tunnel test reports upon request. Results of the test will determine the proper rating for modules (which will differ across the design of the array).	Low/Medium
1b	Frame bolt hole failure	Engineering connection calculations	Module back side (uplift force) rating may not be adequate for local loads	Specify engineer calculations for module connection hardware, including frame where used.  Collaborate with module manufacturers to improve supply chain.  Engineer of record for the project should request and approve engineering connection calculations.	Low/High

1c	Laminate impact damage	UL 1703 hail impact tests and ASCE wind-prone debris. Some severe hail-damaged modules are available	Hurricane debris can be large compared to hail	Specify that site prep and clean-up shall include removal or securement of all foreign objects (debris).	Low/High

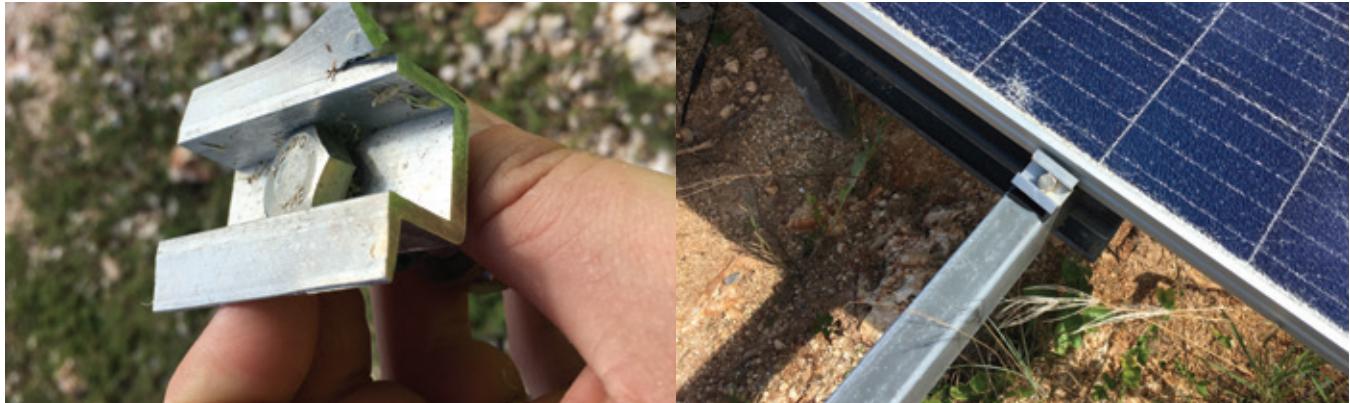
**TABLE 2**

PV MODULE CONNECTION HARDWARE

#	FAILURE MODE(S)	CURRENT MITIGATION	LIMITATIONS	POTENTIAL MITIGATION ACTION	COST/IMPACT
2a	Bolt self-loosening	Partial torque check and proper documentation of the torque checks	Self-loosening common due to washer-clamping surface translation during vibration	Specify bolt locking solution appropriate for the environment and workforce. (Nyloc nuts have been anecdotally reported to provide mitigation even when not torqued properly.)	Low/High
2b	Connection hardware failure (fracture, rupture, tear out, shear)	SE hand calculations are typical	Hand calculations not always updated with site-specific wind load and topography	Specify SE site-specific review of module attachment hardware per AISC or equivalent.	Low/High
2c	Cascading failure of T clamps	Module T clamps designed for symmetric boundary conditions	Module T clamps rotate with loss of one module and allow liberation of second module	Specify module frames to be through bolted in accordance with manufacturing specification for the design wind speed. If necessary, use top clamps that do not allow cascading failure.	Low/High

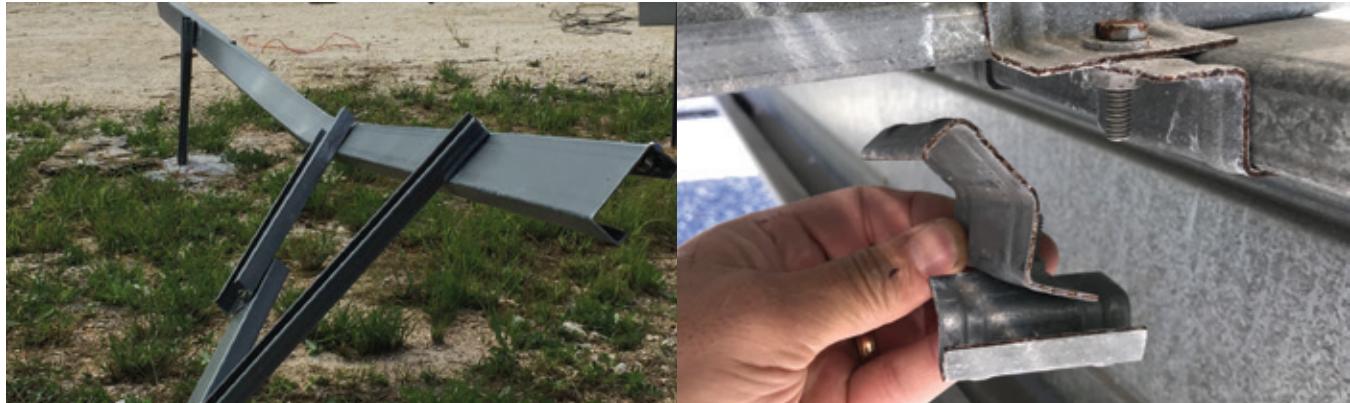
**TABLE 3**

## STRUCTURAL RACKING MEMBER

#	FAILURE MODE(S)	CURRENT MITIGATION	LIMITATIONS	POTENTIAL MITIGATION ACTION	COST/IMPACT
3a	Member global failure (plastic deflection, buckling, torsion)	Steel code (AISC or equivalent) check with software package (RISA 3D or equiv.) and updated according to site-specific ASCE 7 loads	ASCE 7 prioritizes normal loads due to buildings focus. Lateral loads on eBoS commonly omitted	<ul style="list-style-type: none"> <li>1. Utilize owner's project engineer to review calculation package.</li> <li>2. Specify racking design for the wind speed recommended by ASCE 7-16.</li> <li>3. Specify SE review of lateral loads due to racking and eBoS hardware.</li> <li>4. Specify racking with documentation of full scale load test.</li> <li>5. Specify any tracker included in the project shall be designed for worst case wind exposure, no stow position for extreme wind allowed.</li> </ul>	1. Low/Medium 2. Med/High 3. Low/High 4. Low/Medium 5. Medium (Tracking only)

3b	Dynamic excitation	Building code requires dynamic load amplification for structures with resonant frequency <1 Hz>	PV arrays with inter-row spacing experience modified airflow more conducive to dynamic excitation	SE project engineer should check dynamic loading if resonant frequency is <5 Hz (Cain and Banks, 2015).	
3c	Tracker torque tube torsion	Trackers designed for wind load experienced in "stow" mode	Stow mode is not a fail safe control. Extreme wind may occur outside of stow	If tracker must be used within Category 4–5 wind zones, solicit third-party review of tracker design by firm experienced in designing for dynamic wind loading. Tracker design is quickly evolving in regard to dynamic wind response, so this will keep recommendations most up to date.	High/Medium

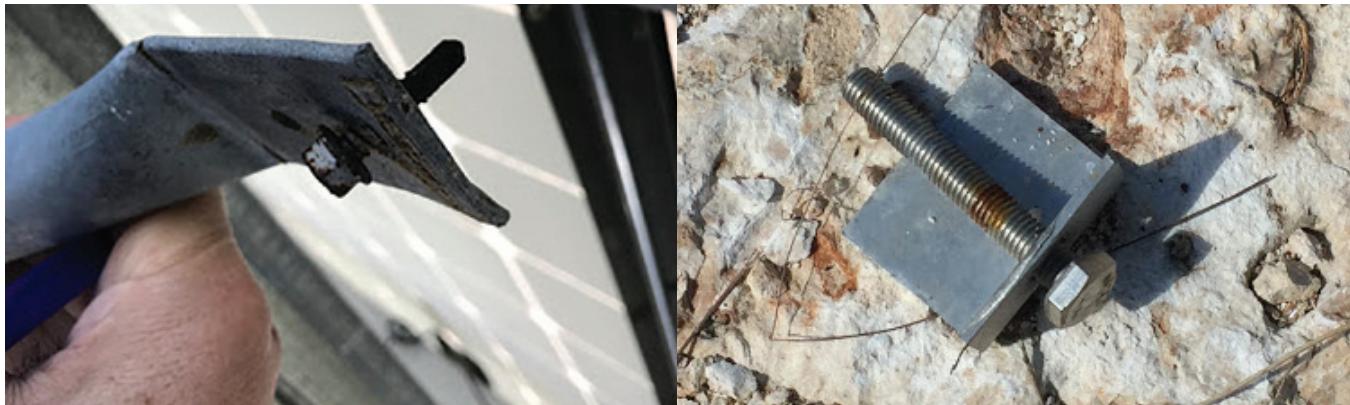
**TABLE 4**  
STRUCTURAL RACKING CONNECTIONS

#	FAILURE MODE(S)	CURRENT MITIGATION	LIMITATIONS	POTENTIAL MITIGATION ACTION	COST/IMPACT
4a	Bearing bolt shear	AISC check with hand calculations typical	Hand calculations not always updated with site-specific wind loads	Specify structural engineer to complete site-specific connection review	Low/High
4b	Bolt self-loosening	Partial torque check and documentation typical	Self-loosening common due to washer-clamping surface translation during vibration	Specify bolt-locking solution appropriate for the environment and workforce. <sup>6</sup>	Low/High
4c	Self-tapping screw corrosion and shear failure	Steel code	Sizing does not always account for highly corrosive environment	Either specify no self-tapping screws or specify self-tapping screws to be sized based on 25 years and for expected vibrations.	Low/High

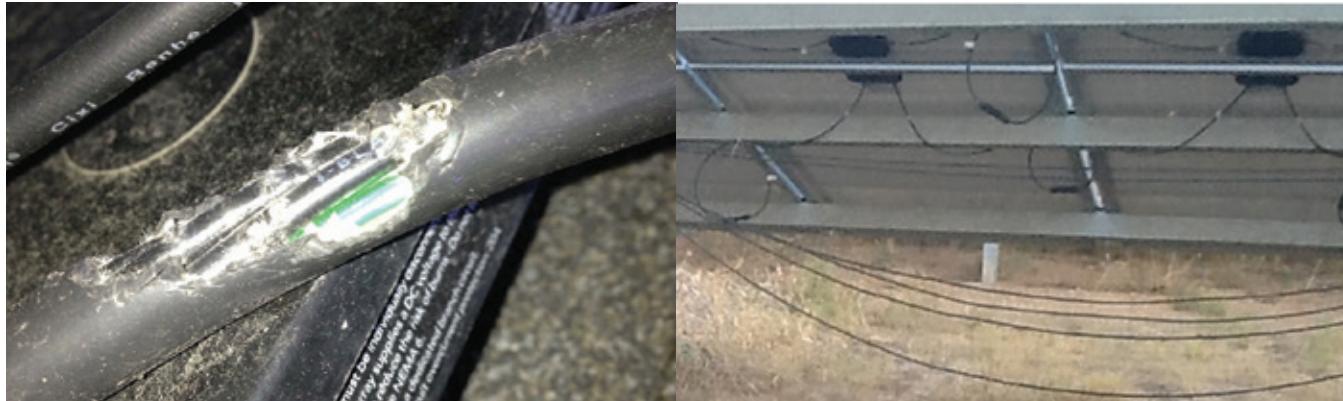
**TABLE 6**

ELECTRICAL BALANCE OF SYSTEMS

#	FAILURE MODE(S)	CURRENT MITIGATION	LIMITATIONS	POTENTIAL MITIGATION ACTION	COST/IMPACT
6a	Wire pull out or terminal damage	UL specification for each electrical component (e.g., UL 1703 PV modules)	Terminal torque values unchecked in field	Specify QA/QC procedure and documentation for terminal torques.	Low/Low
6b	Wire sheath chafing (ground fault)	NEC or IEC conductor management and support specifications	Wires sag and subject to gyration based on field installation	Specify wire management practices, including support schedule and sag tolerance.  Specify stainless-steel or heavily galvanized wire clips or PVC coated stainless-steel cable clamps instead of plastic zip ties.	Low/Low
6c	Wire management fracture	NEC or IEC	Direct and reflected UV exposure increases risk of embitterment and fracture	Specify UV-resistant and corrosion-resistant wire management solution.  Require plan set to incorporate wire management technique for review against NEC or IEC.  Specification of conduit in lieu of open-air wire management may be appropriate in some locations.	Low/Low

6d	Rain intrusion into combiner boxes or inverters	NEC - NEMA specification	Hurricane wind blowing sideways can penetrate NEMA 3	Specify NEMA 4X to 6P enclosures based on engineering review. IEC equivalent is IP56 to IP67.	Medium/High

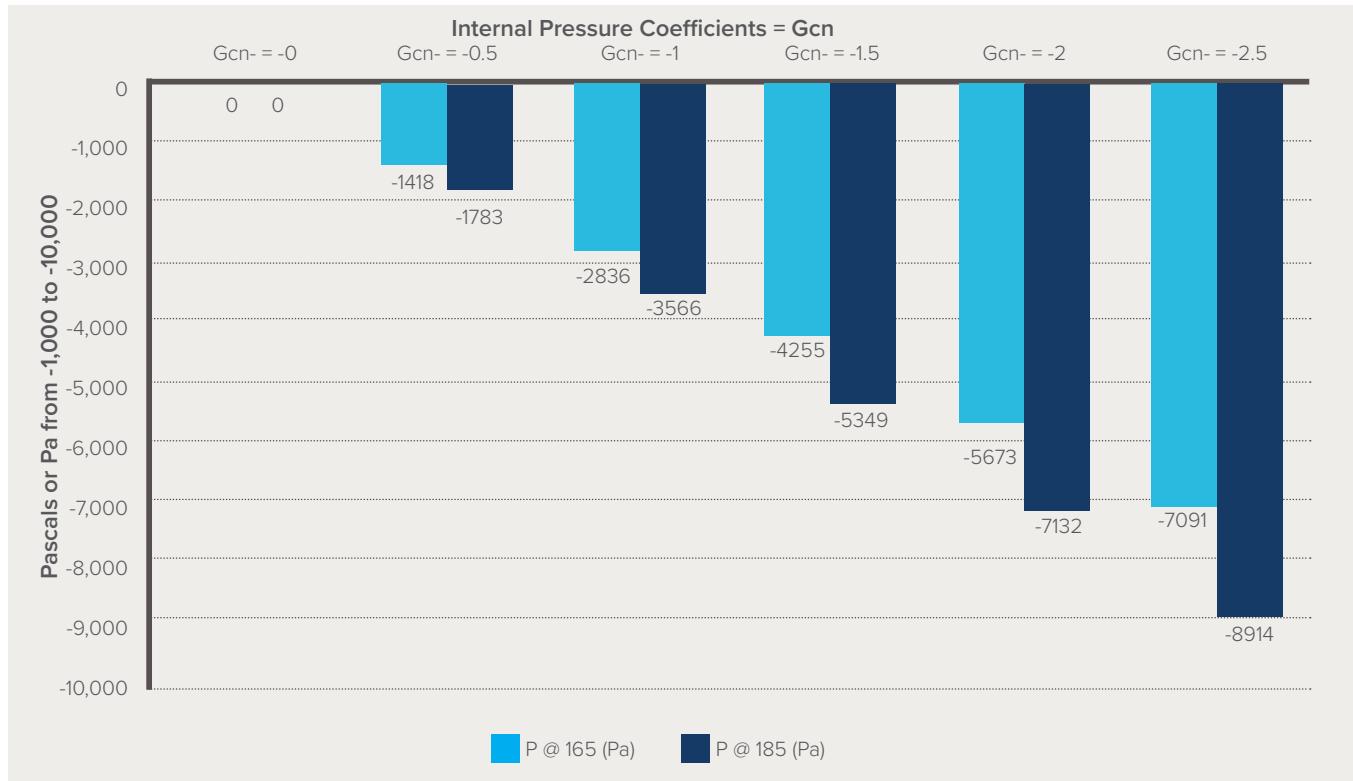
**FIGURE 3**

Project stakeholders should be able to review structural calculation to determine a design wind pressure for each component or member of interest. Figure 3 illustrates a set of wind pressures for design wind speeds of 165 and 185 mph for pressure coefficients from 0 to 2.5. In this example, a pressure coefficient of 0.5 corresponds to design pressures less than 2,000 Pa (Pascals, 49 Pa = 1 PSF). In contrast, a pressure coefficient of 2.5 corresponds to design pressures in excess of 7,000 Pa. Given the potential variability, **one can not assume that a high load rating module is either necessary or adequate.**

SAMPLE EXTREME WIND UPLIFT PRESSURE ON MODULE SURFACE

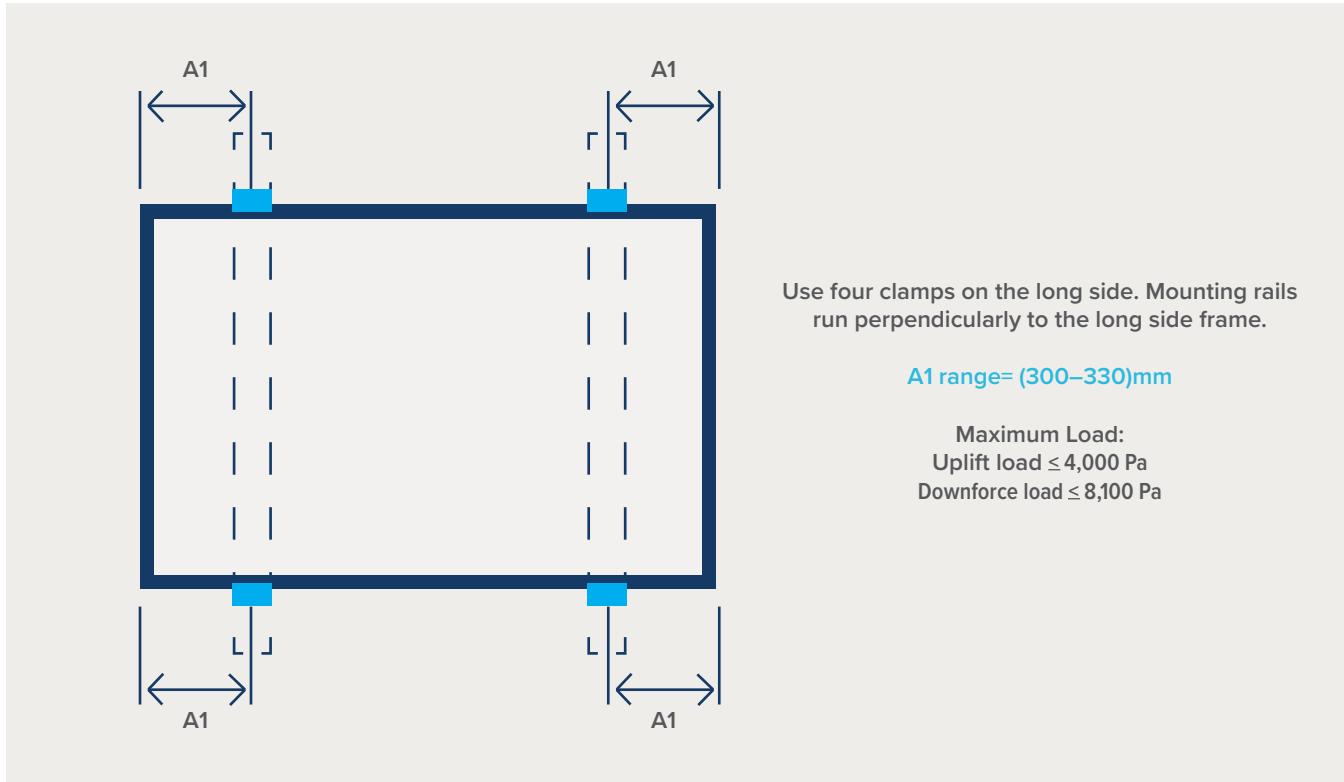
**FIGURE 4**

Project stakeholders should be able to review product specifications or engineering sets for all structural components, members, and connectors, including PV modules. Figure 4 illustrates the specification from a module that has one of the highest structural capacities known to the authors. Key information in this specification includes the range of allowable support conditions (A1) along with the specific AND unique uplift load.

PV MODULE MOUNTING SPECIFICATION
