**RED-POWER ELECTRICAL ENGINEERING PTE LTD**

NEE SOON TOWN COUNCIL

NEE SOON LINK DIVISION

**MONTHLY HOSEREEL SYSTEM CHECKLIST REPORT**

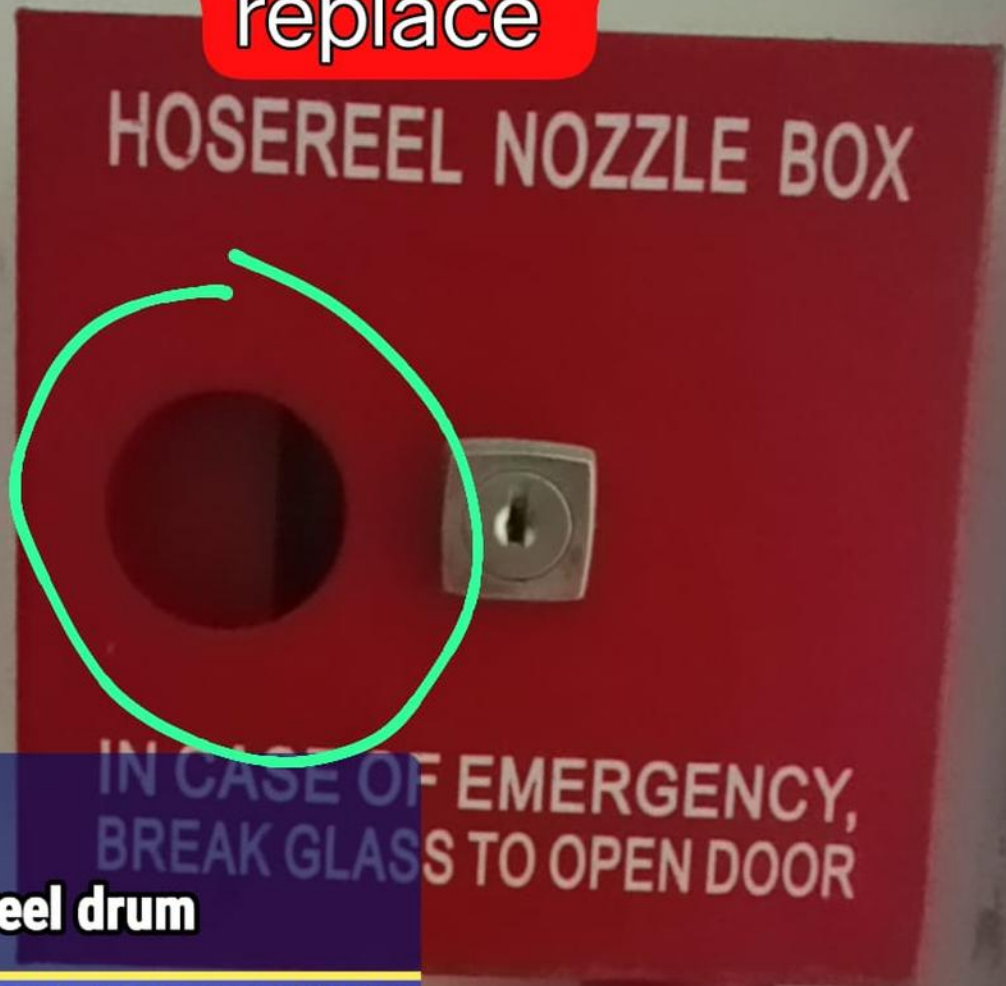
Blk 471B #1 1-2  
Nozzle Box Glass  
Broken need to  
replace

- Work Content: glass missing & broken
- Forest Spring @ Yishun,  
471B Yishun Street 42,  
761471

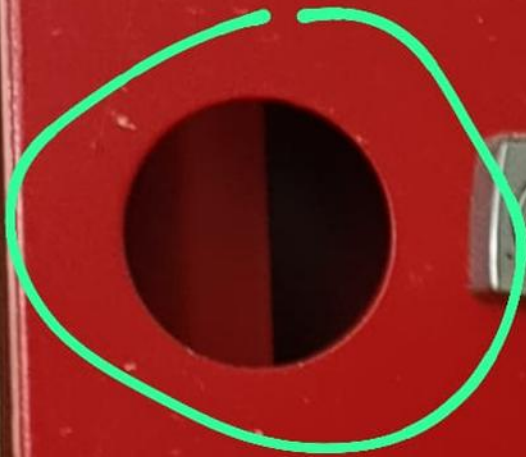
Blk 472B #1 Nozzle  
Box Glass Broken  
need to replace

- Work Content: glass missing & broken
- Forest Spring @ Yishun, 472B Yishun Street 42, 762472

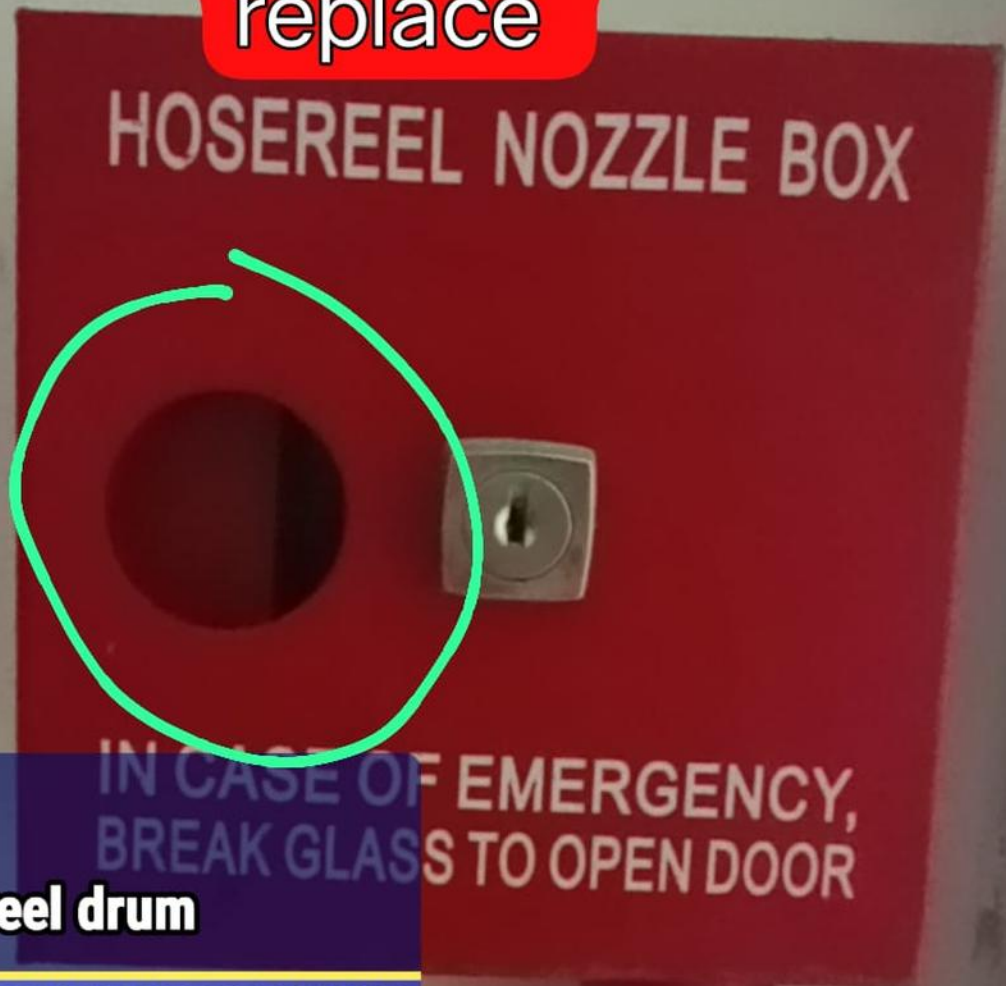
Blk 471B #1 1-2  
Nozzle Box Glass  
Broken need to  
replace

- Work Content: glass missing & broken
- Forest Spring @ Yishun,  
471B Yishun Street 42,  
761471
