**RED-POWER ELECTRICAL ENGINEERING PTE LTD**

NEE SOON TOWN COUNCIL

NEE SOON LINK DIVISION

**MONTHLY HOSEREEL SYSTEM CHECKLIST REPORT**

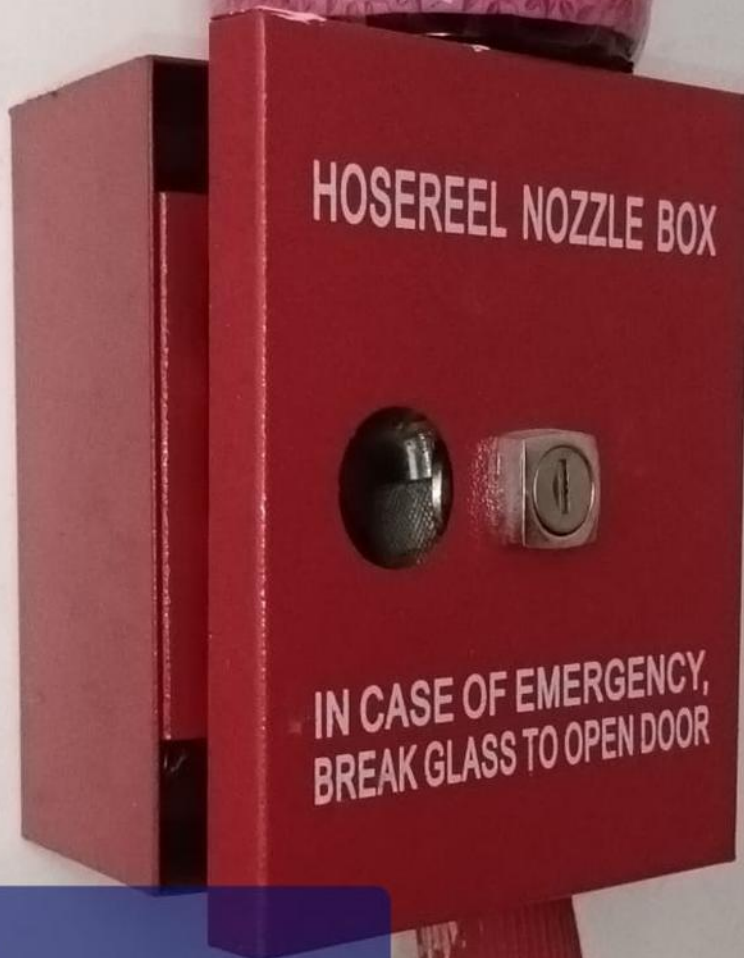
**Blk 478 MSCP level- 1**  
**glass broken**

- Valley Spring @ Yishun, 478  
Yishun Street 42, 760478
- Missing and broken glass

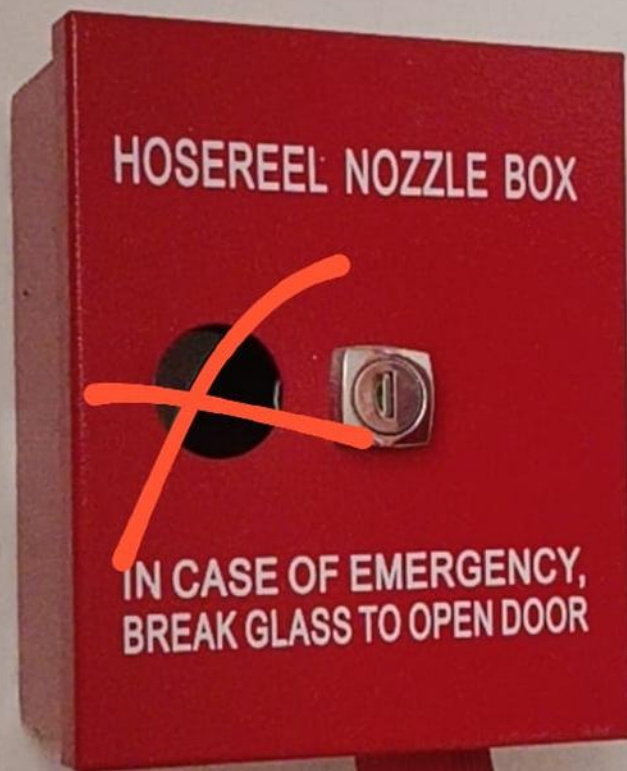
**Blk 478A level- 13 glass  
broken**

- 478A Yishun Street 44
- Missing and broken glass

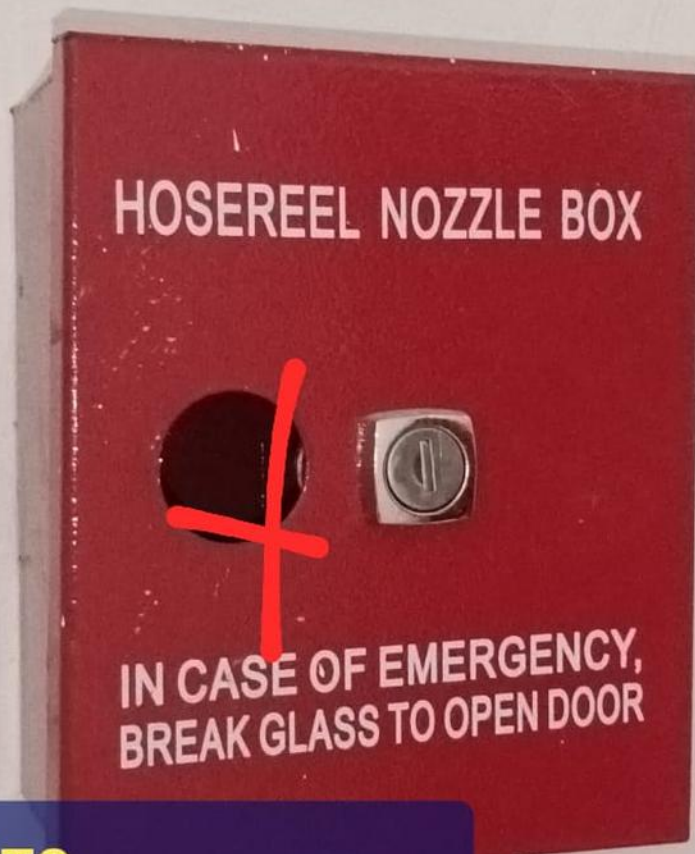
**Blk 478B level- 1 glass  
broken**

- 478B Yishun Street 44
- Missing and broken glass

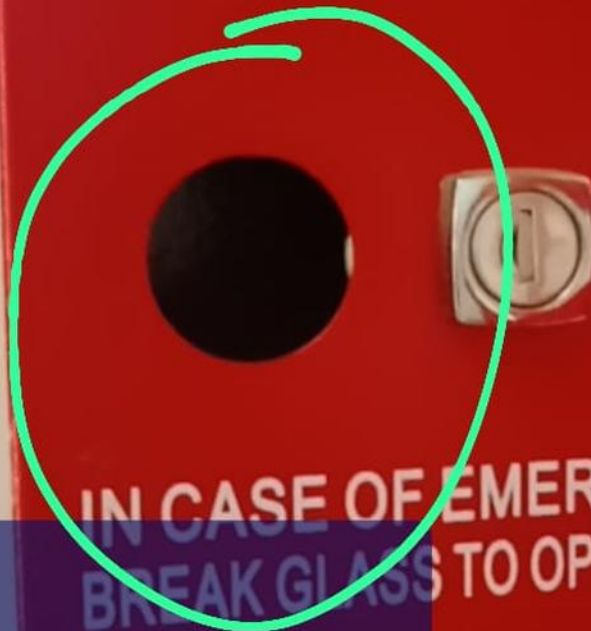
BIK 478B #3 1-2  
Nozzle Box Glass  
Broken need to  
replace

- Work Content: glass missing & broken
- Valley Spring @ Yishun, 478B  
Yishun Street 44, 762478

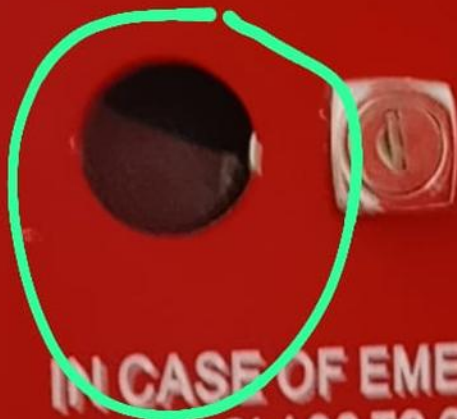
Blk 478B #14 1-2  
Nozzle Box Glass  
Broken need to  
replace

- Work Content: glass missing & broken
- Valley Spring @ Yishun, 478B  
Yishun Street 44, 762478

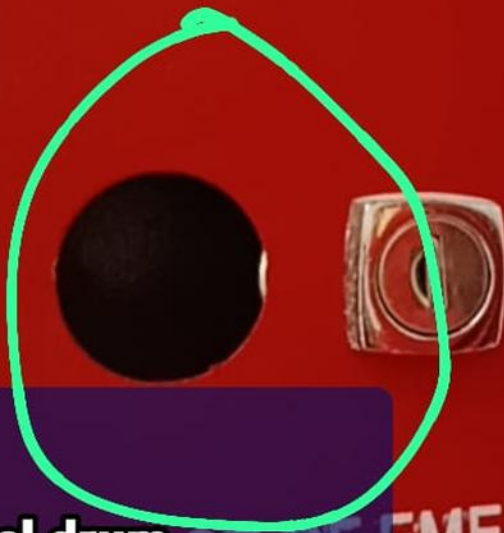
Blk 478B #12 1-2  
Nozzle Box Glass  
Broken need to  
replace

- Work Content: glass missing & broken
- Valley Spring @ Yishun, 478B  
Yishun Street 44, 762478
