WASHINGTON METROPOLITAN AREA TRANSIT AUTHORITY

CARMEN TURNER FACILITY HOMT REHABILITATION GUIDE

NEW FLYER 2015-2016

XCELSIOR DIESEL-ELECTRIC 40 FT. TRANSIT BUS

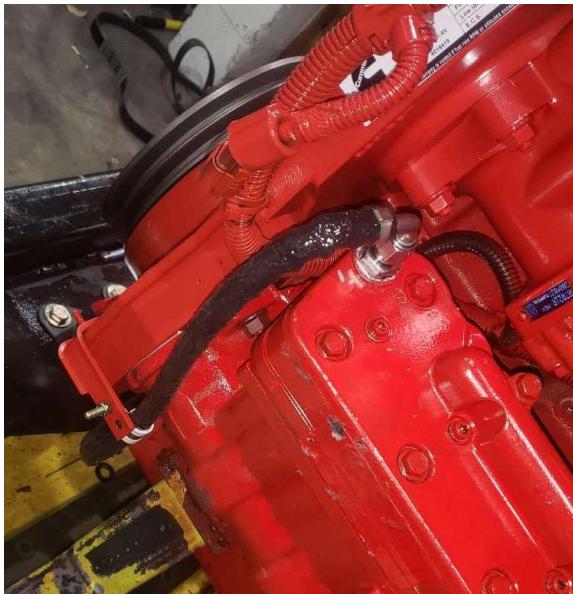
Figure 1: Example of Bonaco Hose Installed

This EMI is designed to improve the reliability of the Cummins air compressor outlet coolant tube by reducing hose failures. This EMI details the replacement of the original problematic air compressor tube.

WMATA's New Flyer Xcelsior fleets 56 and 57 were manufactured with Cummins ISL9 (CM2350 L101) Engines, which came with air compressor coolant hoses that are prone to failure.

Bus Fleet Engineering investigated these failures and found that the OEM hard plastic lines become brittle over time and rupture, leading to service interruptions. Bonaco, an industrial hose manufacturer, has developed a stainless steel braided hose assembly with a PTFE (Teflon) core tube and an additional heat shield cover. This upgraded hose assembly was tested and evaluated on 5 WMATA buses under TCN #23-PT-01-00 with no failures or issues recorded during the 1-year test. The work instructions below are applicable to the rehab process only.

7.10 The 90 degree hose end will have a gentle sweeping bend to the inside of the bracket. Do not pull the hose tight (Figure 1).

7.13 The hose should have a gentle curve underneath, between the engine oil pan and frame rail (Figure 1, 2). The hose can not rub on the frame, oil pan, or other components.
