ENGINEERING MODIFICATION INSTRUCTION - BUS

**BENDIX PP-1 VALVE BUTTON INSPECTION
AND REPLACEMENT**

**BENG ENGINEERING - BUS
WMATA EMI NO. 50L23
Sheet 1 of 4**

ALL BUS FLEETS

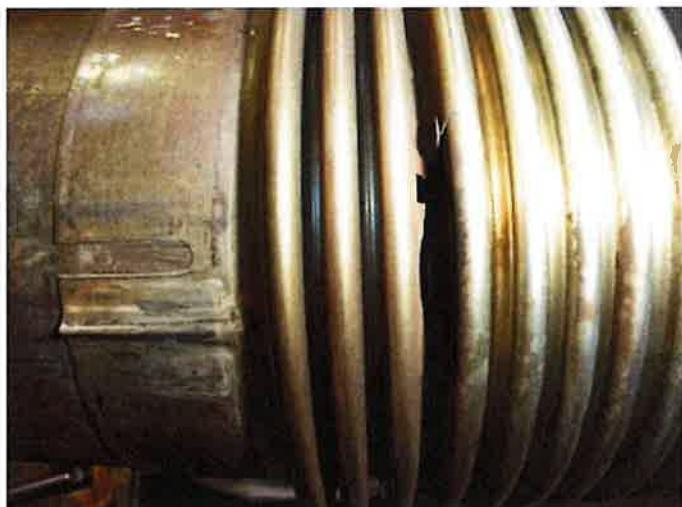
Fig.1: Failed Flex Connector

1. Turn the main battery disconnect switch to the "OFF" position.
2. Open the rear engine access door.
3. Remove belt guard.
4. Inspect exhaust tubes installation for proper alignment specification. Refer to Appendix A.
5. Inspect Vibrant flex connector P/N 089572 for visible crack or signs of failure. See Fig. 1 below for common flex connector failure.

7. Reinstall hybrid exhaust tube using new seal clamp 5" P/N 053791. Leave clamp loose enough to be able to manipulate pieces into proper position.
8. Line-up the exhaust tubes making sure that the centerlines of the exhaust elbow and hybrid exhaust tube are aligned. This will ensure that the new flex connector can be installed without twisting or stretching it beyond its' limits.
9. Install a new Vibrant Exhaust Bellow P/N 089572 using new seal clamp 4" P/N 089572. Leave clamp loose enough to be able to manipulate the flex connector into proper position.
☞ **NOTE: Make sure the flex connector is not stretched or compressed when attached to the exhaust pipes.**

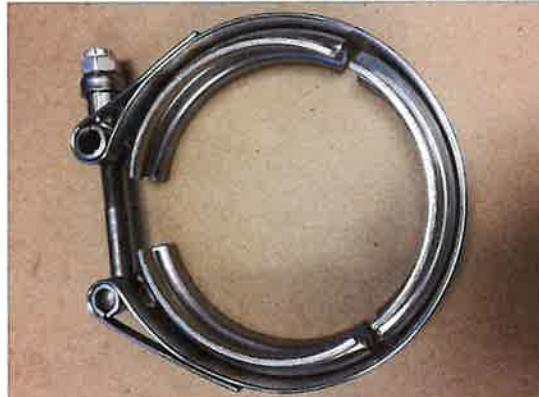
Figure 1 Vibrant Power Inc. V-Band Exhaust Clamp

Bus Maintenance continues to experience a high number of reported service interruptions for fumes in the bus. The top cause of these service interruptions has been exhaust leaks, particularly on the New Flyer LFAs and Xcelsior fleets. These buses use several sizes of V-band exhaust clamps manufactured by Vibrant Power Inc. (see figure 1). When servicing systems with these types of clamps it is imperative to note the following:

1. Used clamps should never be reinstalled. These clamps are single use only and should be discarded after removal and replaced with a new clamp.
2. The lock nut should be torqued to 75 in-lbs. Under or over torqueing can lead to a poor seal and allow exhaust fumes to escape.

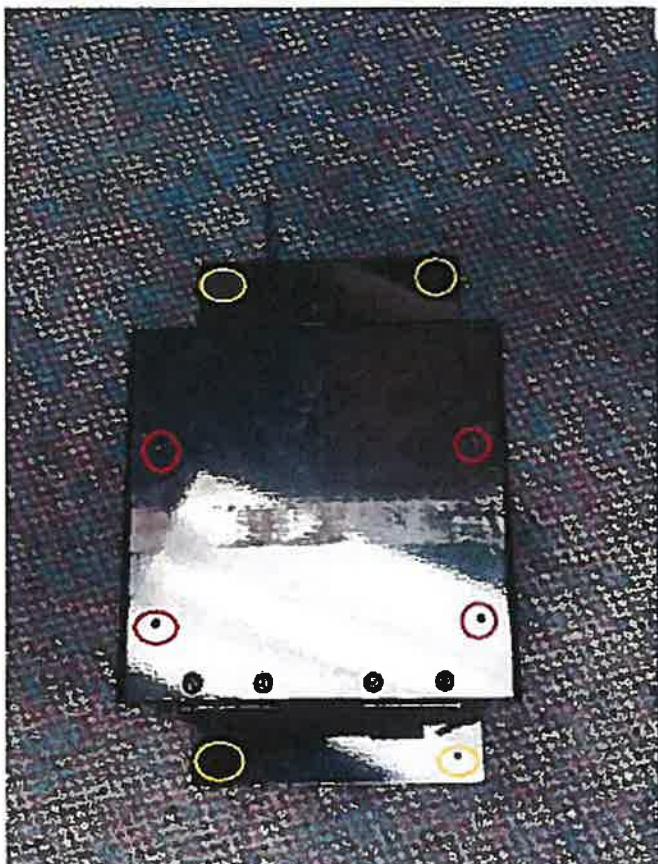
Figure 1 Mounting Hardware Locations
BENG 3/2/2022 rev 00

Several back up battery enclosures for the camera systems were found with loose/missing mounting hardware and/or broken welds. This allowed the battery back-up unit to move around in the SDS box (electrical enclosure behind the driver's seat) causing damage to electrical cables and components. All of these units should be checked immediately to ensure that all mounting hardware is present and secure (see red and yellow circles in figure 1). The welds should also be examined for signs of cracking (see figure 2). The unit in question is a black metal enclosure located on the top tray of the equipment rack in the SDS box. For proper mounting configuration see figures 3 and 4 below. During the inspection, the screws that hold the battery enclosure to the SDS equipment tray (see item 21 in Figure 3) should be removed, have a light coating of blue Loctite applied to the threads, and then be reinstalled. Additional information can be located in the fleet-specific New Flyer Parts Manual in Section 9 Tray Assembly – Video Surveillance. Any loose/missing hardware should be tightened or replaced immediately. If any welds on the enclosure are broken, a CCTV service request should be submitted immediately per SOP 1.27 Bus Camera CCTV Surveillance System Maintenance Program. A check off sheet noting which buses were found to have missing/ damaged hardware or broken welds should be submitted to Steve West (SWest@wmata.com) as soon as possible.

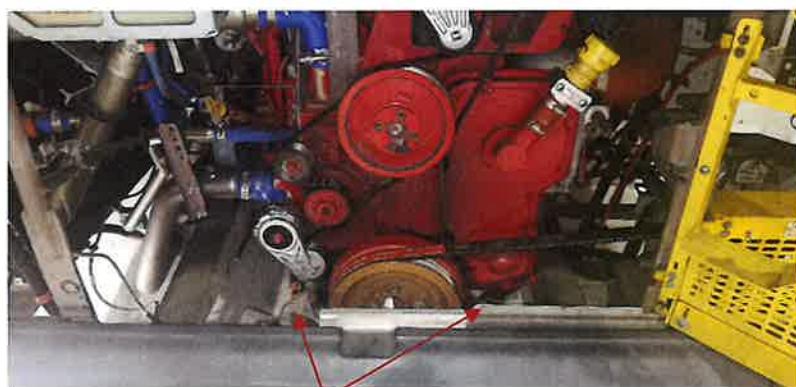
Figure 1 (Engine Mounts)

The following part numbers should be used as per application chart below to prevent installation of incorrect component and possible premature failure:

WMATA #	New Flyer #	Applicable Bus Fleets
802-60-0003	109982	7001-7100; 7101-7152; 7153-7167; 7168-7263 7264-7272; 5460-5480; 2830-2993; 7300-7409; 3100-3199; 3200-3274; 4450-4474
811-70-0002	499546

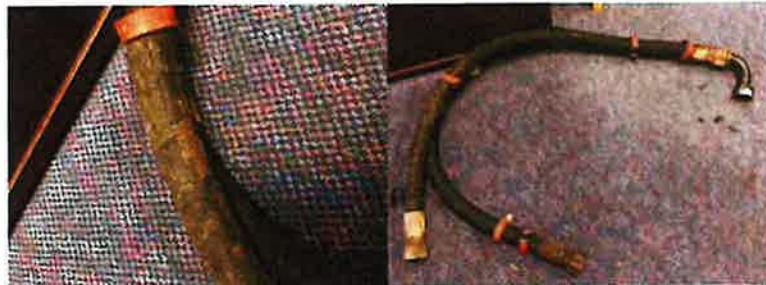
Fig. 1 Deteriorated Transmission Line Figure 2 Manulli Transmission Fluid Line

The transmission fluid lines that run to/from the transmission to the transmission cooler are deteriorating (see Figure 1) due to the increased temperatures in the engine compartment of CNG buses. The current hoses are made of a black Manulli material (see Figure 2). Upgraded hoses have been identified and placed in stock. The upgraded hoses are made of a blue Aeroquip material (see Figure 3). The stock number for these new hoses are WMATA # 906-70-0101 (New Flyer # 6366943) and 906-70-0121 (New Flyer # 6366944). A campaign to replace the Manulli lines with the upgraded Aeroquip lines has been generated under Job Plan 8091. Any deteriorated lines should be replaced as soon as practicable. Replacement instructions can be found in the Attachments section of the campaign work orders
