Technical Due Diligence Report

MAH Pont Neuf
23/25 Rue du Pont Neuf, 75001 Paris, France

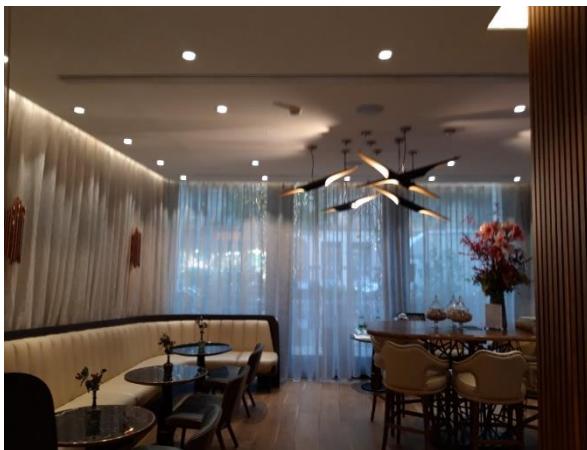
Hotel lobby

- 3.8.1. **Assessment:** The finishes and fittings of the reception lobby are in a satisfactory condition. The interior is well maintained.

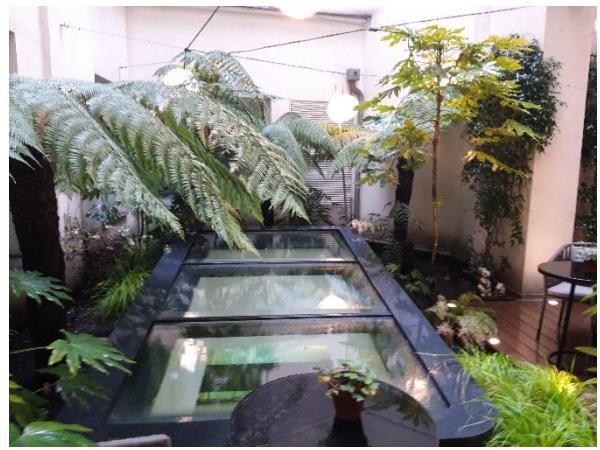
Hotel courtyard

- 3.5.1. **Assessment:** The courtyard terrace with garden is well maintained and in a good condition. ●

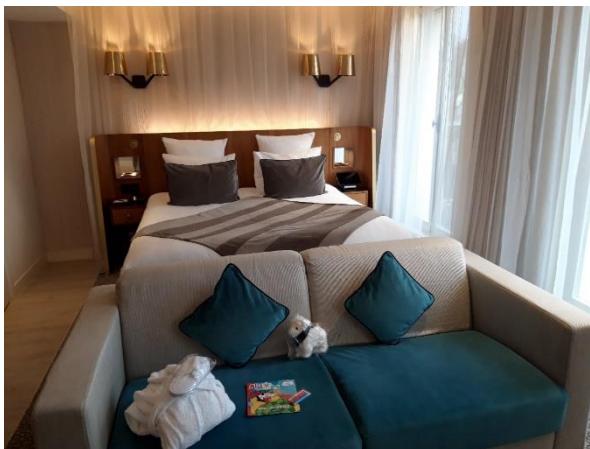
Guestroom #510

- 3.6.1. **Assessment:** The finishes and fittings of the guestrooms are in a satisfactory condition. The interior is well maintained.

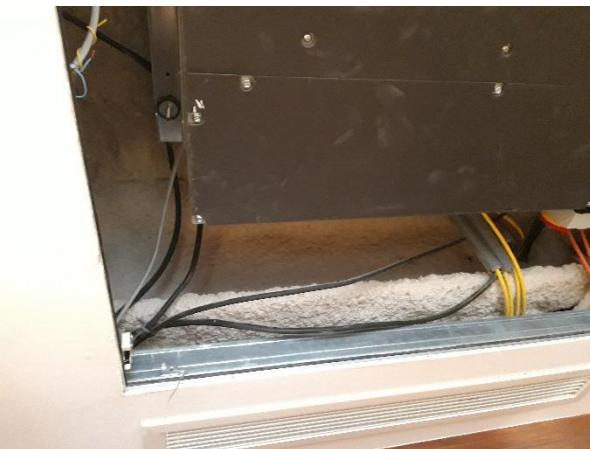
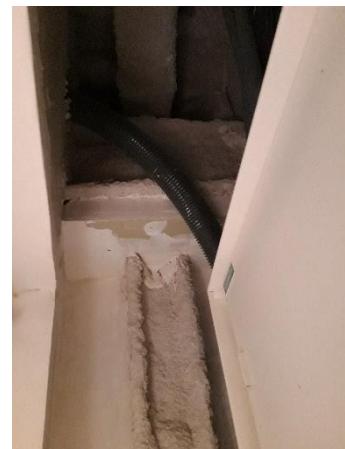
- 3.2.1. **Assessment:** The structure of the building is in good condition and no visible displacement, failure or damage was noted.
- 3.2.2. **Assessment:** The structural frame provides good floor-to-ceiling heights (see table in section 2.3).

Fire-protected steel beam for slab reinforcement

Fire-protected steel column

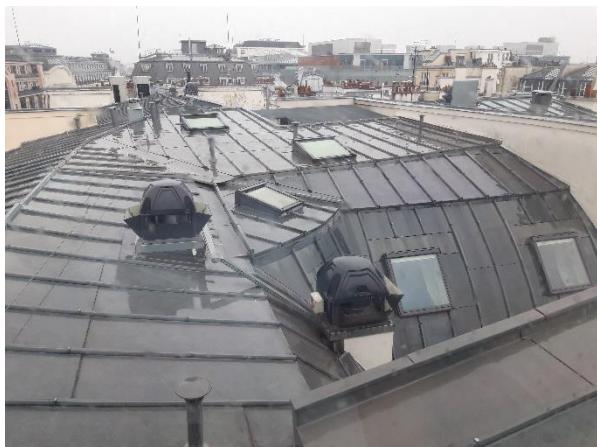
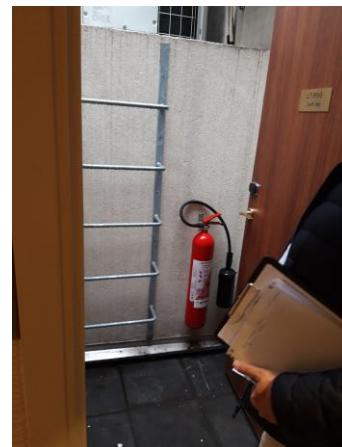
- 3.3.1. **Assessment:** The roof zinc covering is in good condition (renovated in 2016). We saw no evidence of leaks and water damage.

Hotel roof

Technical roof access

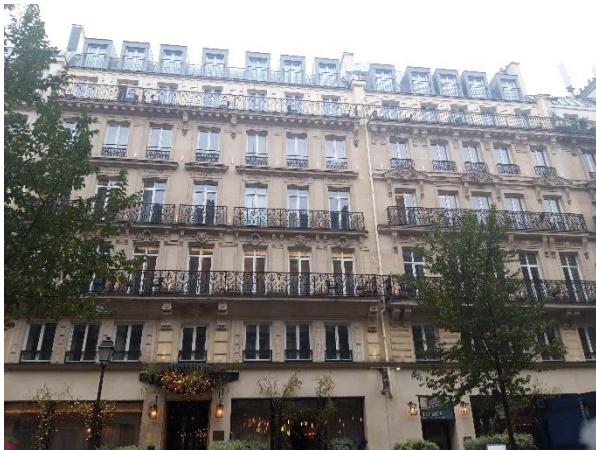
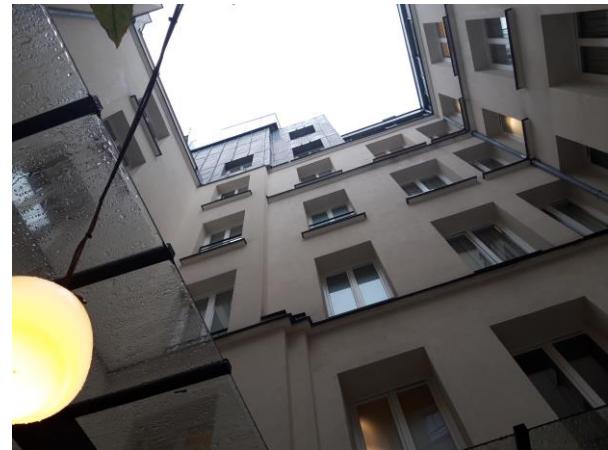
- 3.4.1. **Assessment:** The façades to the building (front and courtyard) appear in good condition. No major damage was noted.
- 3.4.2. **Assessment:** On the basis that the French Building and Housing Code "Code de la Construction et de l'Habitation" (CCH) in articles L. 126-2 and L. 126-3 requires façades of buildings in Paris to be renovated every 10 years, we have allocated a cost for façade cleaning and repainting in the medium term.
- 3.4.3. **Assessment:** The hotel façades are of solid masonry with internal thermal insulation so there is a low risk of flame spread as indicated in the Tristan Façade Fire Safety Risk Matrix.

Front Façade of Hotel

Courtyard Facade

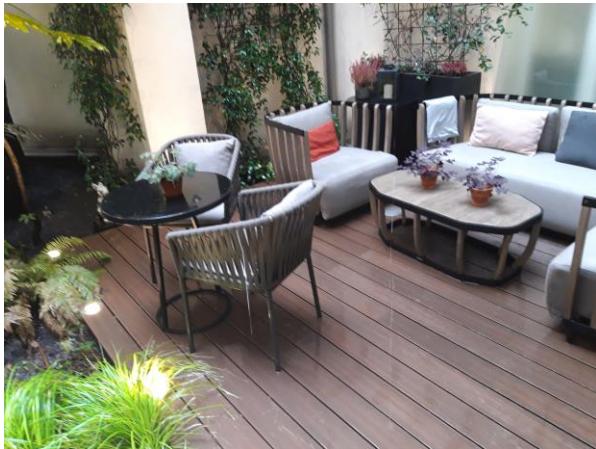
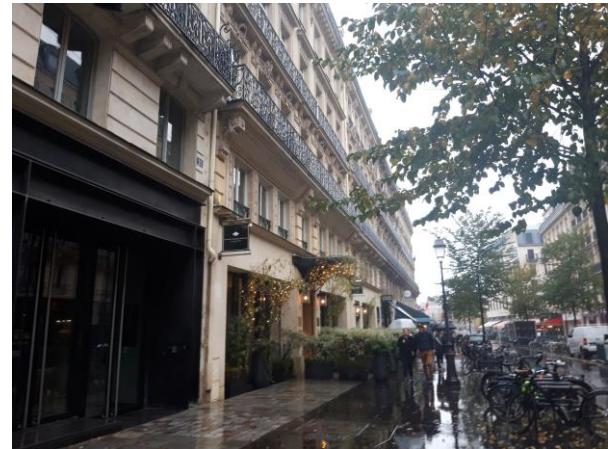
Courtyard terrace

Public pavement

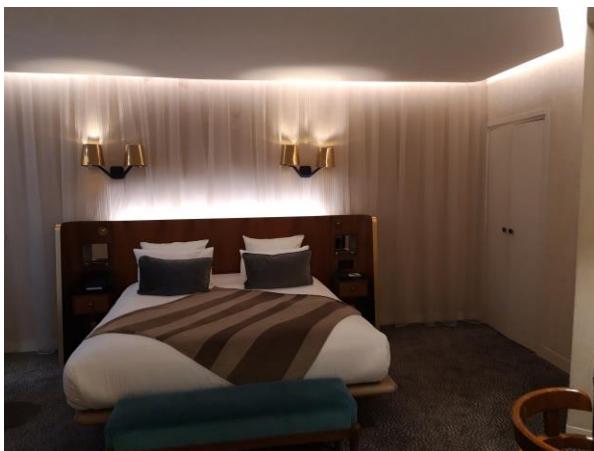
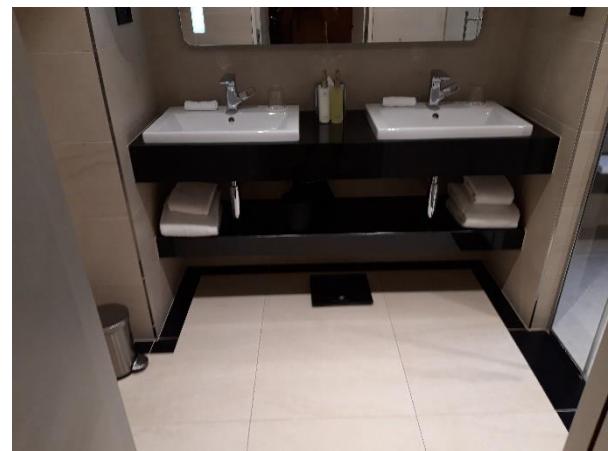
Guestroom #308

Bathroom #308

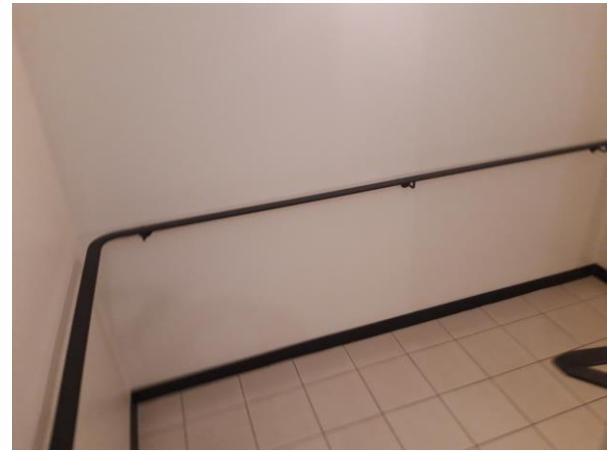
3.9.1. **Assessment:** The finishes of the back of house are in a satisfactory condition. However, we noted that the epoxy coating to the floor is lifting in several areas. We have allowed a cost to re-apply an epoxy coating to the affected areas.

'Back of House' Areas
