Rolls-Royce

| TV No. | <b>287869</b> | Issue: | <b>1</b> | Date of Application: | <b>07 JAN 2025</b> |
| Part Description | <b>LPT STAGE 1 ROTOR DISC ASSEMBLY</b> | Eng/Mod Serial No. | | <b>85169 / N/A</b> | |
| TV Title | <b>REPAIR SCORING ON EDGE BETWEEN SLEEVE ABUTMENT FACE AND CHAMFER OF BORE 22</b> | | | | |

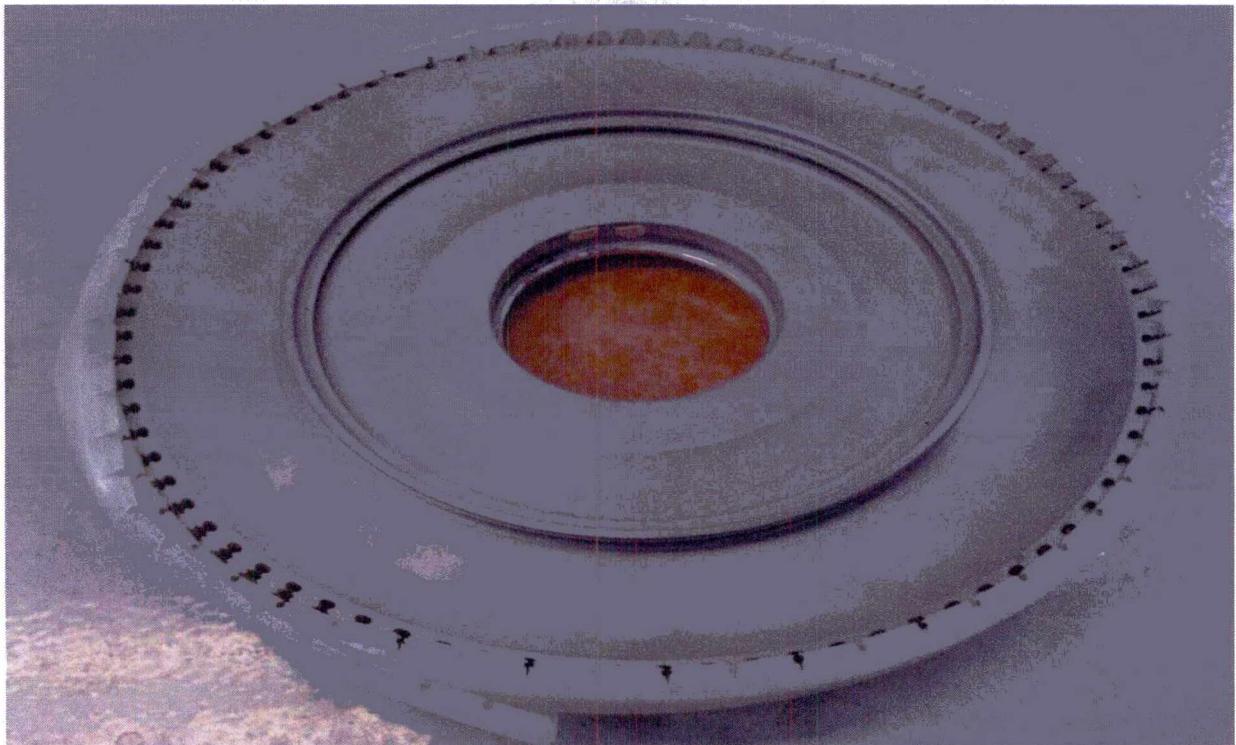
Figure 3: General view to show affected LPT Stage 1 Rotor Disc Assembly

| Location | Damage Details | Damage Depth | Dressing Depth |
|---|--|---|---|
| Bore at Location 22 | Scoring on the edge between the sleeve abutment face and chamfer covering 60% of circumference | 0,13 mm (0.005 in) | 0,13 mm (0.005 in) |

- Repair the reported scoring on the edge between the sleeve abutment face and chamfer of the Bore at Location 22 in accordance with the Repair HRS5631 Part 1, EM TASK 72-52-22-300-014 'LPT Stage 1 Rotor Disc - Repair Minor Damage by Hand Dressing (HRS5631, Iss.01)'. Make sure to dress in the circumferential direction and ensure any blending in the radial direction is kept to a minimum to maintain the disc abutment face with the Sleeve. The minimum dressing ratio (50:1) in the radial direction may be omitted. Make sure that the depth of dressing does not exceed the depth of damage and the repair blends smoothly with the adjacent area. Refer Table 1 for dressing details.

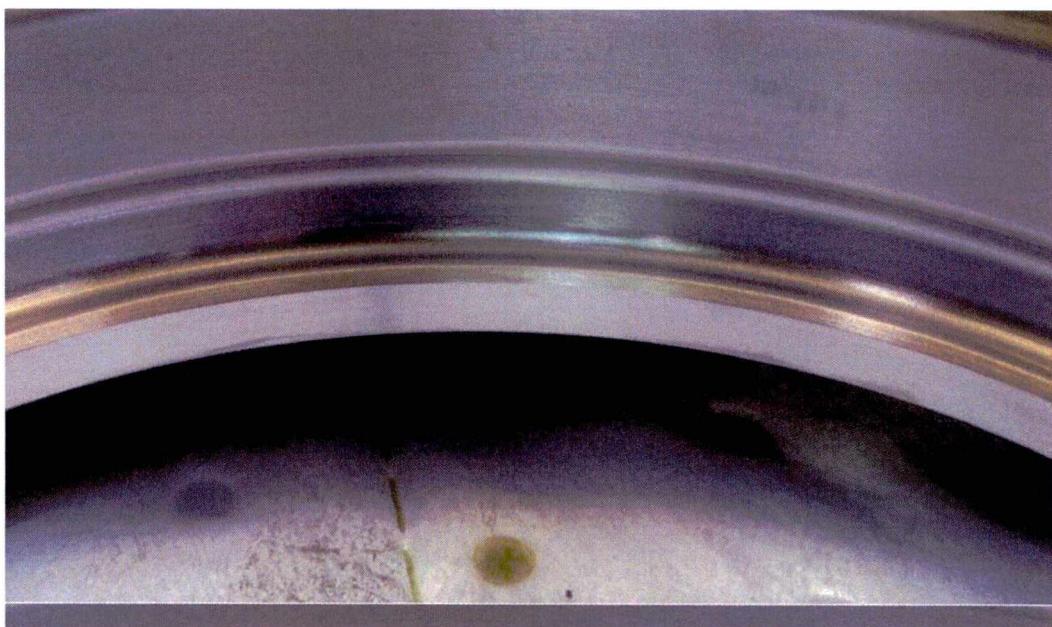
The Scoring on sleeve abutment face and chamfer at Location 22 of the LPT Stage 1 Rotor Disc Assembly is already repaired in accordance with recommendations given in this TV.

Below are the post dressing dimensions and post repair photos:

| Damage Location | Damage Depth |
|---|---|
| Scoring on sleeve abutment face and chamfer of bore 22 with 60% circumference | 0,13 mm (0.005 in) |
