Rolls-Royce

TV No.	289228	Issue:	01	Date of Application:	06 FEB 2025
Application Type	One-off <input type="checkbox"/>	Repeater <input checked="" type="checkbox"/>	Expiry date (If Repeater)	05 FEB 2026	
Operator/Applicant	ALL OPERATORS / ALL APPLICANTS			Original Request No.	BRG3462 Issue 02
Engine Type	BR700-710			Engine Mark/Model (s)	BR700-710D5-21
Part Description	Low Pressure (LP) Compressor Fan Blade Assembly			Eng/Mod Serial No.	N/A
Part No.	KH89518, KH90969 and LV31558			Part Serial No.	N/A
Manual Title	EMM	Ref.	M-710-8BR	ATA/DMC Ref.	72-31-02
TV Title	ADVANCE COPY OF BRG3462 ISSUE 02 (LOW PRESSURE (LP) COMPRESSOR FAN BLADE ASSEMBLY – REPAIR OF THE LEADING AND TRAILING EDGES BY RE-PROFILING)				
Hours	N/A		Cycles	N/A

LP compressor fan blade assembly

Repair of the leading and trailing edges by re-profiling– BRG3462, Issue 02

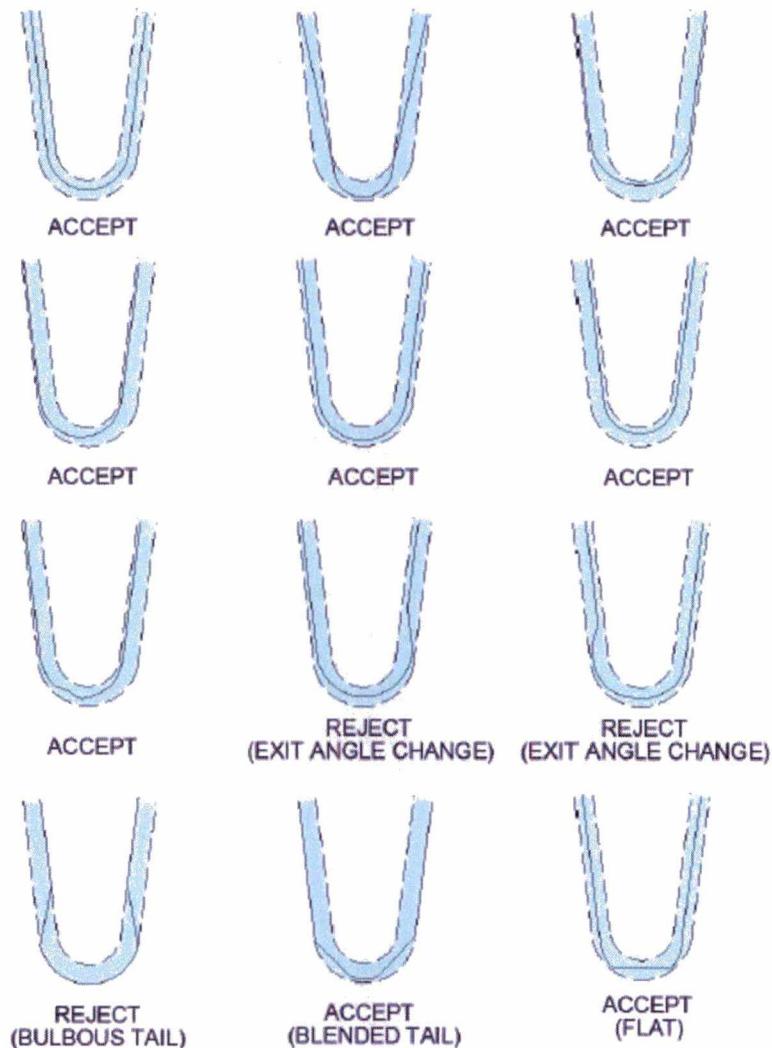
Figure 1, Sheet 7: LP compressor fan blade assembly – Repair details and dimensions (Sheet 7 of 89)
[Applicable to: BR710D5-21]

TYPICAL TRAILING EDGE PROFILE
