Location: Dalgety Bay, Dunfermline

Client: AMEC

Ref: P3191-11-R1-A

SUMMARY REPORT

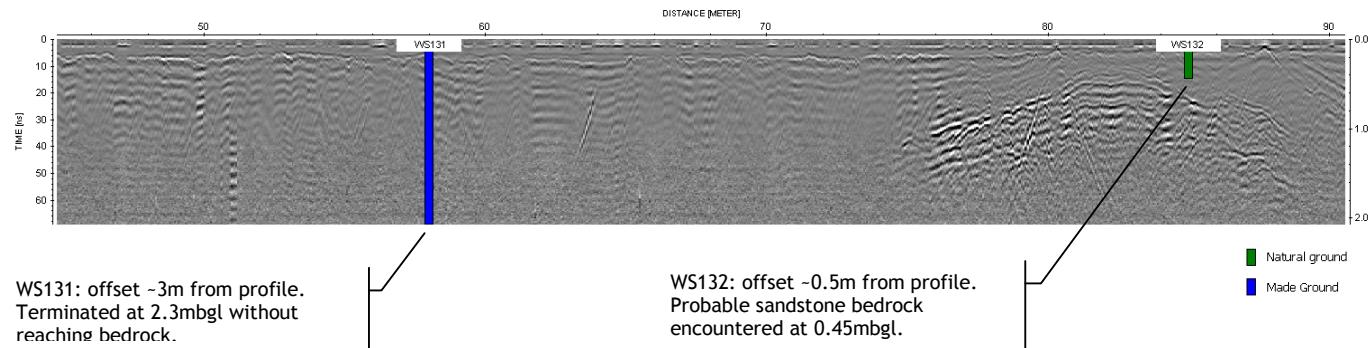
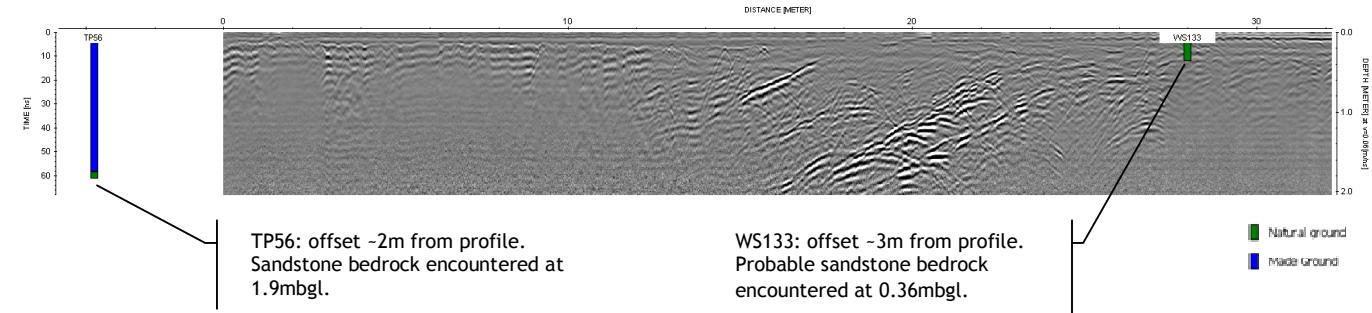
Figure 2: Example radargrams from the south of the Site

Example GPR data from the south of the site, together with information from nearby boreholes.

This interpretation is supported by the GPR data which shows a highly attenuated signal throughout the interpreted Made Ground (see Figure 3).

Further west, several dipping reflectors are visible in the GPR data which coincide with a decrease in the depth to bedrock observed in the boreholes (illustrated in Figure 3). These reflectors have therefore been interpreted as the top of, or beds within, the observed sandstone bedrock. In this area the GPR signal is far less attenuated, the ground conductivity is low and there is a low concentration of buried metal detected in the magnetic survey. It is therefore likely that the ground is predominantly natural in this area.

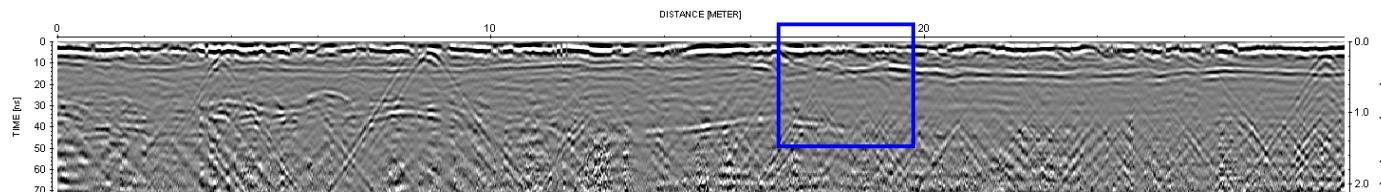
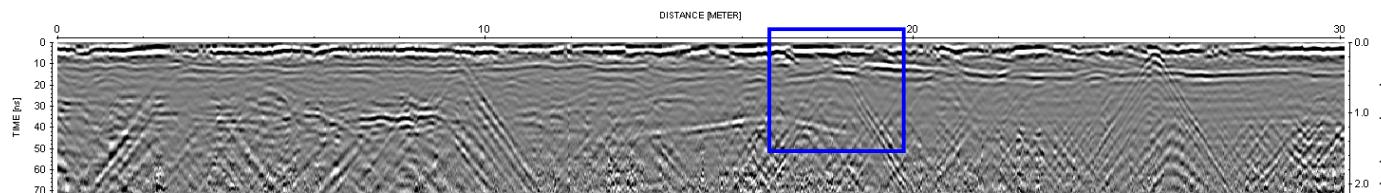
Figure 3: Example radargrams from the north of the Site

Example GPR data from the north of the site showing a change in stratigraphy (boxed in blue).

Further to the south west there is a high concentration of buried metal coinciding with Made Ground in the borehole logs. This has been interpreted as 'Made Ground - Zone 2'. The area south of this region has a lower concentration of buried metal and the borehole logs comprise mostly natural materials. This area is therefore considered likely to be predominantly natural ground. However, unlike in the southern area, the boundary between natural ground and 'Zone 2' is not corroborated by a feature in the GPR data.

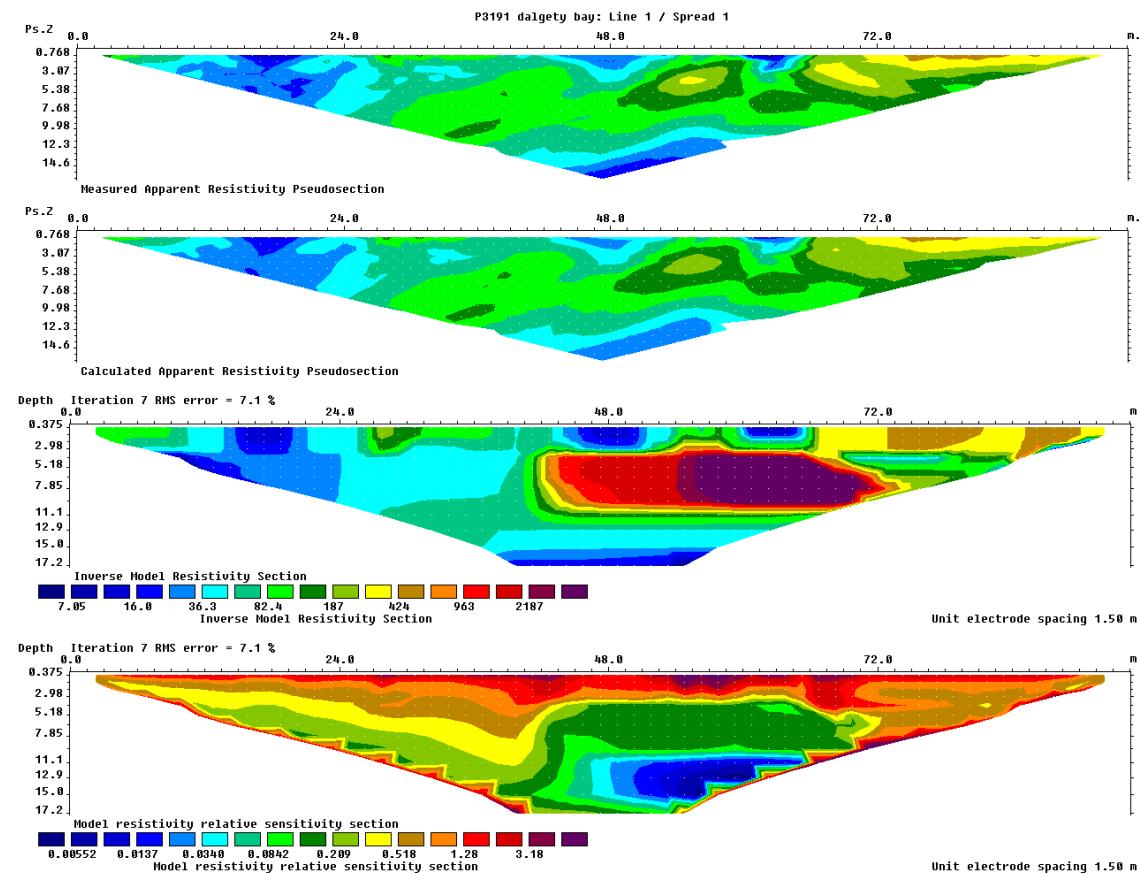
Figure 4: Example ERI data

Example resistivity data from the south of the site.

An ERI profile was also acquired in this area (see Figure 4) in order to determine the thickness of the conductive anomaly. The resulting cross section of ground resistivity is shown in the third panel in Figure 3. The results show a change from resistive to conductive to resistive ground moving west to east. This is consistent with the FEM data and provides additional confidence in the results of the survey. Unfortunately the results do not allow an estimate of the thickness of Made Ground to be made. This is primarily due to shallow buried metal affecting the sensitivity of the model at depth.

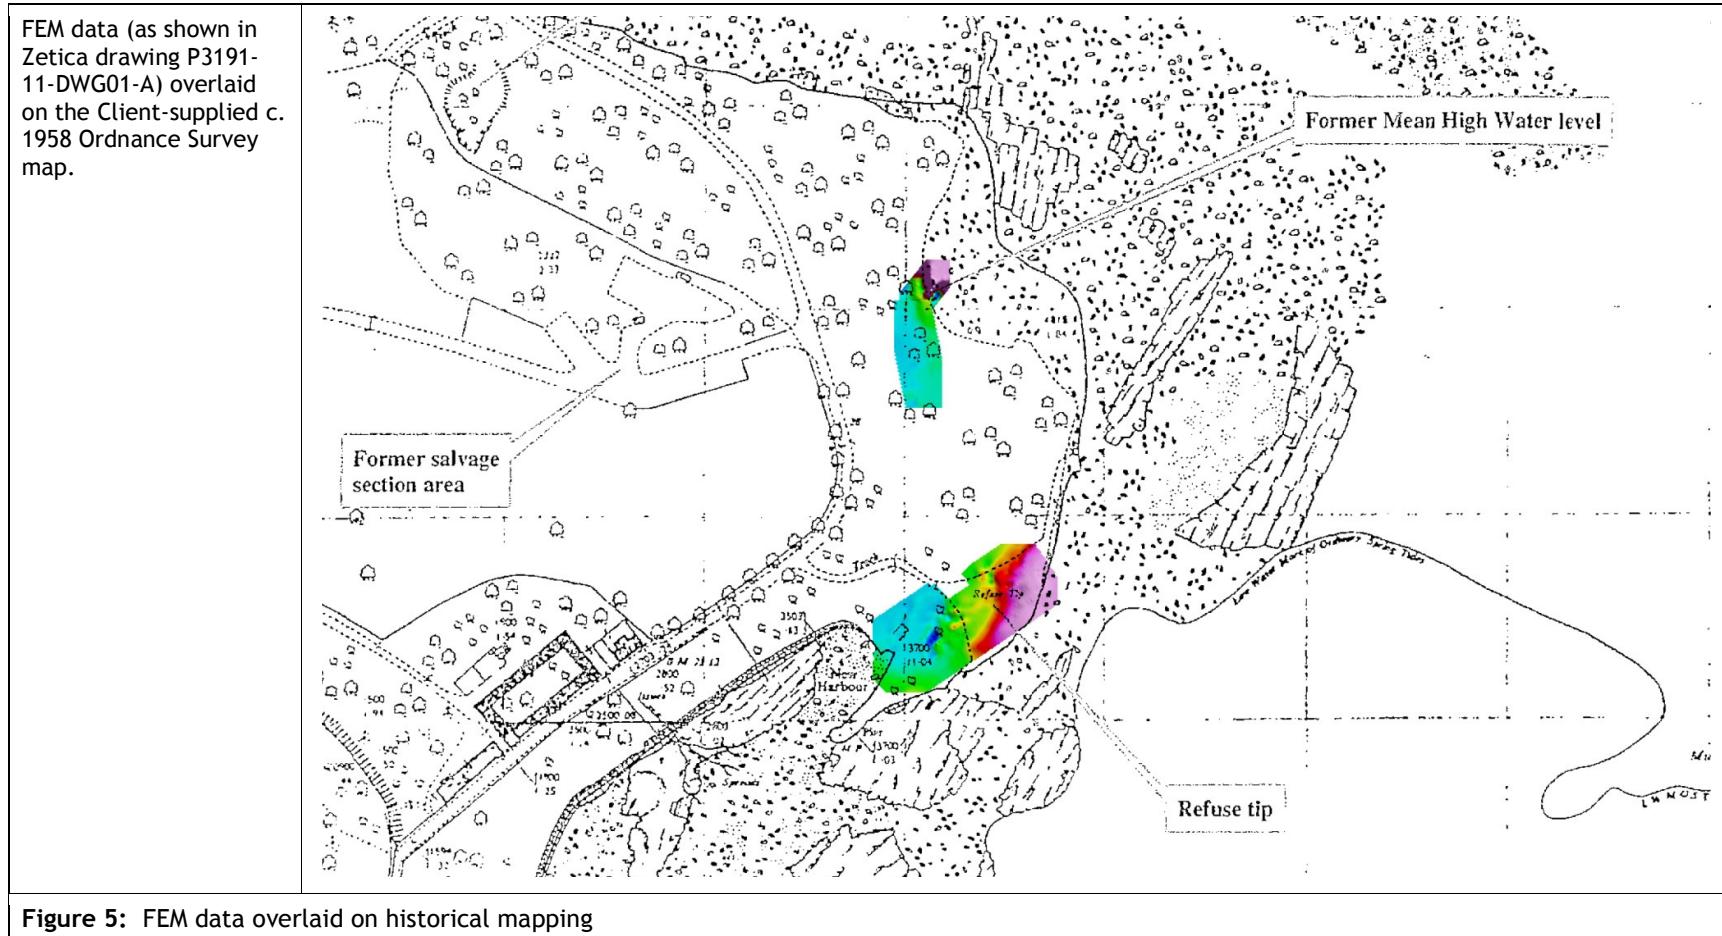
Figure 5: FEM data overlaid on historical mapping

The FEM data (see Zetica drawing P3191-11-DWG01-A) in this area shows a high conductivity anomaly ('warm' colours) to the south-east. This anomaly coincides closely with the location of a refuse tip shown in the historical mapping (see Figure 5). Borehole logs in this area show layers of ash and clinker within the Made Ground. It is therefore considered likely that this anomaly corresponds to an increased concentration of the incinerator waste suspected to have been deposited in this area. This area corresponds to 'Made Ground - Zone 1' in DWG03.

In the northern area, the FEM data again shows a high conductivity anomaly which closely coincides with a feature in the historical mapping (see Figure 5). In this case the edge of the anomaly coincides with the former coastline indicated on Ordnance Survey map. The FEM data in this area were significantly affected by the presence of boats and other metal objects on the surface so this feature must be interpreted with caution. However, the shape and character of the anomaly is difficult to explain based on the surface metal alone. Furthermore, the edge of the anomaly coincides closely with a change in stratigraphy observed in the GPR data. Finally, the boreholes within this anomaly are the only ones in this vicinity of the survey area which contain ashy Made Ground. This anomaly has therefore been interpreted as 'Made Ground - Zone 1'.

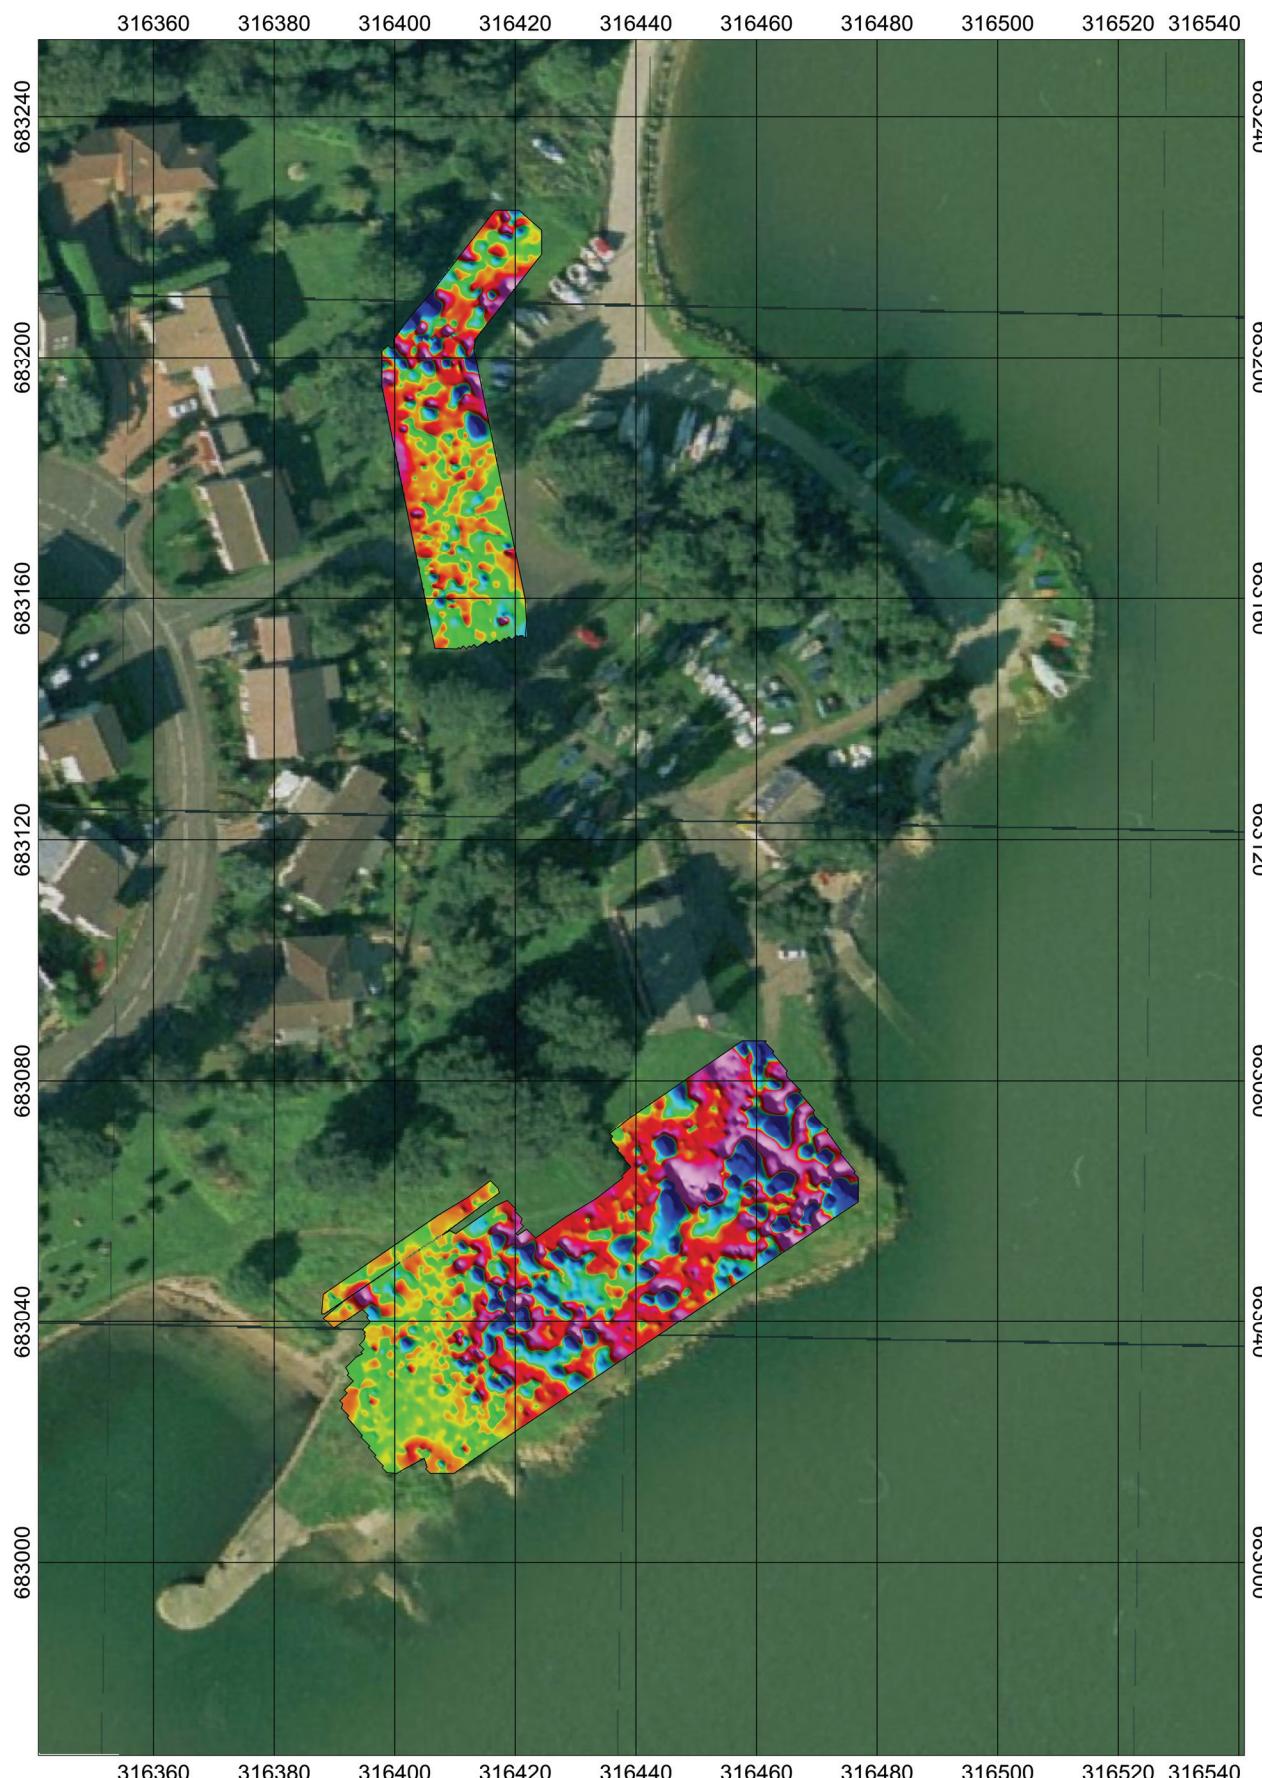
P3191-11-DWG02-A

Further west the ground conductivity is lower but the magnetic data (see Zetica drawing P3191-11-DWG02-A) shows a high concentration of buried metal consistent with Made Ground. This area corresponds to 'Made Ground - Zone 2' in DWG03.

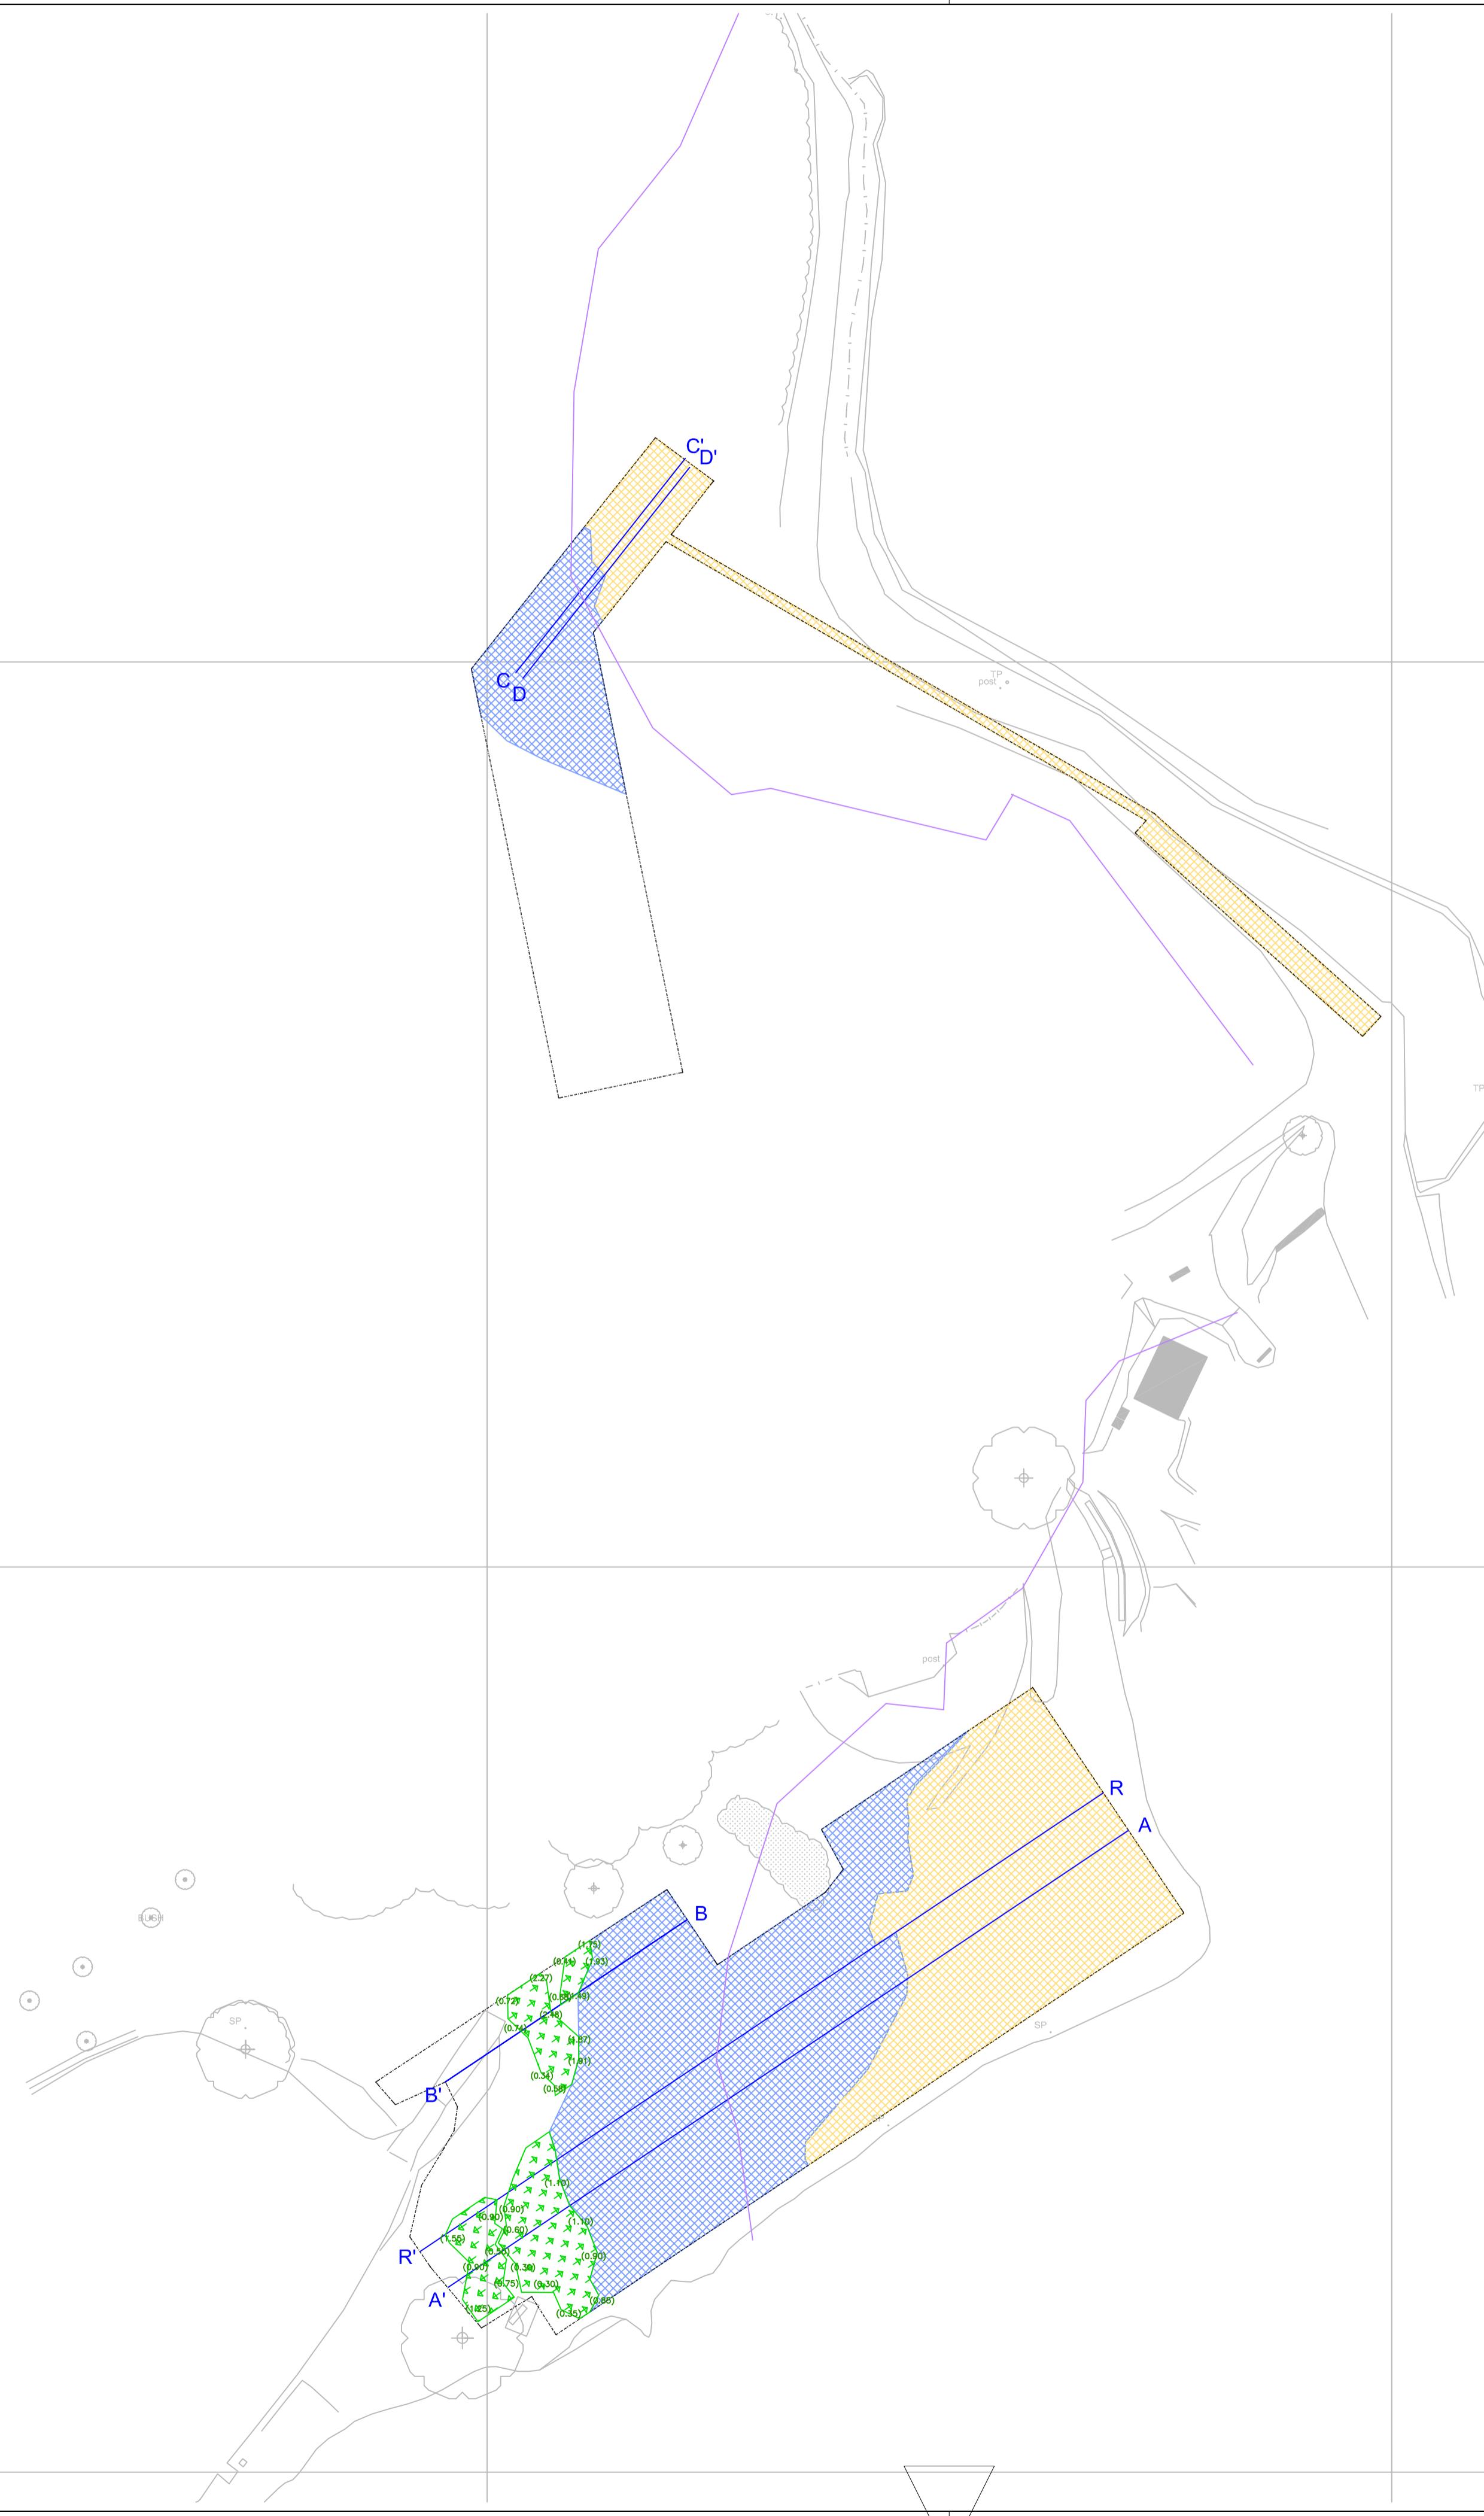
The results of the survey are summarised in Zetica drawing P3191-11-DWG03-A. The survey has successfully delineated several areas of probable Made Ground. These have been grouped into two categories according to their signature in the geophysical data.

'Zone 1' shown in DWG03 is characterised primarily by a high bulk electrical conductivity. Given the history of the site and the results of the intrusive works this likely due to an increased concentration of the incinerator waste suspected to have been deposited on the Site. 'Zone 2' shown in DWG03 is characterised by a lower electrical conductivity with a high concentration of shallow buried metal (detected in the magnetic survey). The remainder of the survey area is considered likely to comprise predominantly natural ground.
