Reference: Summary report of the boiler explosion on the s.y. Carola - 13.06.92 - Resulting in scalding and death to two people - Ref: 943/92 - File No: MAIB 1/2/36

Re: F0007155 – Freedom of Information request regarding S/Y Carola

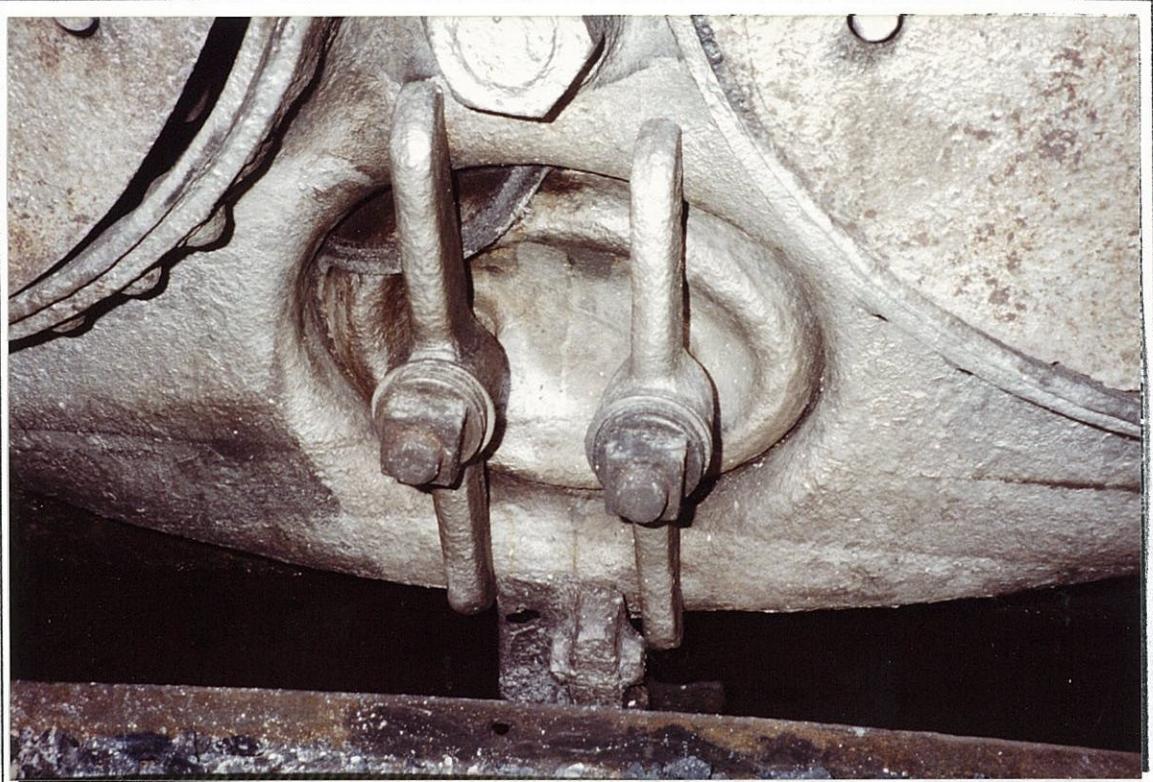
*Further examination showed that a 5" section of the lower mudhole door jointing had become displaced allowing free access for the flow of water within the boiler space to the front of the boiler.*

*It was also noticed that the starboard strongback (or right hand side looking towards the boiler) was some 15mm lower than the port strongback. This indicated that the door had not been fitted in a central position.*

No 4 Close-up view of lower mudhole door showing length of door joint blown out on port upper side of door. Note right hand side, or starboard, strongback visually lower than left hand side. Water was still in the boiler at this time but below the level of the blown joint.

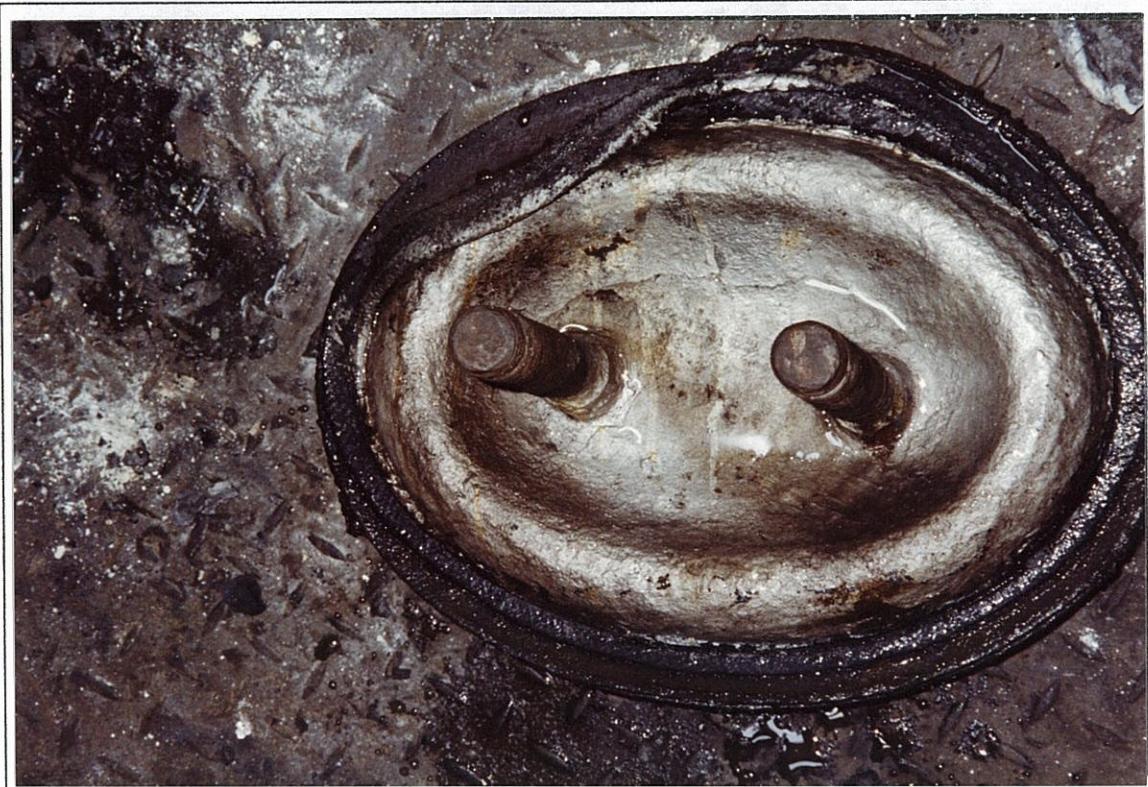
*The door was removed from the boiler and the joint examined. The impressions left on the joint showed that the door had been tightened up when not central with the result that the upper port edge of the joint was only just nipped. The normal width joint under compression should be in the order of 1/2" on the whole circumference whereas on the joint removed from the lower manhole, compression width varied between the full 1/2" and approximately 1/8". This variation in compressed area was the result of in-correct refitting of the mudhole door.*

No 5 Lower mudhole door removed showing intact joint and compression marks.

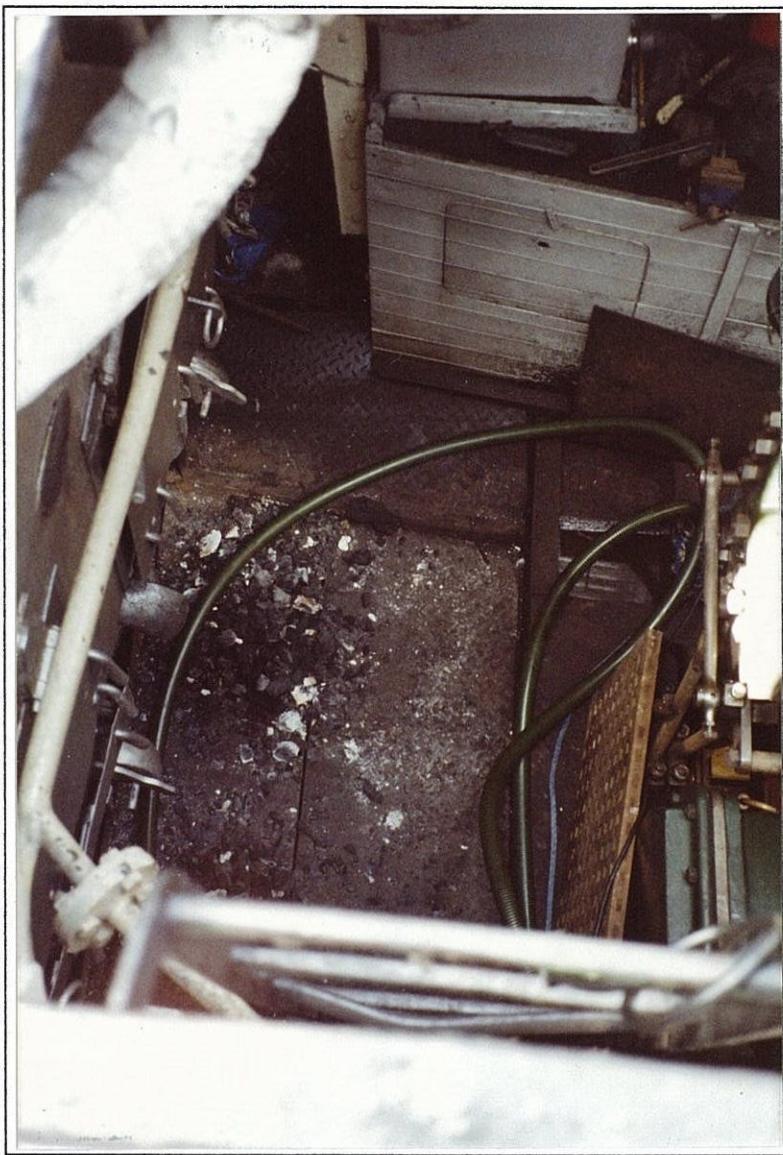
No 1 General view from deck access hatch, looking to starboard, showing front of boiler, floor plates in front of boiler and forward end of main engine. Note ash on floor plates deposited when coal fires were drawn. The probable position of Mr Richard Martino at the time of the accident would have been towards the top of the picture alongside the work bench. i.e on the starboard side.

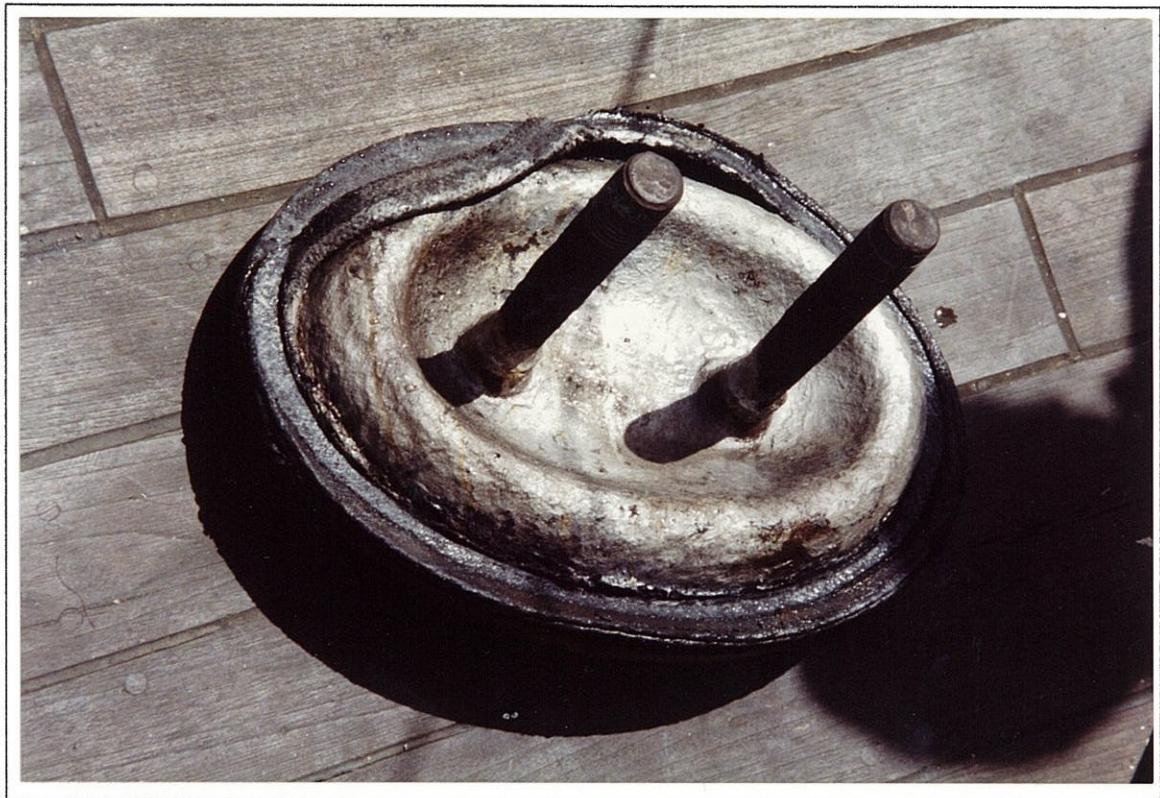
No 6 General view of lower mudhole door removed from engine room to deck. Note compression marks on joint tapering off the door cill on the left hand side. i.e. on port upper side of door.

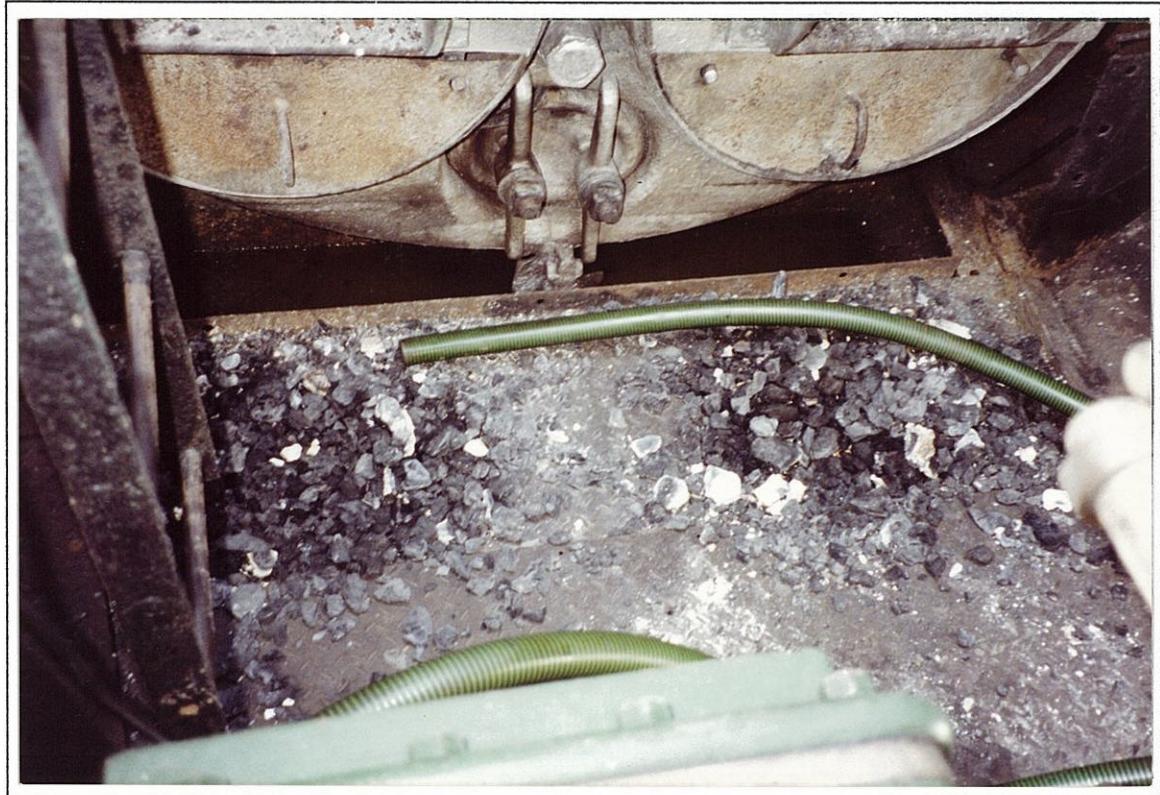
No 3 Similar view to above. Note this was condition of boiler front on inspection and prior to opening up and removal of mudhole door.
