SPECIAL CONSIDERATIONS IN USING THE MC6801 INTERRUPT CAPABILITIES

Prepared by
Clint Bauer
Systems Engineer
Motorola Automotive Electronic Systems
Mesa, Arizona

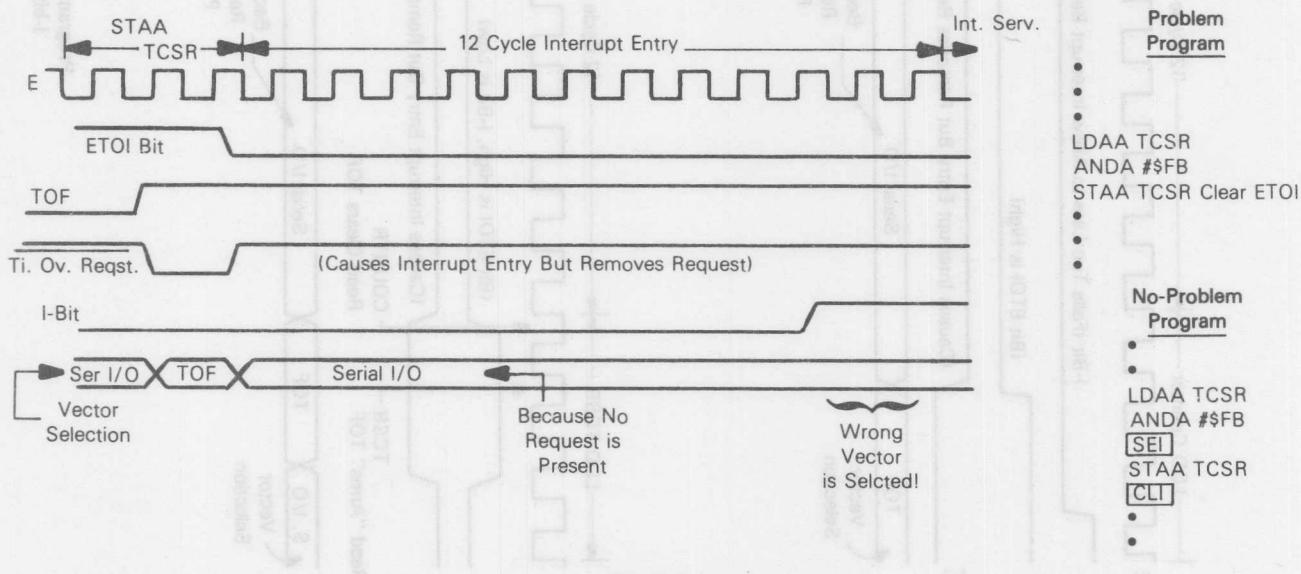
1. *Clearing IRQ2 Enable Bits While I-bit is Clear* — Programs are often structured such that mask-bit I is clear during background or non-interrupt execution. Some programs will also purposely clear the I-bit during interrupt service routines. At either time, software that clears an $\overline{IRQ2}$ enable bit should be avoided because the corresponding interrupt flag may have just become set. Figure 6 shows that an $\overline{IRQ2}$ interrupt only momentarily requested can result in erroneous selection of the serial I/O vector. To prevent this, use in-

FIGURE 6
Programs that clear IRQ2 enable bits while
I-bit is clear risk improper vector selection.

struction SEI to mask all interrupt requests for the short time that it takes to clear the desired enable bit, then clear the I-bit again with instruction CLI. The SEI/CLI combination is unnecessary when the programmer knows that the I-bit is already set, as is usually true within interrupt service routines that do not themselves alter the I-bit.

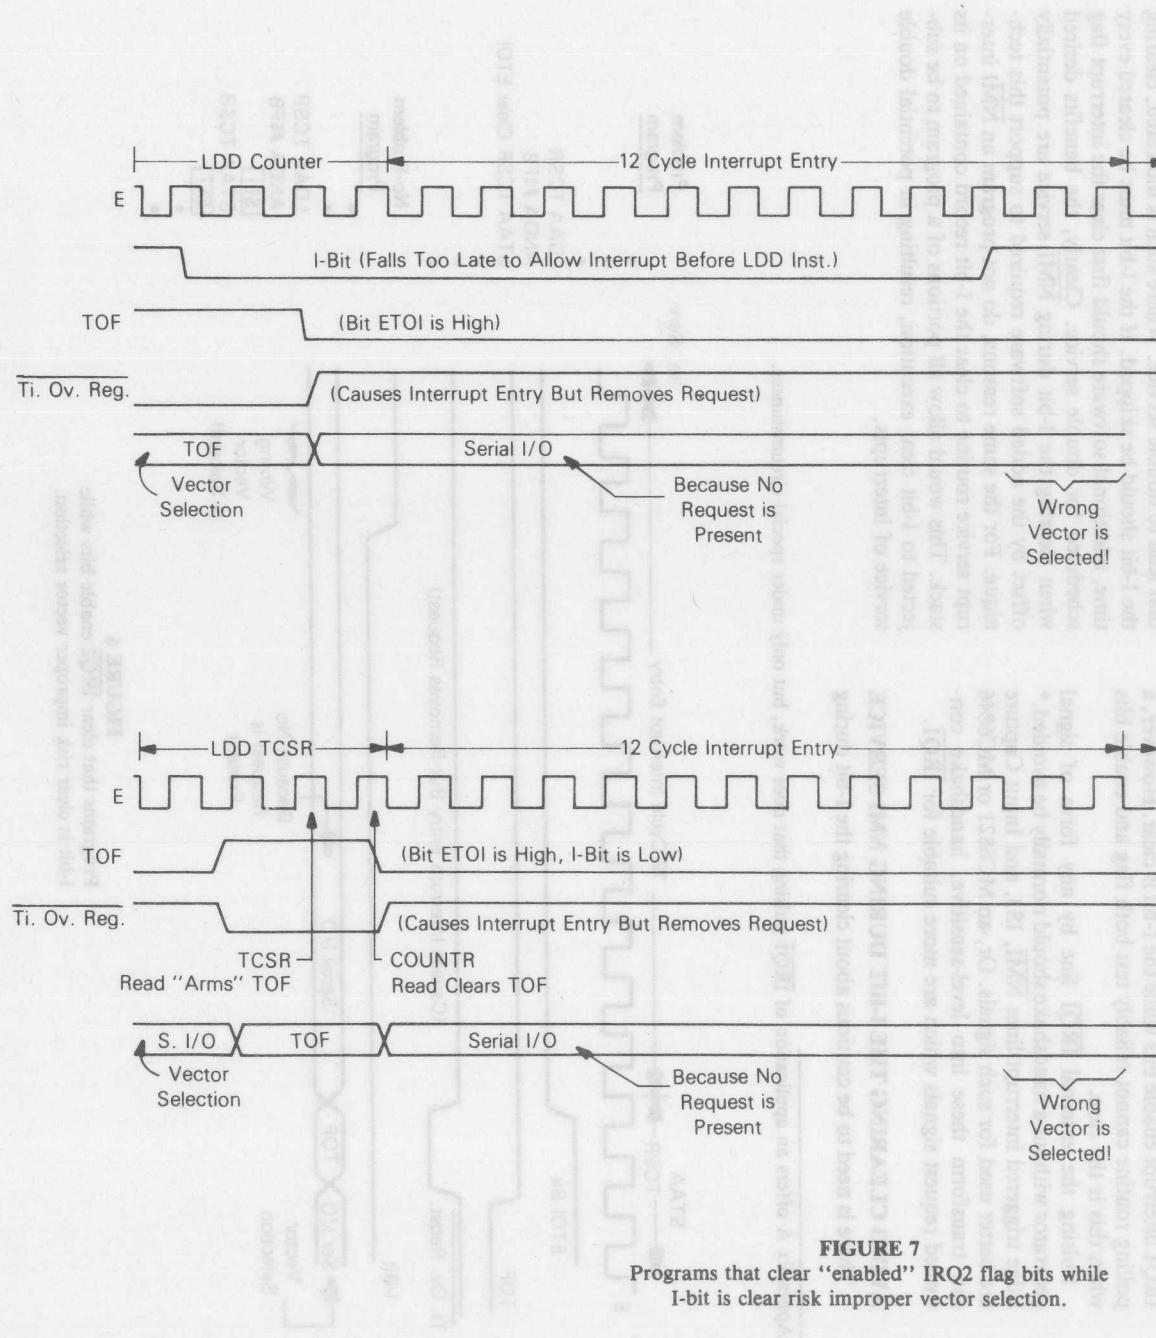
2. *Clearing Enabled $\overline{IRQ2}$ Flag Bits while I-bit is Clear* — $\overline{IRQ2}$ requests can also be removed by clearing the interrupt-flag itself. Doing so just as the interrupt is to be serviced should be avoided to prevent improper serial I/O vector selection, as demonstrated in Figure 7a.

Two special cases of programming practice can also generate this undesirable result. The double-byte read instructions "LDD TCSR" (\$8) and "LDD TRCSR" (\$11) are used to arm and clear interrupt flags TOF, RDRF, and ORFE. As such, they are excellent for use as the software handshake needed during service of these flags, but altogether improper any time their interrupts are enabled and the I-bit is clear.

For example, TOF might set, arm, and clear within the four cycles of "LDD TCSR" execution. Though the request is removed, it is still able to initiate an interrupt entry sequence, resulting in erroneous service of the serial I/O routine (see Figure 7b). Good programming practice would clear interrupt flags only during the appropriate service routine, which is the best solution to this difficulty. "LDD TRCSR" can similarly clear RDRF and/or ORFE while simultaneously initiating an interrupt sequence. Again, the serial I/O vector is selected, which is seemingly proper in this special case. However, the serial interrupt service routine normally polls flags RDRF, ORFE, and TDRE to determine the actual interrupt source. It is possible, then, that RDRF or ORFE service be skipped due to improper flag-clearing.

FIGURE 7
Programs that clear "enabled" IRQ2 flag bits while
I-bit is clear risk improper vector selection.

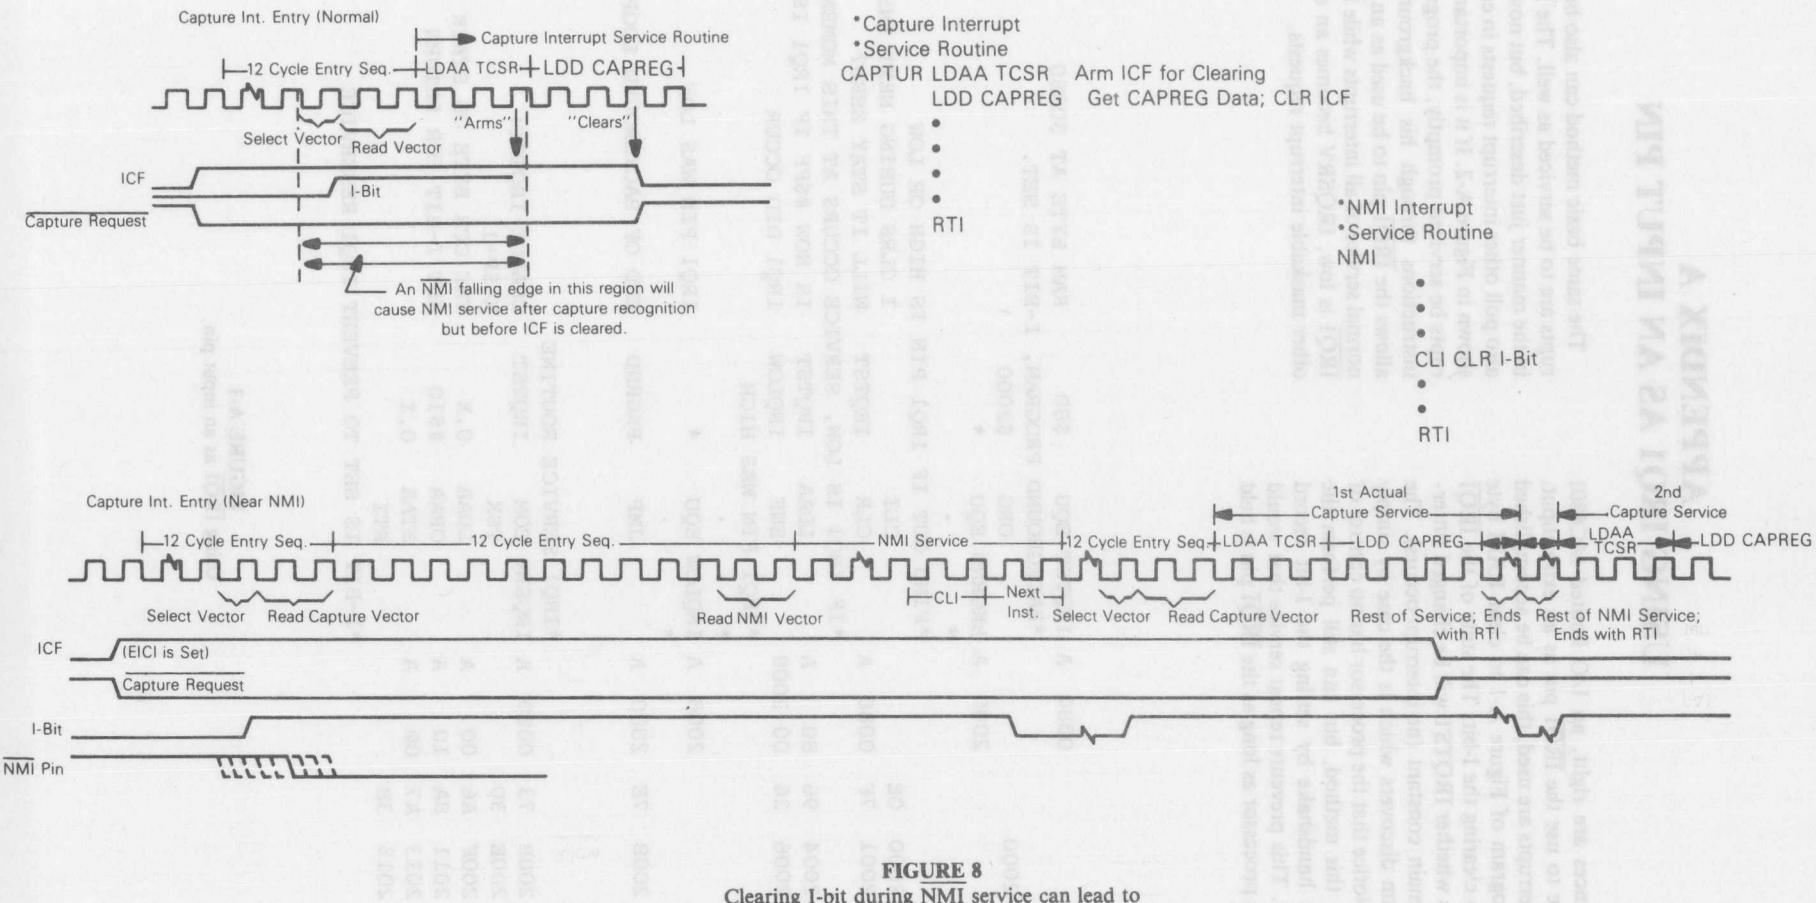
Double service occurs whenever an I-bit clearing NMI service routine is executed before the flag-clearing handshake of an already entered IRQ1 or IRQ2 service routine. For example, Figure 8 shows that an NMI occurrence during a particular window of time prevents the quick handshake that clears ICF. When NMI service executes instruction CLI, flag ICF teams with enable bit EICI to again request capture service. As shown, all routines will execute properly and to completion, including *double* service of the twice-called capture routine.

FIGURE 8
Clearing I-bit during NMI service can lead to double service of IRQ1 or IRQ2 interrupt.

Clearing the I-bit during other service routines will not generate this situation, although doing so before clearing the calling interrupt request is disastrous. The best way to avoid any problem is to leave the I-bit set throughout NMI service. Where this is undesirable, additional software can be added to the NMI routine stack and compare it to all possibilities that lead to double service. Where such is indicated, clearing the I-bit should be skipped. If the I-bit must be cleared every time, additional software should first clear the interrupt flag scheduled for double service. Clearly, the benefits desired when clearing the I-bit during NMI service are potentially offset by the added software required to support this technique. For the same reasons, do not program an NMI interrupt service routine to clear the I-bit record contained on its stack. This would allow all portions of a program to be subjected to I-bit clear execution, resulting in potential double service of interrupts.
