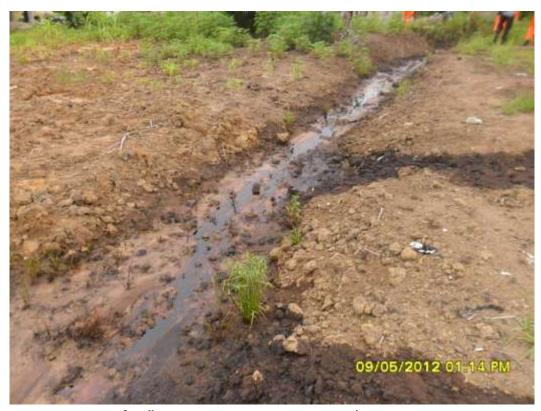
Overview: Part of spill impact on 28" Bomu-Bonny pipeline at K-Dere. Picture was taken during Joint Investigation of 9th May 2012.

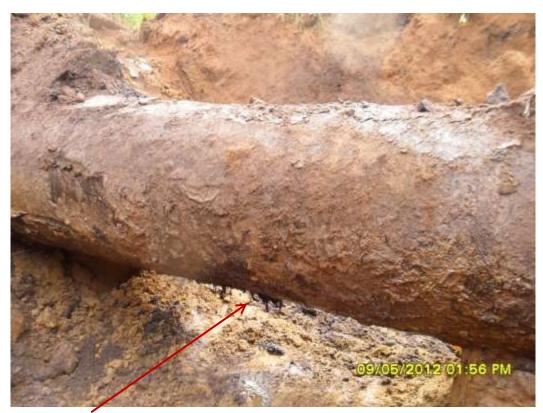
<u>Close up:</u> Leak point, due to corrosion, at 6 o' clock position on 28" Bomu-Bonny pipeline at K-Dere. Picture was taken during Joint Investigation of 9th May 2012.

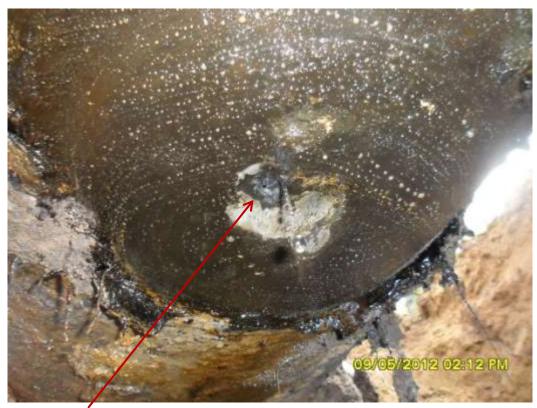
<u>Close up:</u> Leak point, due to corrosion, at 6 o' clock position on 28" Bomu-Bonny pipeline at K-Dere. Picture was taken during Joint Investigation of 9th May 2012.
